Robert C. Jackson
General Manager & Director
Construction & Engineering
Sunrise Powerlink Project

Subject: Response to the Notice of Non-Compliance Dated February 2, 2012:
Sunrise Powerlink Project
Failure to Make Timely Notification after a Serious Accident/Incident

Subject: Assessment of incidental impacts resulting from wire drop in tower spans between CP95/CP96 and CP100

**SUNRISE POWERLINK:
FINAL – Unanticipated Event Notification Form**

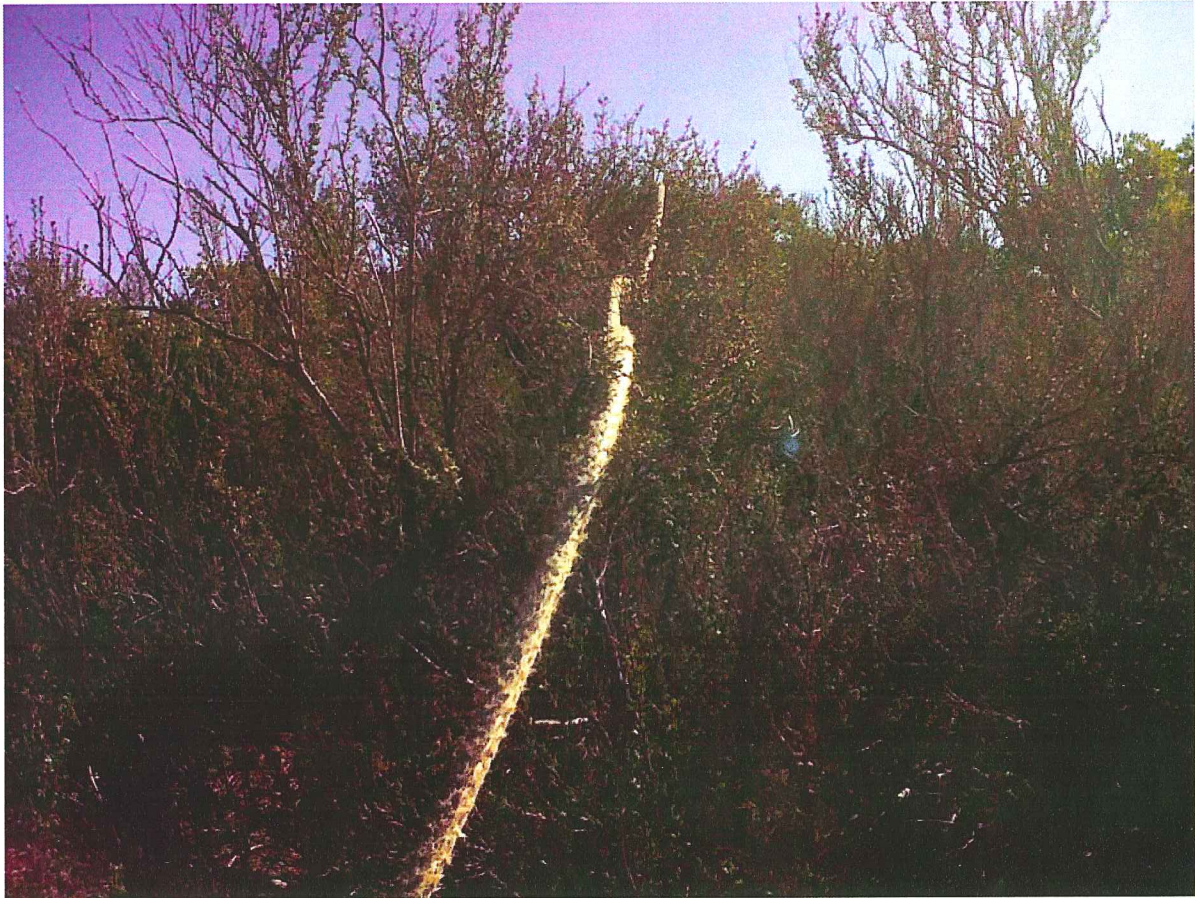
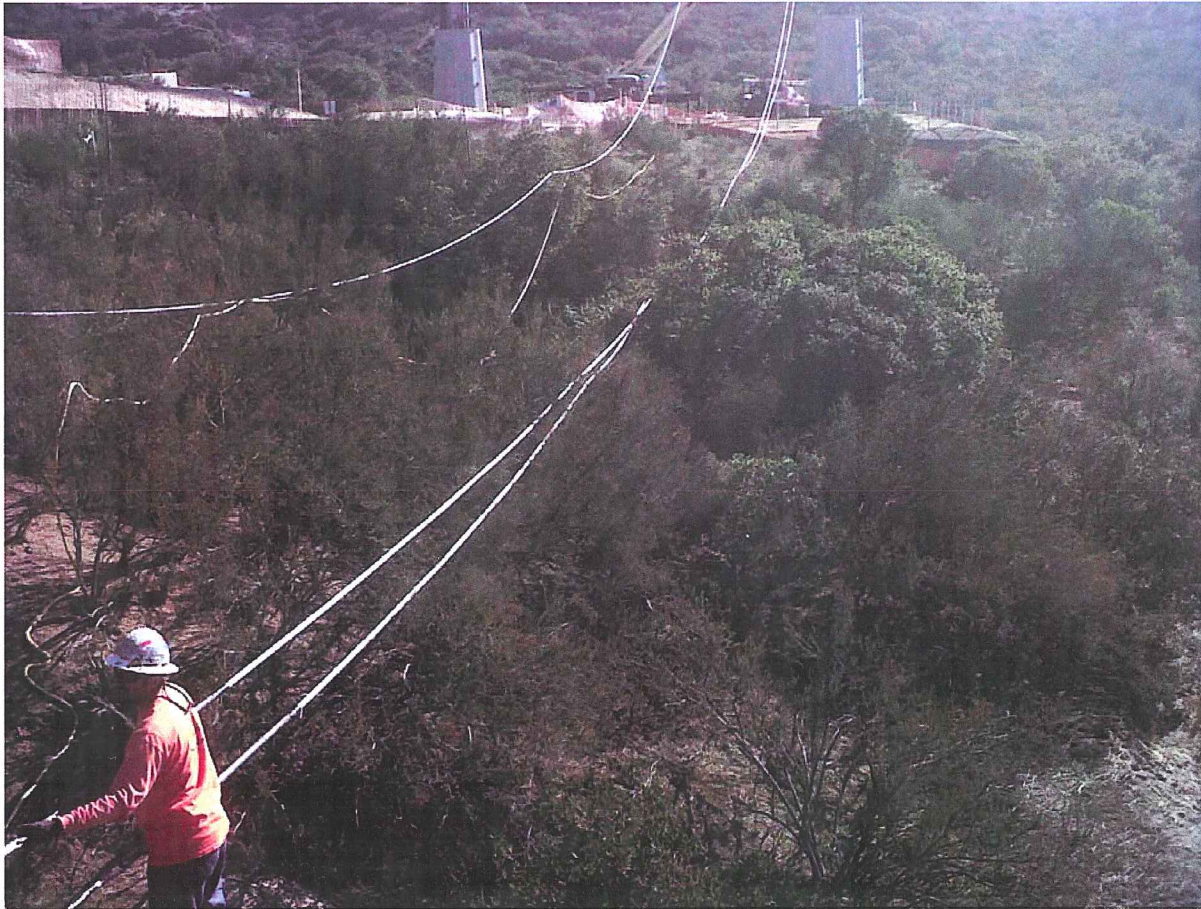
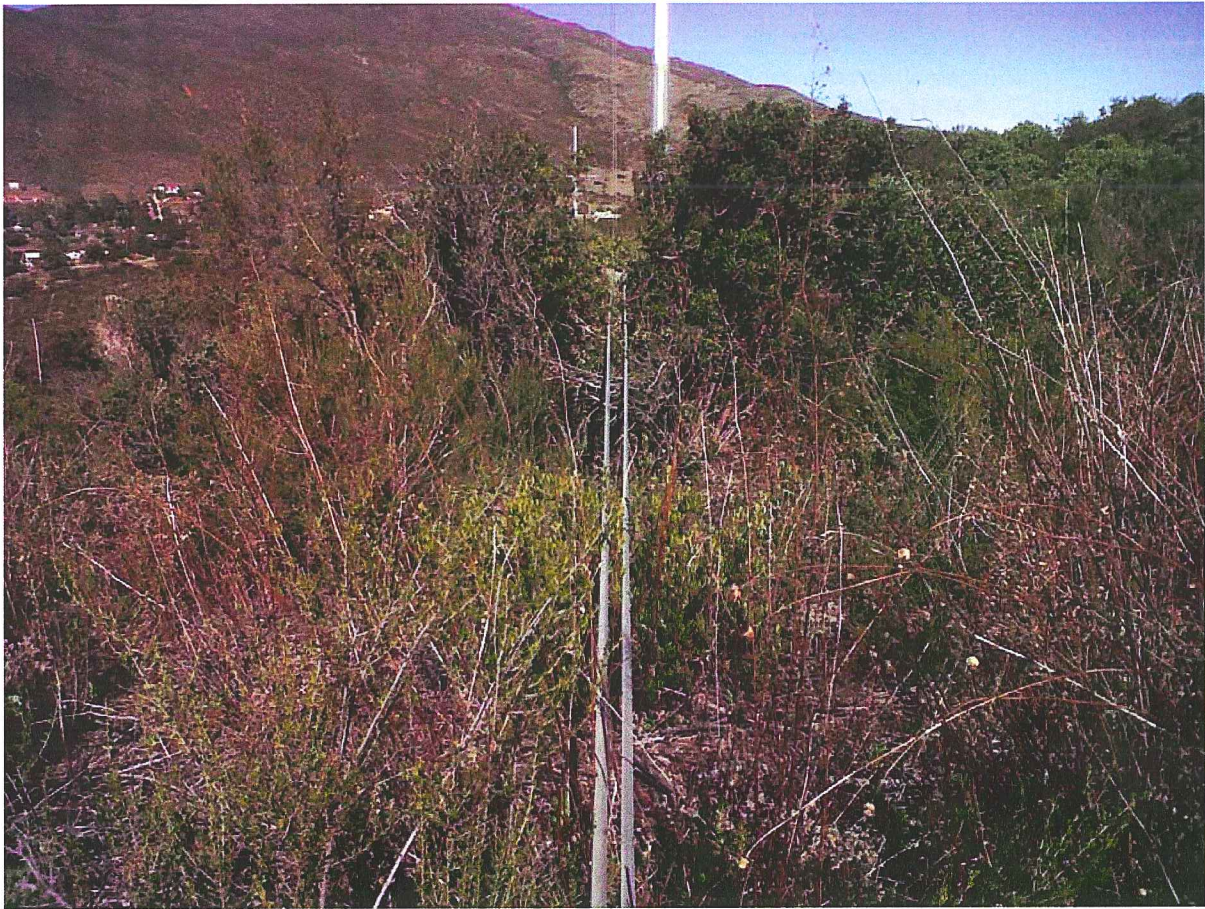
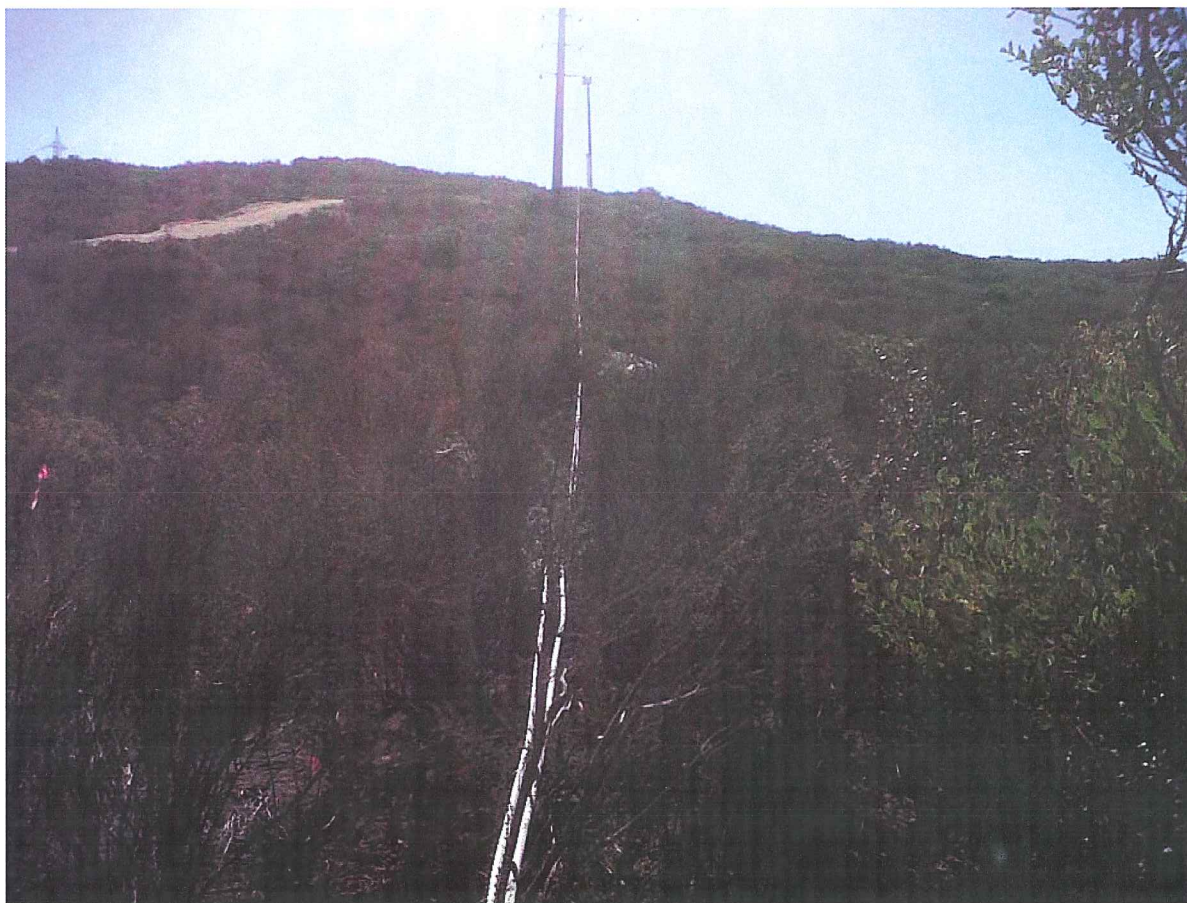
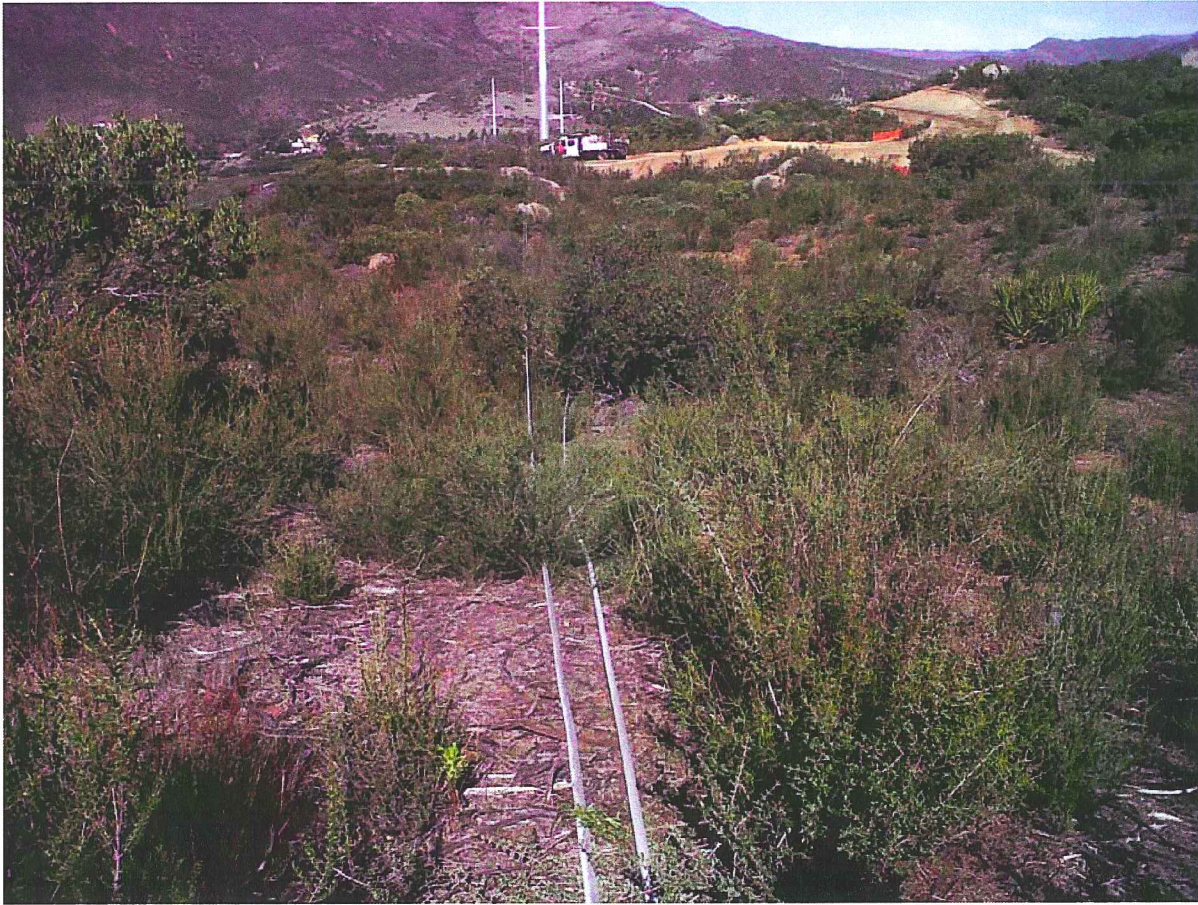
Impacts due to the wire drop occurred over approximately 2500 square feet (1x2500) of the ROW in the form of crushed and/or broken vegetation, primarily between CP98 and CP100. Immediately following the drop, the monitor walked the entire span of the area impacted by the wire drop, searching for dead and/or injured wildlife as well as damaged and/or impacted nests of avian species. 100% visual coverage was obtained.

No impacts to wildlife, including general or listed bird species and their nests, or sensitive species were observed.

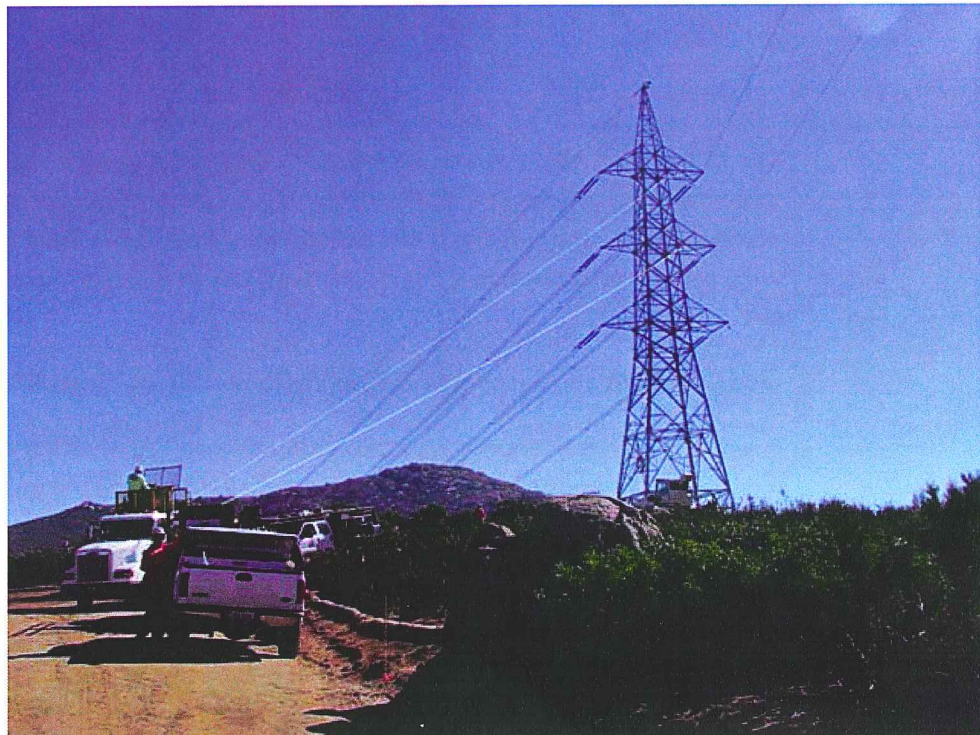
CP100

These photos were taken immediately following the conductor drop.
