**SUNRISE POWERLINK:
FINAL – Response to Non-Compliance Report #5
Operation Outside of Approved Work Areas at EP345/EP346**

Corps of Engineers File Number: SPL-2007-00704-SAS
State Water Resources Control Board File Number: SB09015IN
Department of Fish and Game Notification Number: 1600-2009-0365-R5

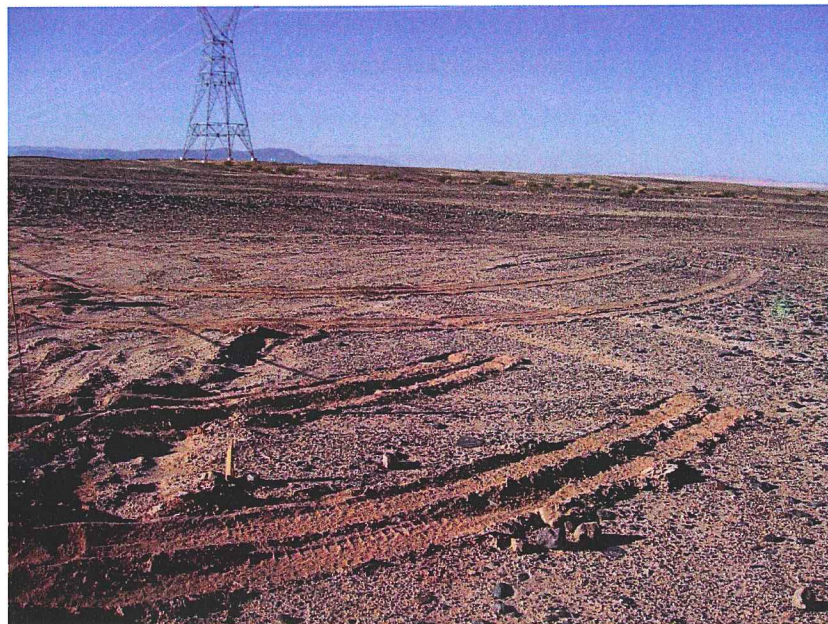
“We went out yesterday (02/09/12) and looked at the area where the gravel truck pulled off the SWPL access road between towers EP345 and EP346...*(specific location eliminated for confidentiality)*....The truck pulled off onto an existing disturbance within the site created by previous off-road recreational vehicle activity not associated with the Project. No artifacts or features were identified near or within the tire ruts. Please let me know if you have any questions or concerns.”

Photo of the site taken by ASM showing tire tracks in the foreground.
