**BIOLOGICAL TECHNICAL REPORT**  
**SYCAMORE TO PEÑASQUITOS 230 KILOVOLT TRANSMISSION LINE PROJECT**  
**CITY OF SAN DIEGO**  
**SAN DIEGO COUNTY, CALIFORNIA**

**SAN DIEGO GAS & ELECTRIC COMPANY**  
8315 Century Park Court, CP21E  
San Diego, California 92123  
Contact: Rob Fletcher

**BUSBY BIOLOGICAL SERVICES, INC.**  
4629 Cass Street, #192  
San Diego, California 92109  
Contact: Melissa Busby

April 2014

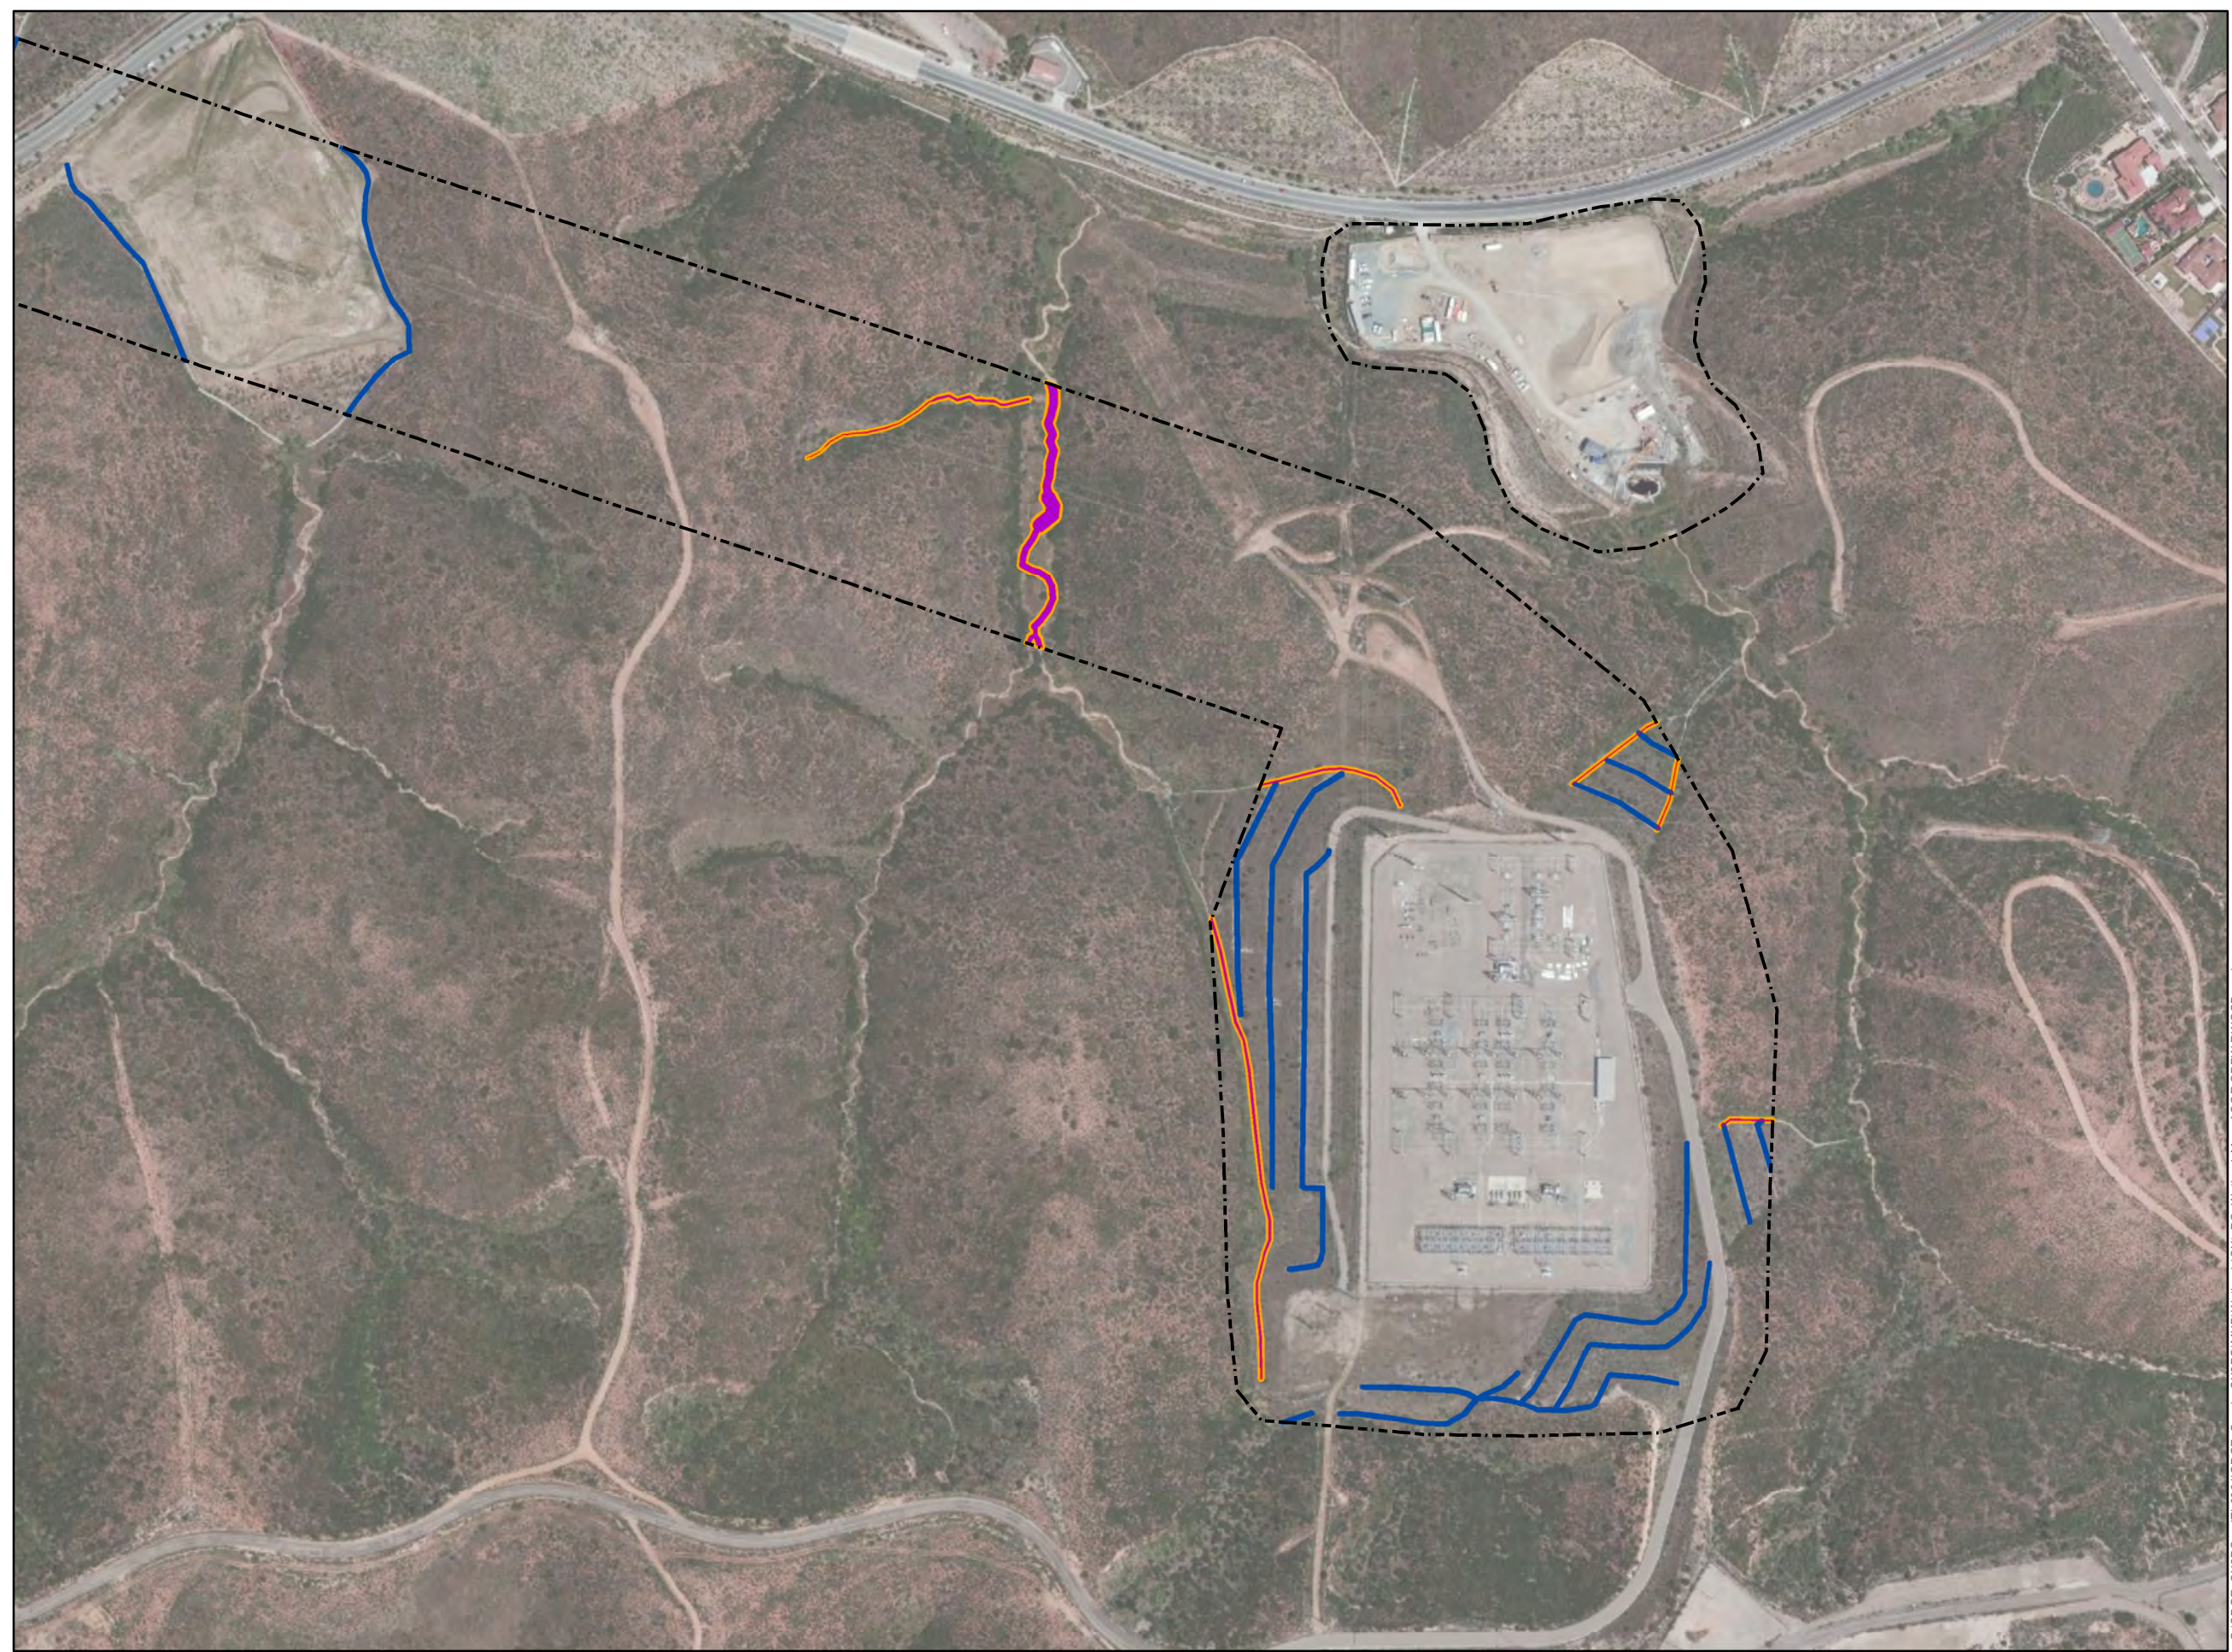
**Sycamore to Peñasquitos  
230 kV Transmission Line Project**  
Proposed Project  
Wetlands  
**Figure 11a**

- Biological Survey Area
- USACE Waters of the U.S.
- USACE Wetland Waters of the U.S.
- RWQCB Wetland Waters of the State
- RWQCB Waters of the State
- RWQCB NPDES
- CDFW Riparian
- CDFW Unvegetated Streambed

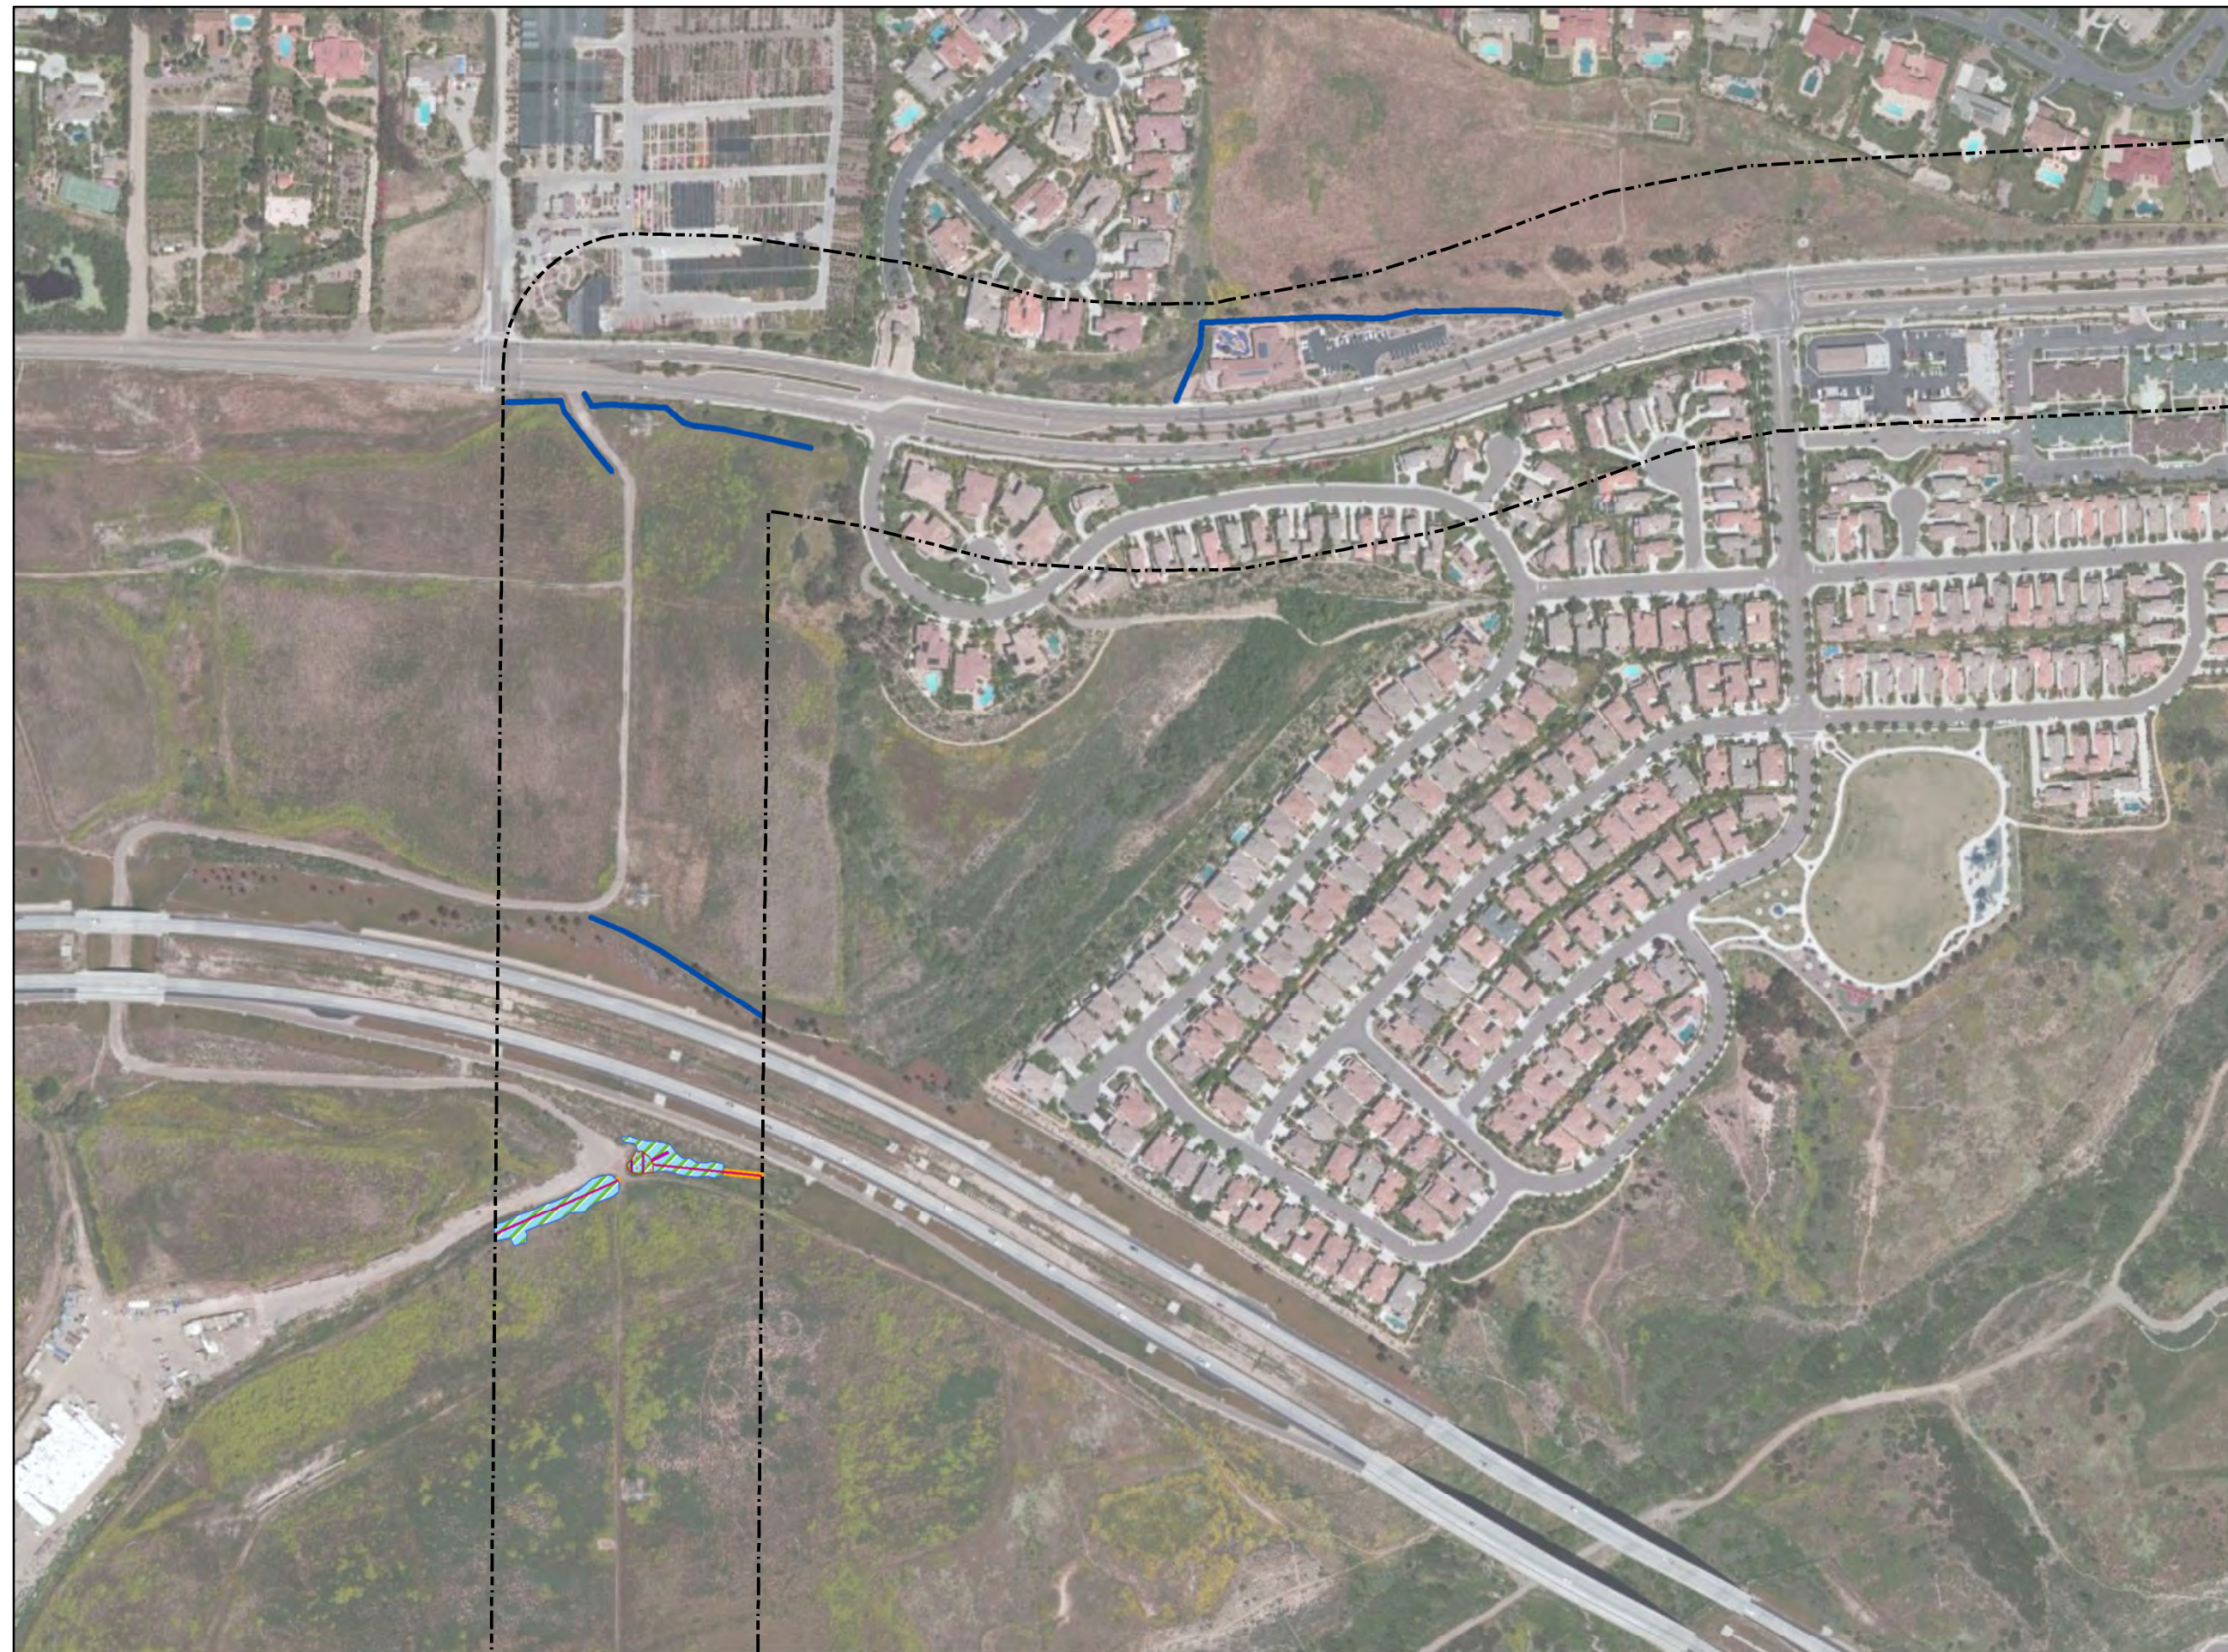
**Sycamore to Peñasquitos  
230 kV Transmission Line Project**  
Proposed Project  
Wetlands  
**Figure 11a**

- Biological Survey Area
- USACE Waters of the U.S.
- USACE Wetland Waters of the U.S.
- RWQCB Wetland Waters of the State
- RWQCB Waters of the State
- RWQCB NPDES
- CDFW Riparian
- CDFW Unvegetated Streambed

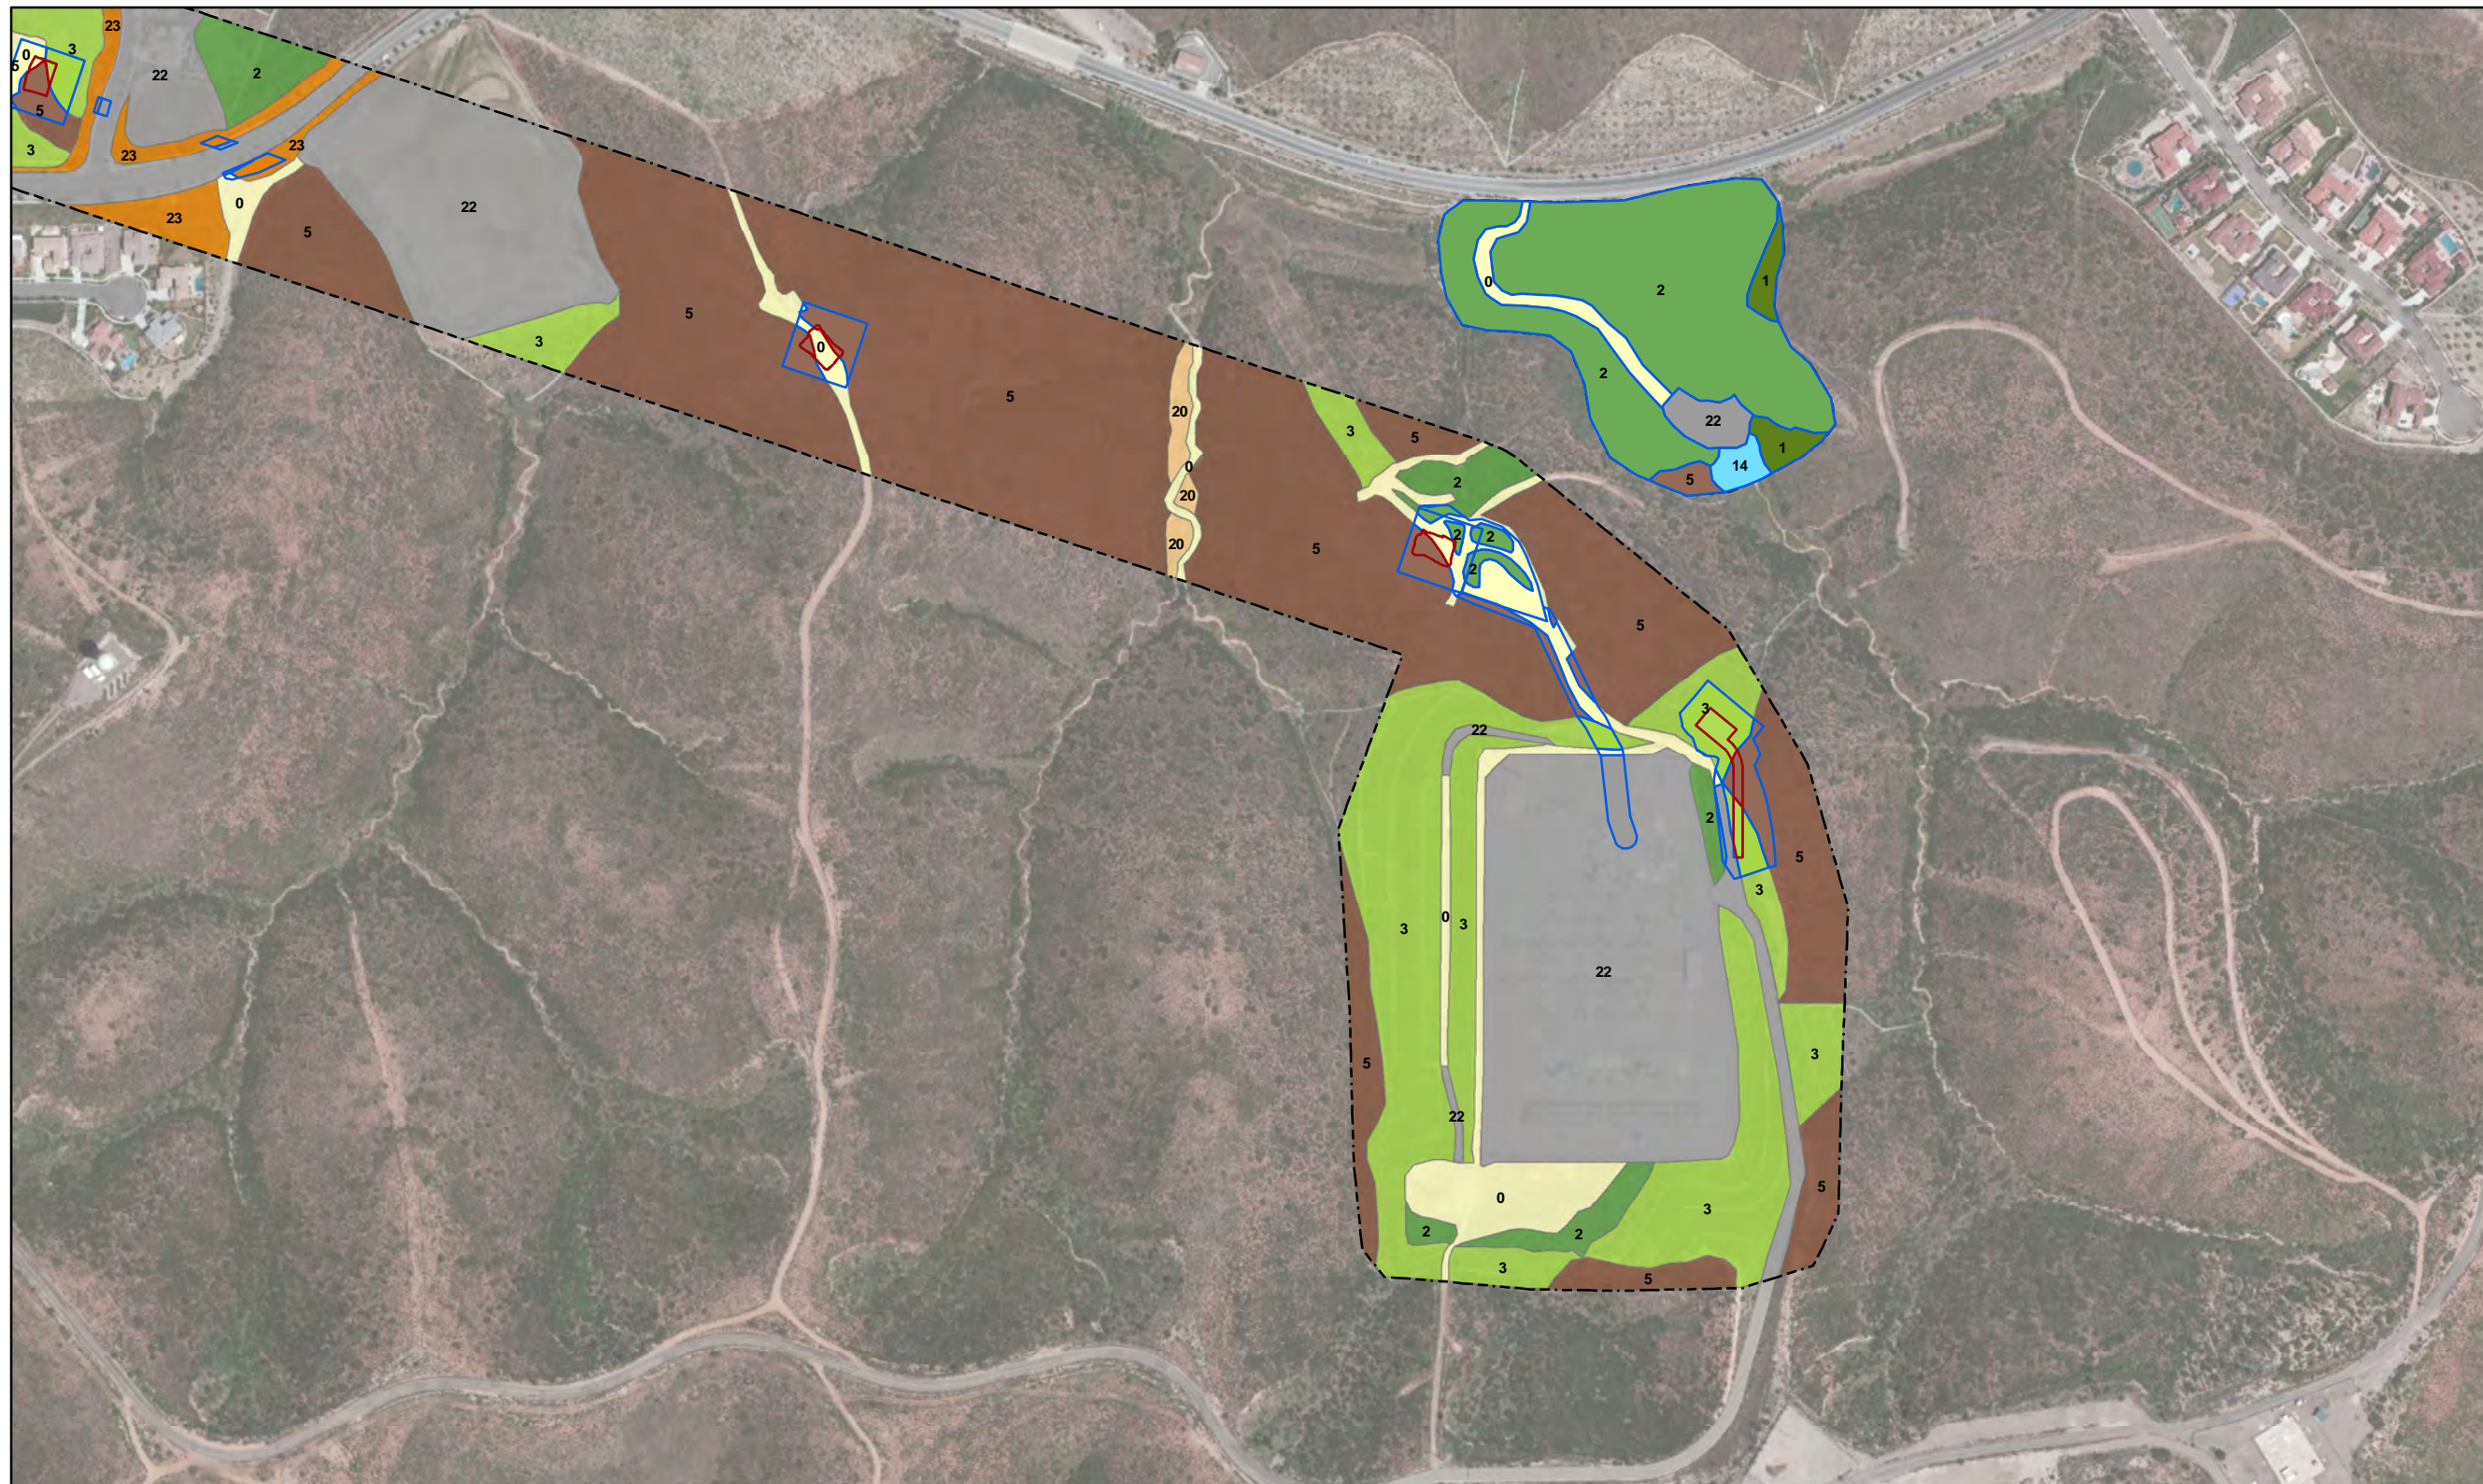
**Figure 12**

Proposed Project  
Vegetation Community  
Impacts

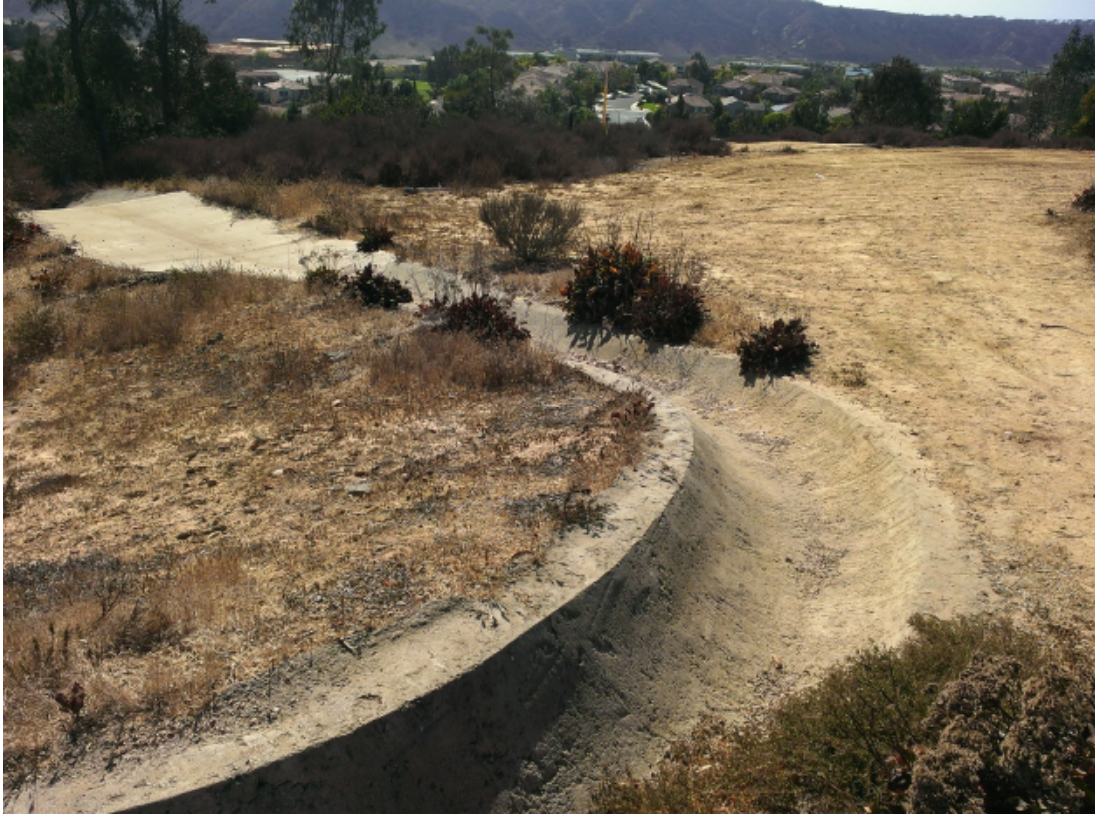
Photo 1: V-ditch draining the Peñasquitos substation pad; Photo direction: N

No vegetation was associated with the feature. The drainage consisted of a bare concrete lined V-ditch. Photographs of the Peñasquitos Substation are included as Appendix C, Photos 1 and 2.

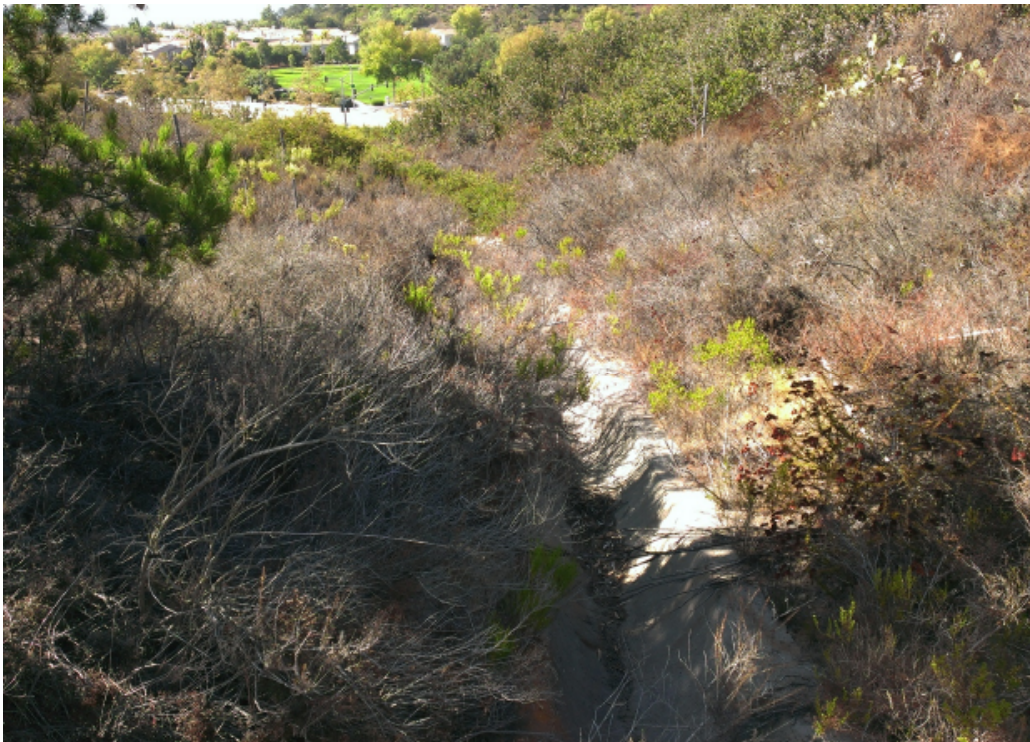
Photo 2: V-ditch draining the Peñasquitos substation pad; Photo direction: W

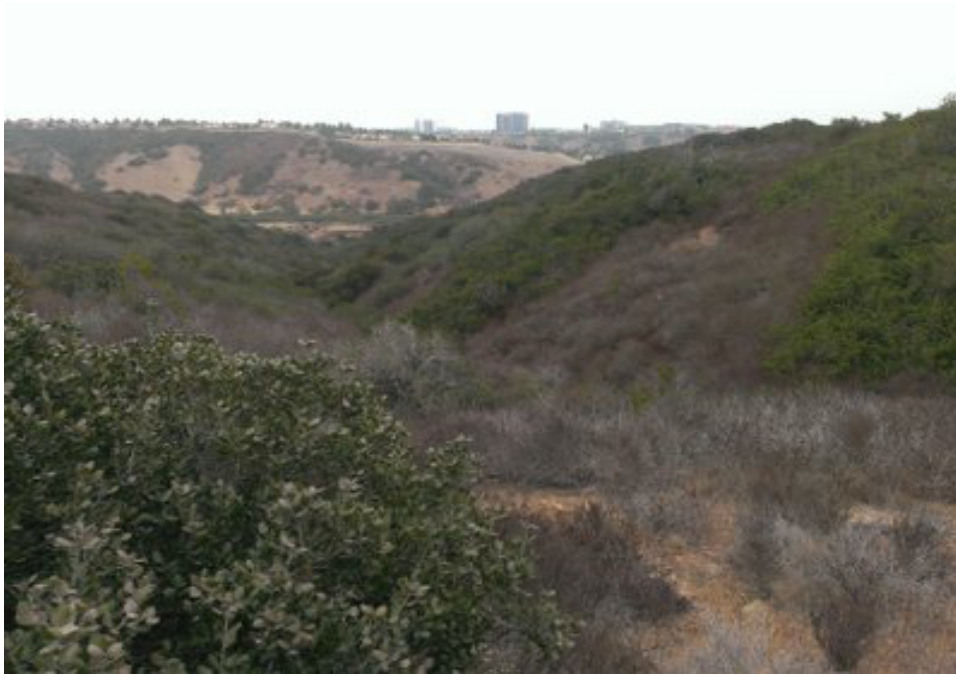
Photo 3: Tributary to Peñasquitos Creek 1, Overview of the confluence of two zero-order headwaters;  
Photo direction: SE

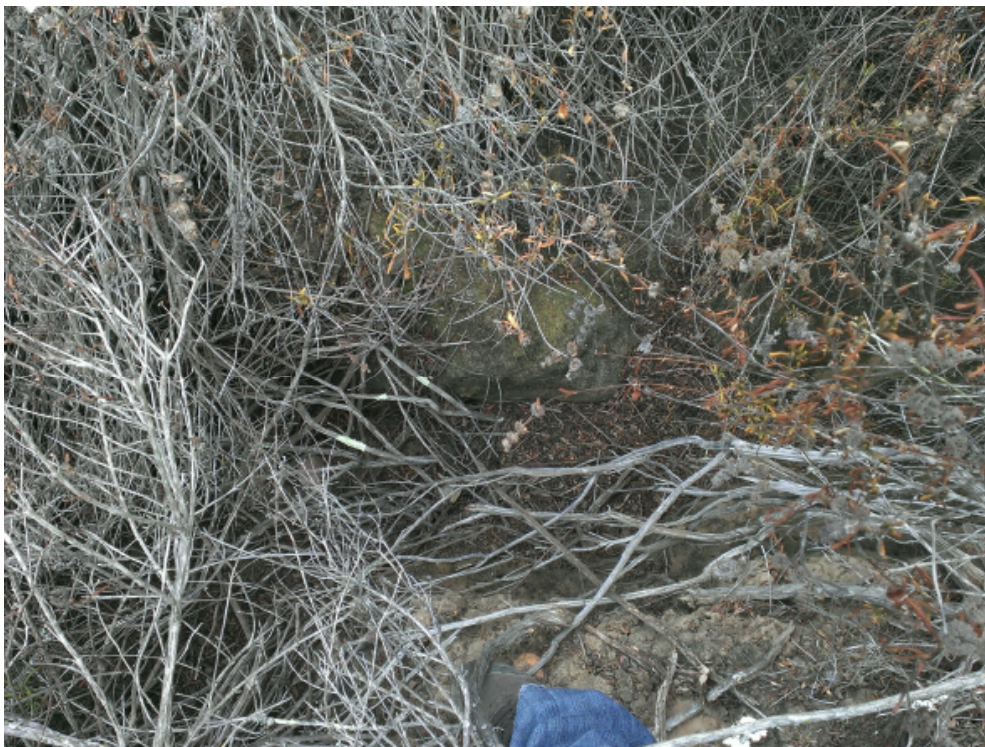
Photo 4: Tributary to Peñasquitos Creek 1, cobble substrate near confluence of headwater tributaries

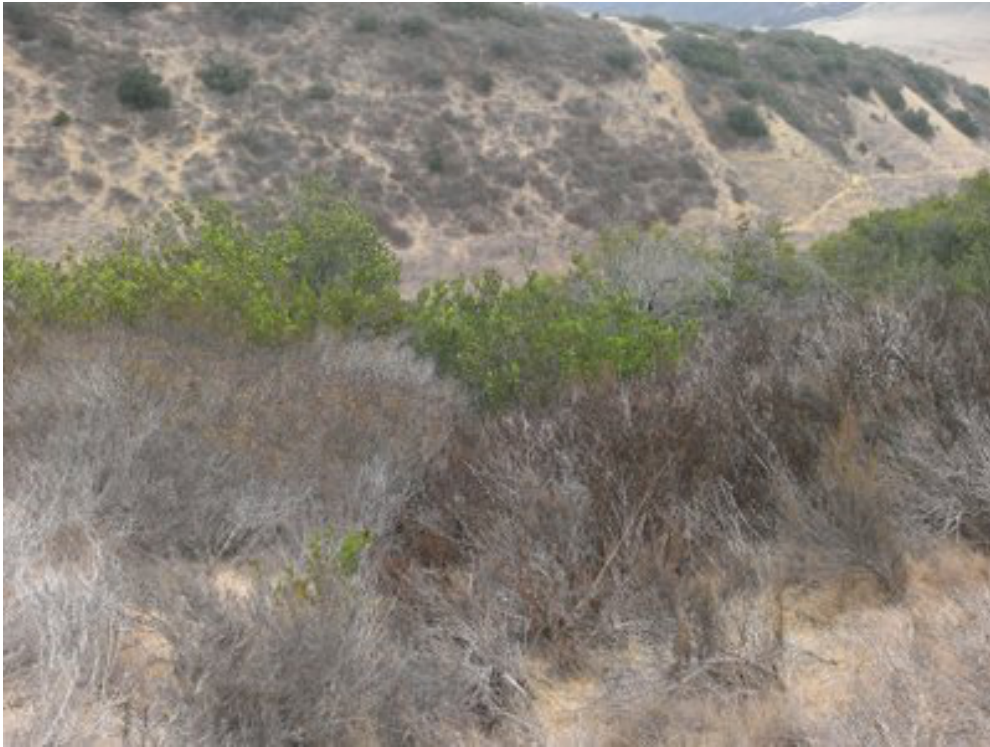
Photo 5: Tributary to Peñasquitos Creek 2, overview of incised intermittent drainage; Photo direction: E

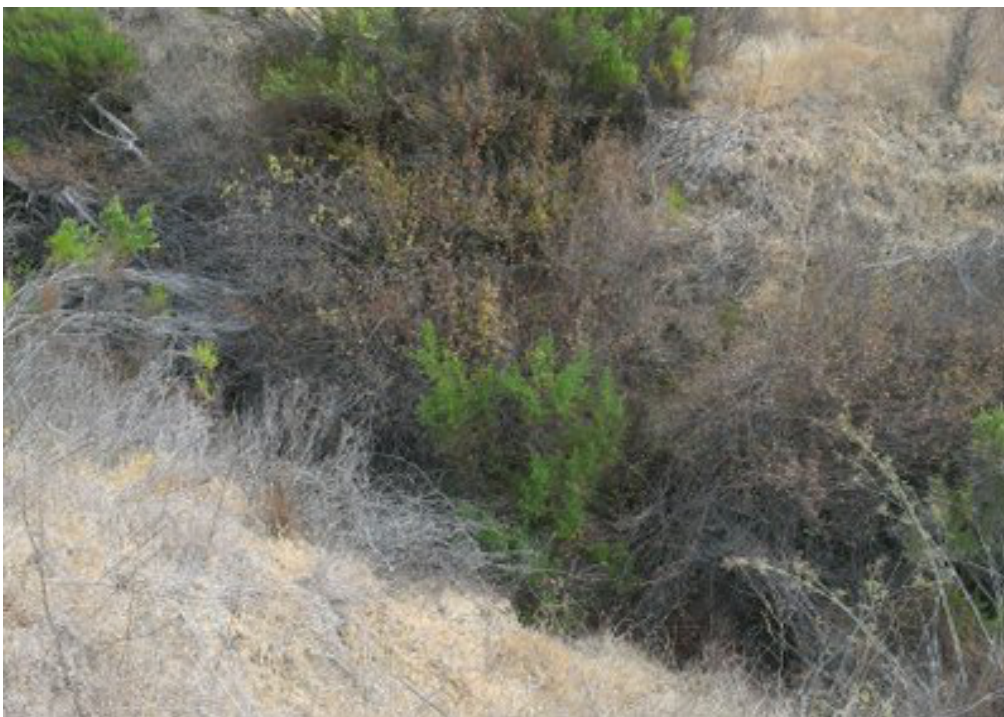
Photo 6: Tributary to Peñasquitos Creek 2, overview of channel; Photo direction: E

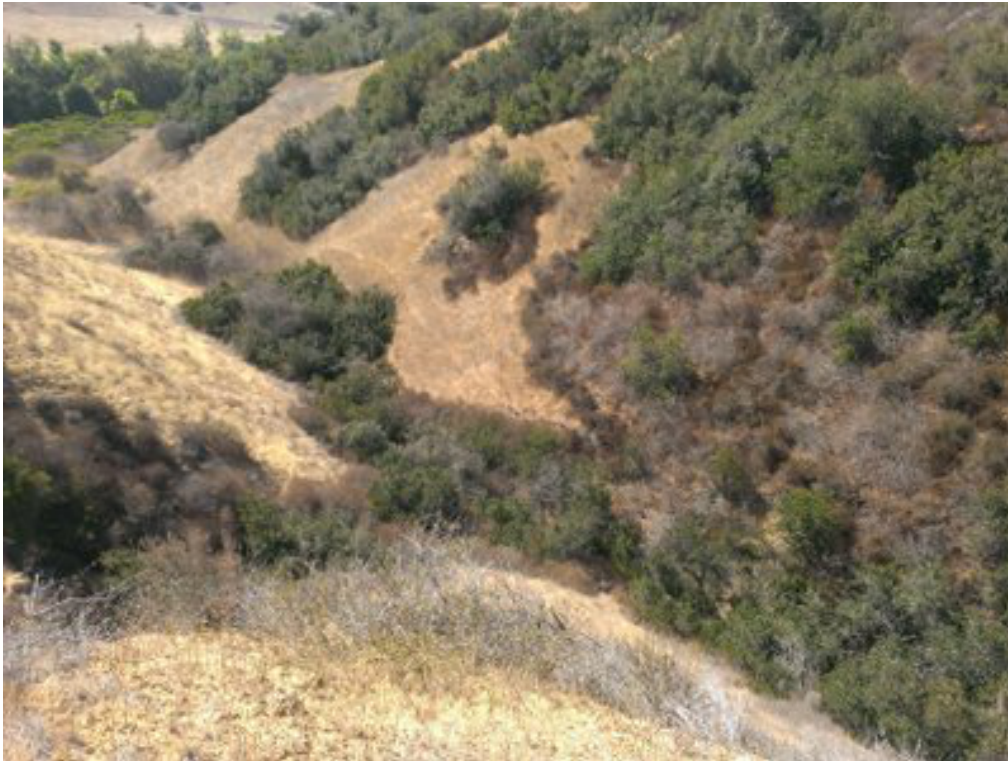
Photo 7: Tributary to Peñasquitos Creek 3, overview of large eastern section of the drainage; Photo direction: S

Vegetation associated with Tributary to Peñasquitos Creek 3 is composed of upland coastal sage scrub vegetation. Dominant species included black sage, lemonade berry, and non-native brome grasses. No riparian vegetation was associated with the drainage. Photographs of Tributary to Peñasquitos Creek 3 are included as Appendix C, Photos 7 and 8.

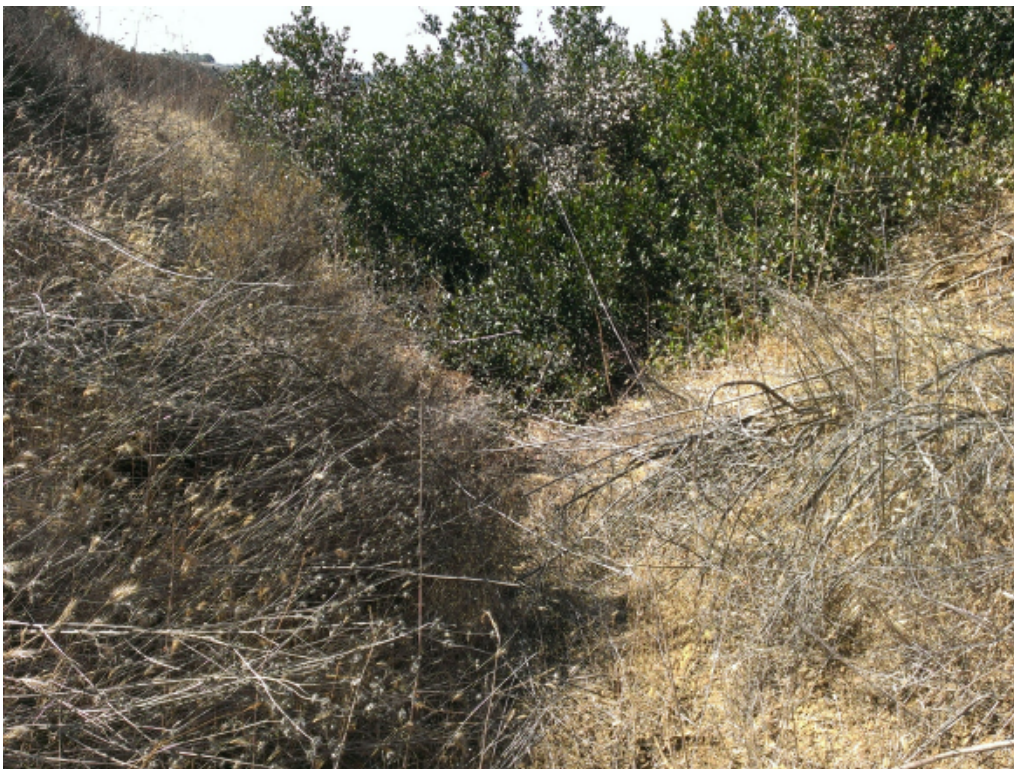
Photo 8: Tributary to Peñasquitos Creek 3, overview of narrow channel width and clay/cobble substrate; Photo direction: N

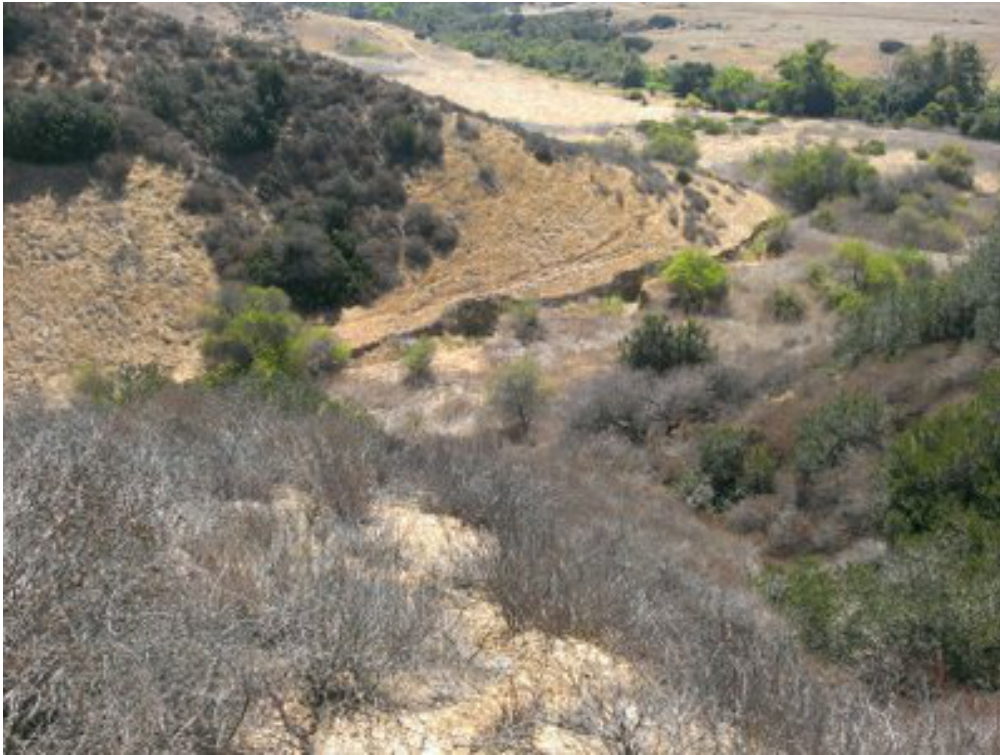
Photo 9: Tributary to Peñasquitos Creek 4, overview of western side of drainage; Photo direction: E

Vegetation associated with Tributary to Peñasquitos Creek 4 is composed of dense upland coastal sage scrub vegetation. Dominant species included lemonade berry, and non-native brome grasses. The only riparian vegetation associated with the drainage was composed of two individual arroyo willows (*Salix lasiolepis*, FACW). Photographs of Tributary to Peñasquitos Creek 4 are included as Appendix C, Photos 9, 10, and 11.

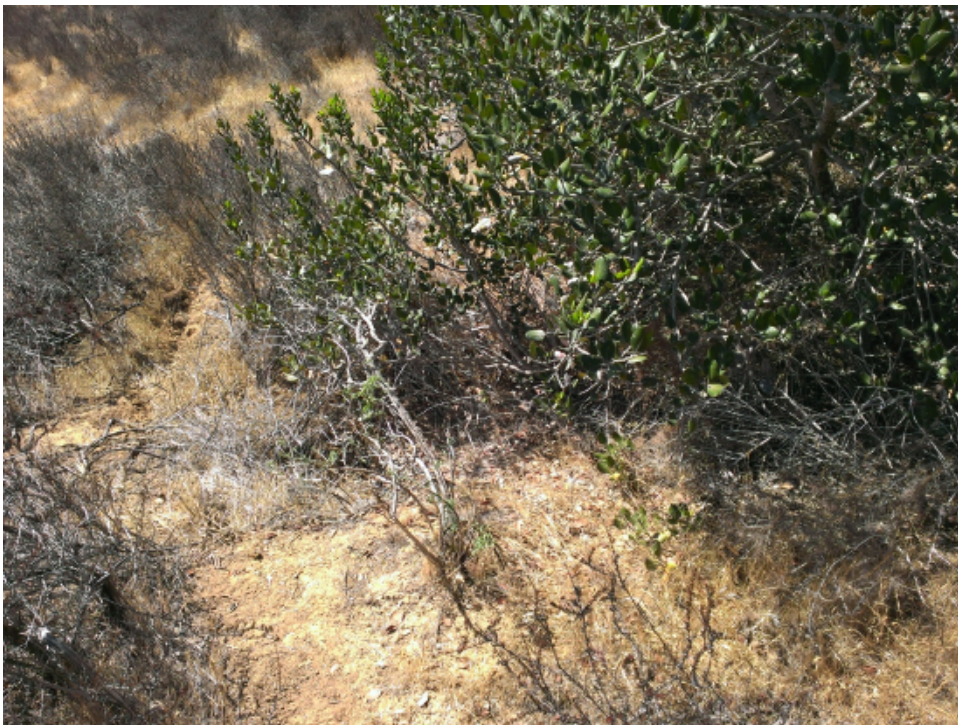
Photo 10: Tributary to Peñasquitos Creek 4, cobble substrate in high gradient headwaters in western side of drainage; Photo direction: SE

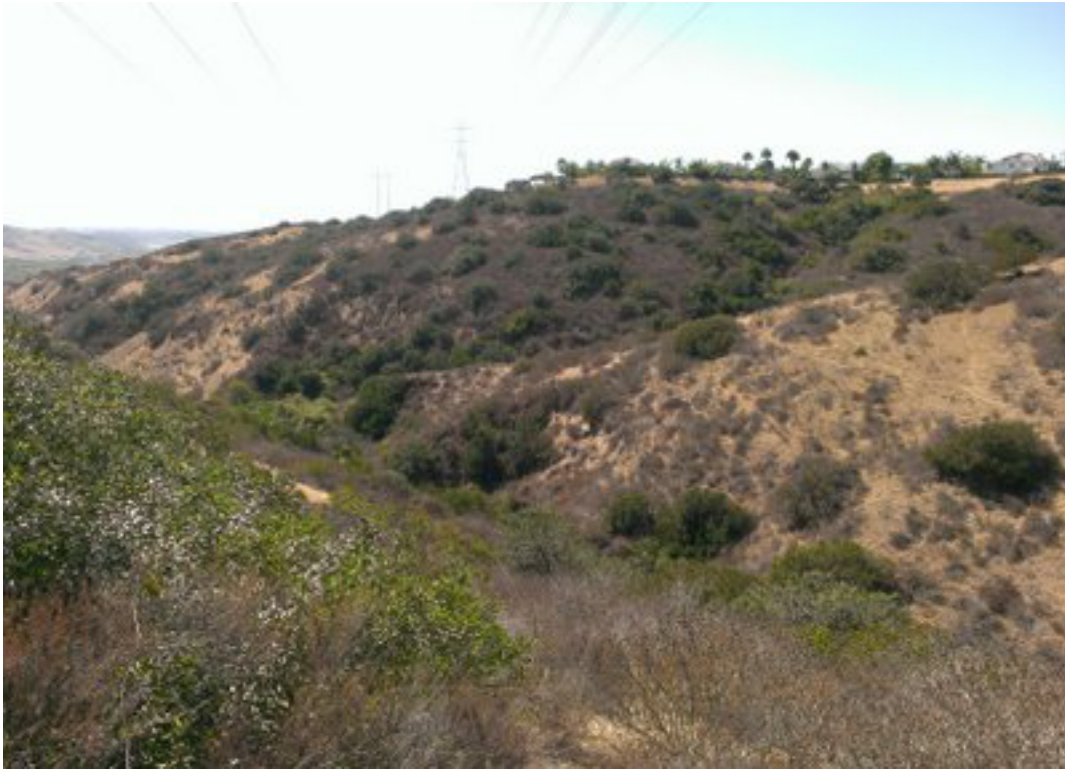
Photo 11: Tributary to Peñasquitos Creek 4, overview of headwaters in western side of drainage; Photo direction: W

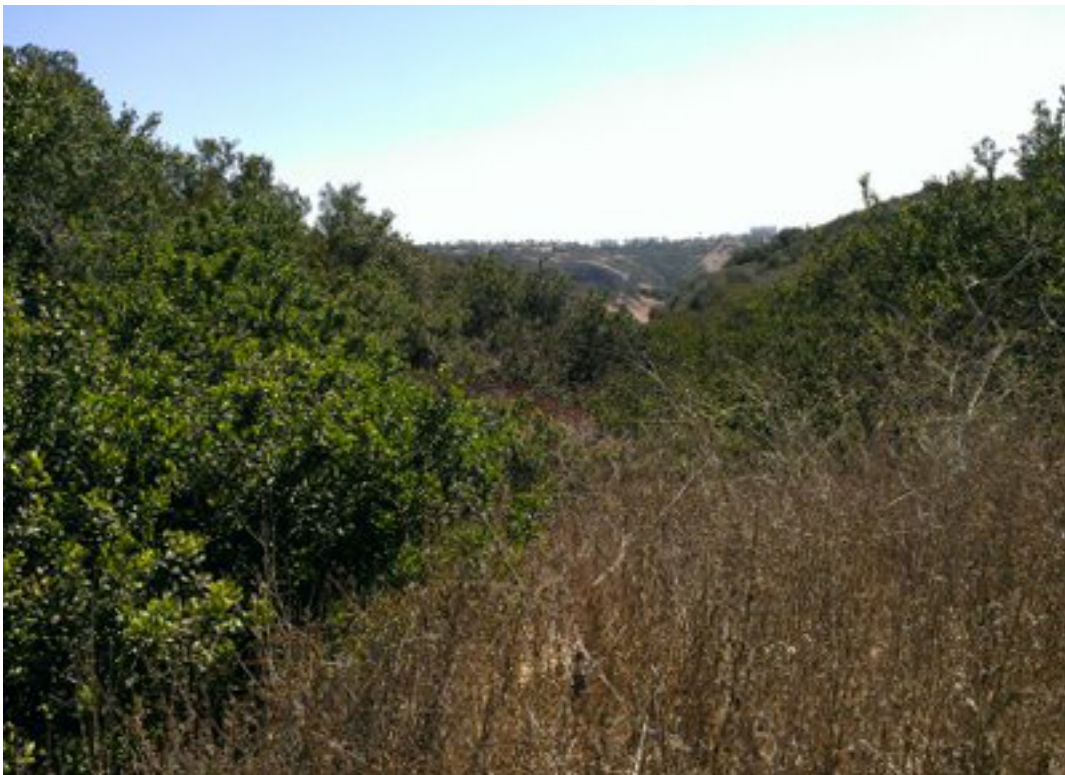
Photo 12: Tributary to Peñasquitos Creek 5, overview of top of westernmost drainage, facing downstream; Photo direction: S

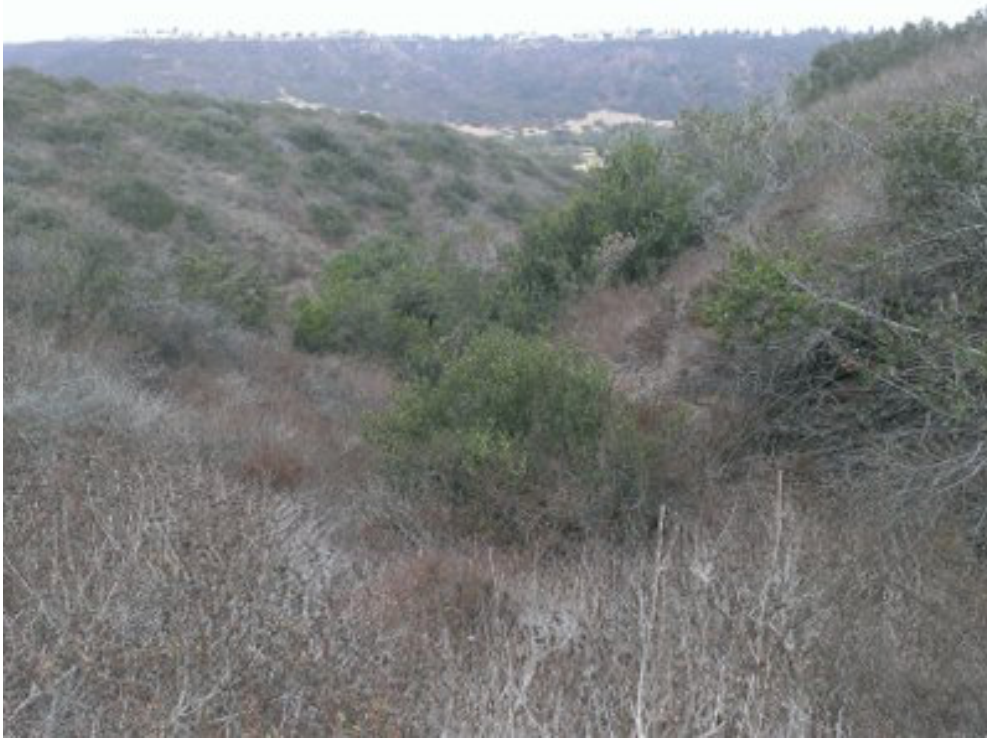
Photo 13: Tributary to Peñasquitos Creek 5, overview of ephemeral headwater in center of drainage, facing downstream; Photo direction: SE

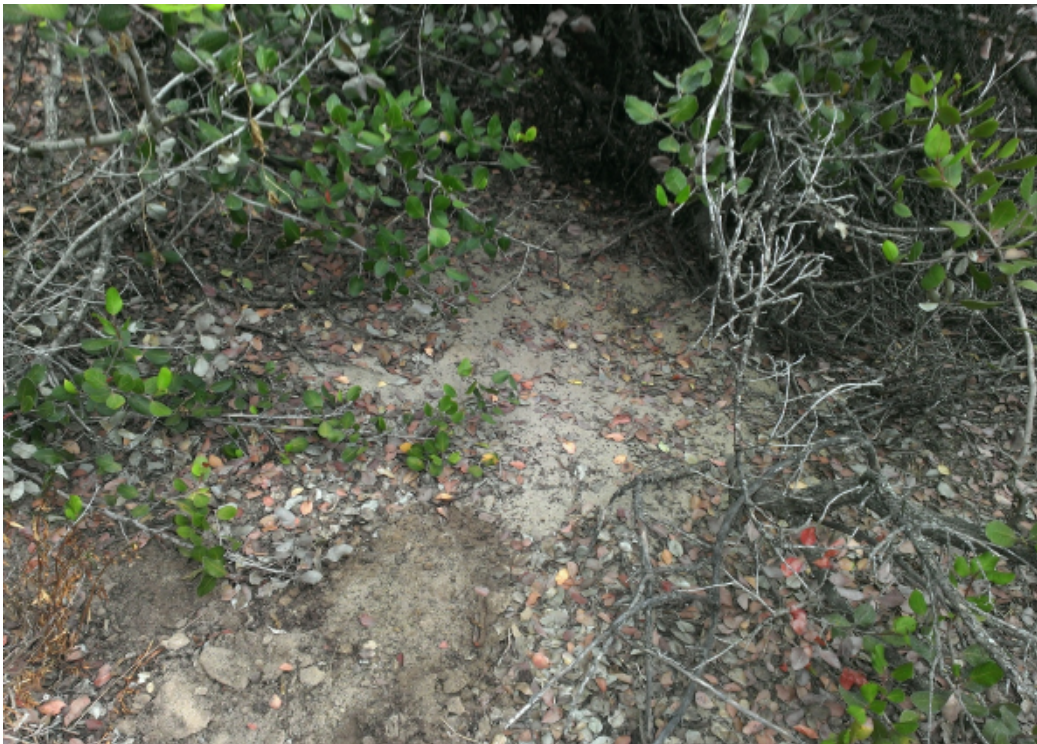
Photo 14: Tributary to Peñasquitos Creek 5, sandy substrate of mainstem tributary
