**BIOLOGICAL TECHNICAL REPORT**  
**SYCAMORE TO PEÑASQUITOS 230 KILOVOLT TRANSMISSION LINE PROJECT**  
**CITY OF SAN DIEGO**  
**SAN DIEGO COUNTY, CALIFORNIA**

**SAN DIEGO GAS & ELECTRIC COMPANY**  
8315 Century Park Court, CP21E  
San Diego, California 92123  
Contact: Rob Fletcher

**BUSBY BIOLOGICAL SERVICES, INC.**  
4629 Cass Street, #192  
San Diego, California 92109  
Contact: Melissa Busby

April 2014

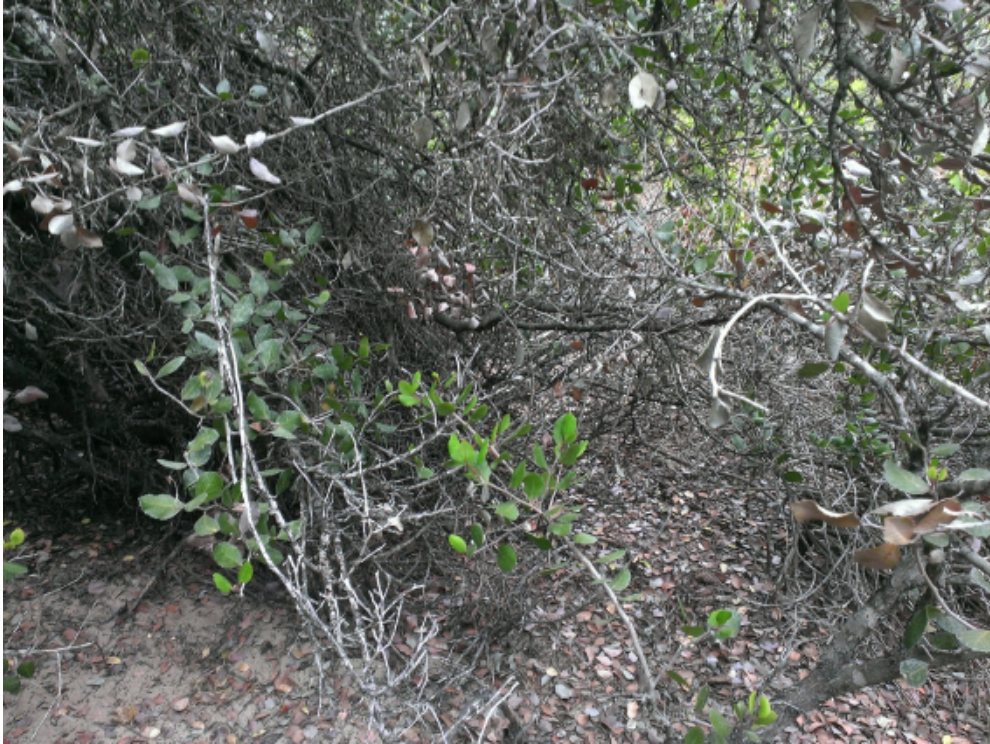
Photo 15: Tributary to Peñasquitos Creek 5, sandy substrate of mainstem tributary

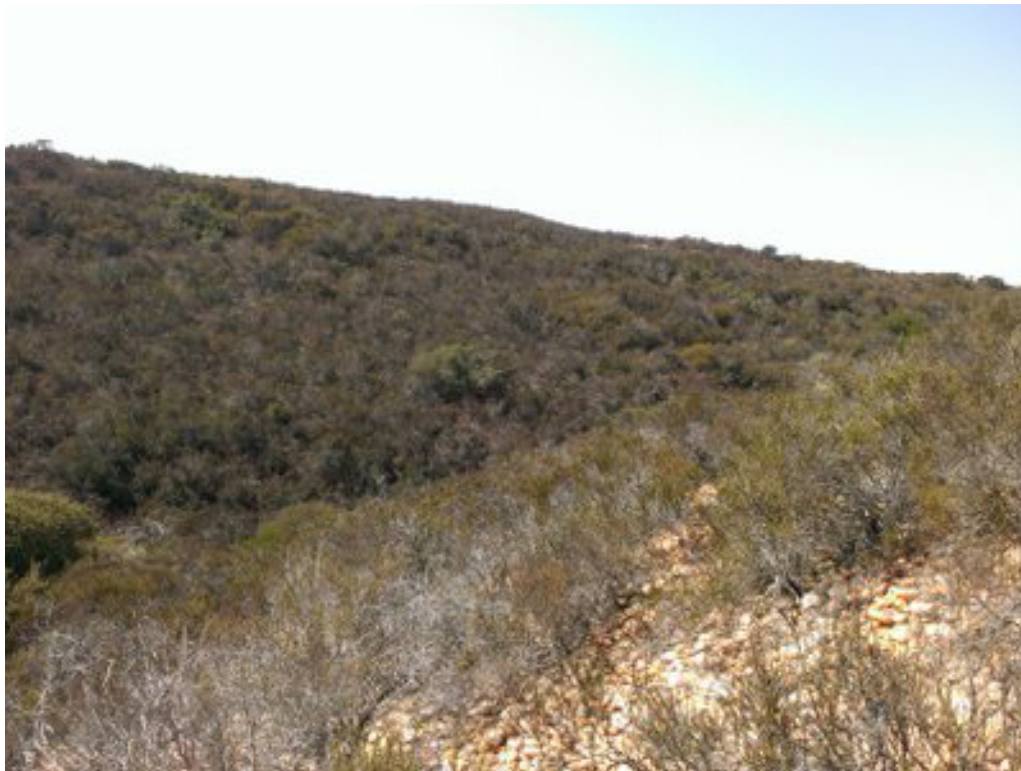
Photo 16: Tributary to Peñasquitos Creek 6, overview of headwaters of easternmost drainage, looking downstream; Photo direction: NW

Vegetation associated with this drainage consists of chaparral vegetation and includes: non-native brome grasses, scrub oak (*Quercus berberidifolia*, UPL), sugar bush and chamise (*Adenostoma fasciculatum*, UPL). Photographs of Tributary to Peñasquitos Creek 6 are included as Appendix C, Photos 16 and 17.

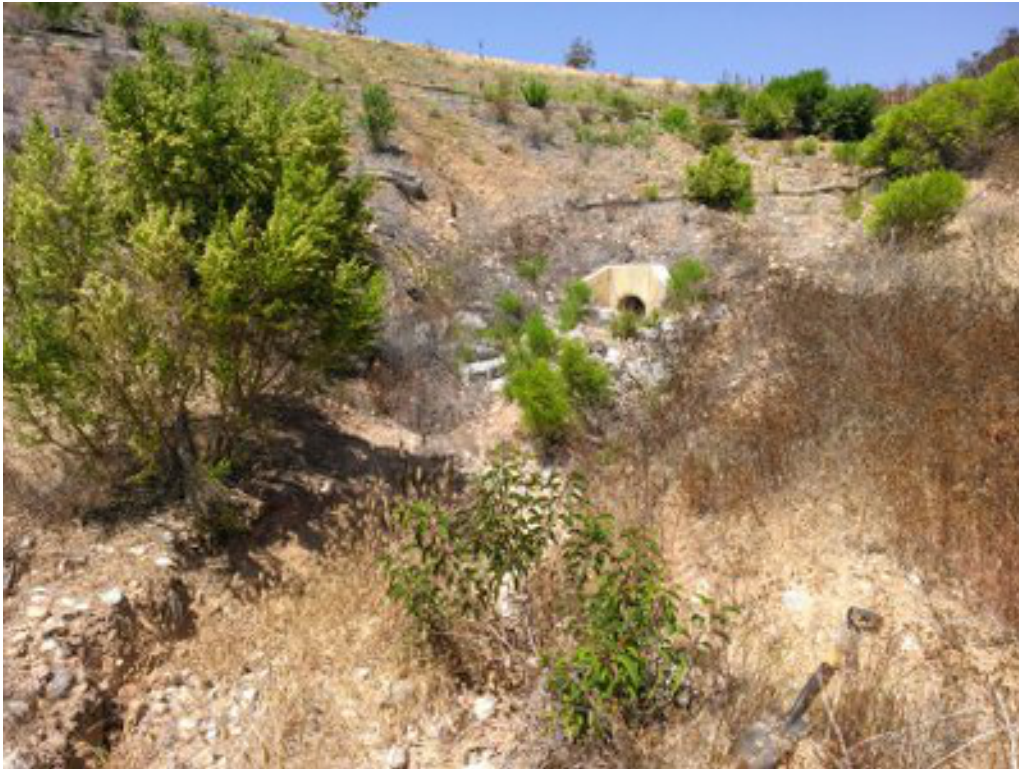
Photo 17: Tributary to Peñasquitos Creek 6, cobble substrate and incised channel of first-order tributary; Photo direction: N

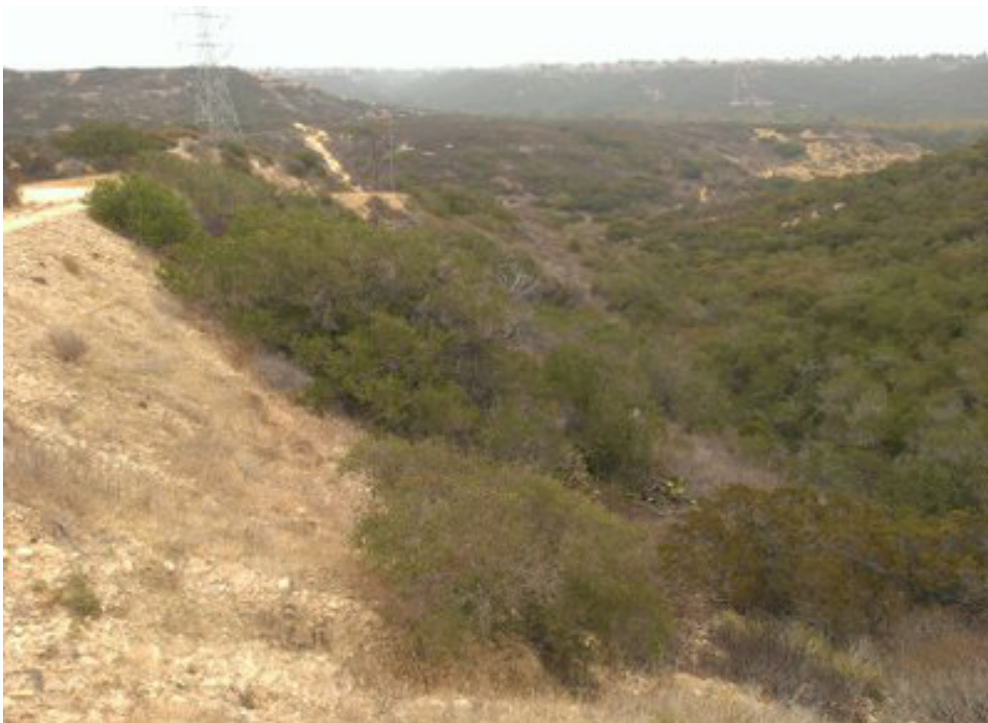
Photo 18: Tributary to Peñasquitos Creek 7, overview of headwaters of westernmost drainage; Photo direction: SE

Vegetation associated with this drainage consists of upland and riparian vegetation. USACE wetland WoUS were composed of emergent marsh vegetation dominated by California bulrush (*Schoenoplectus maritimus*, OBL) and limited to areas with an OHWM. CDFW riparian jurisdictional resources on site were composed of riparian scrub dominated by black willow (*Salix gooddingii*, FACW), and mule fat. Upland vegetation includes non-native brome grasses, scrub oak, chamise, and ladies' tobacco (*Pseudognaphalium californicum*, UPL). Photographs of Tributary to Peñasquitos Creek 7 are included as Appendix C, Photos 18, 19, 20, 21, and 22.

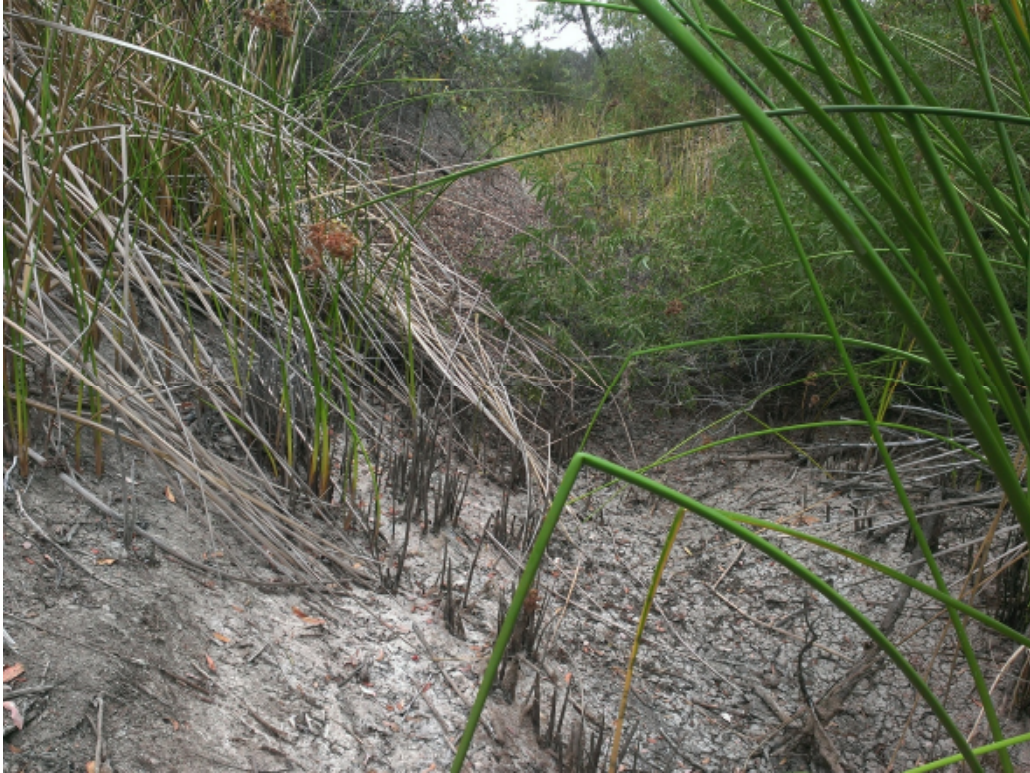
Photo 19: Tributary to Peñasquitos Creek 7, wetland vegetation and hard clay substrate at the fringe of a pond located in the study area; Photo direction: S

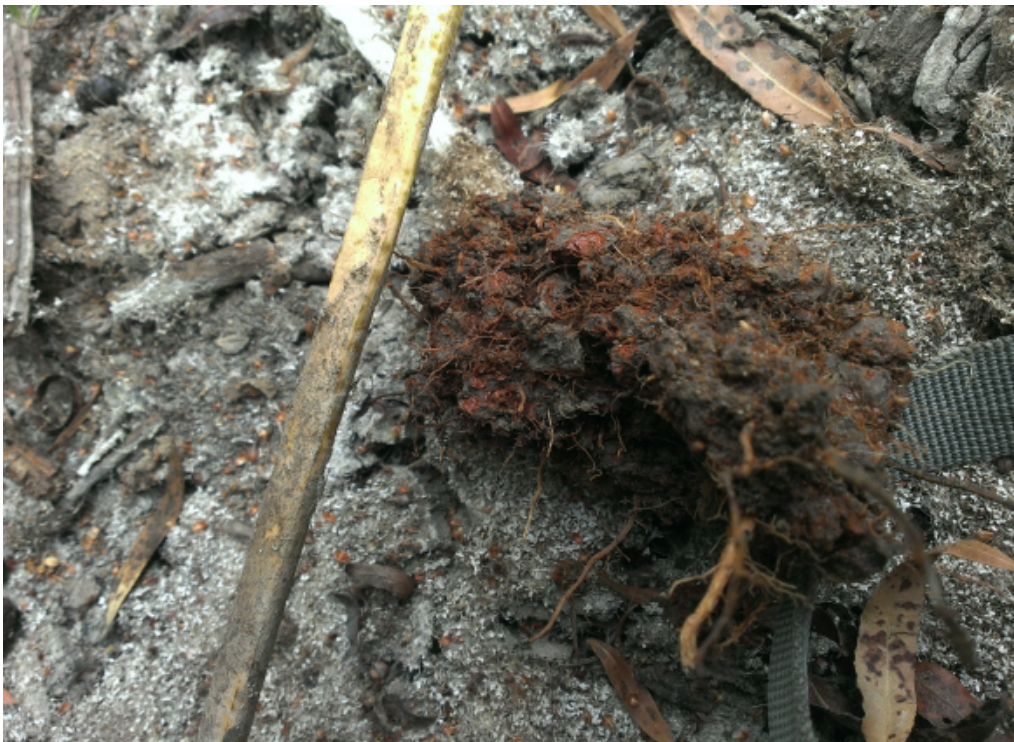
Photo 20: Tributary to Peñasquitos Creek 7, view of redox features in the soil sample from Site 1

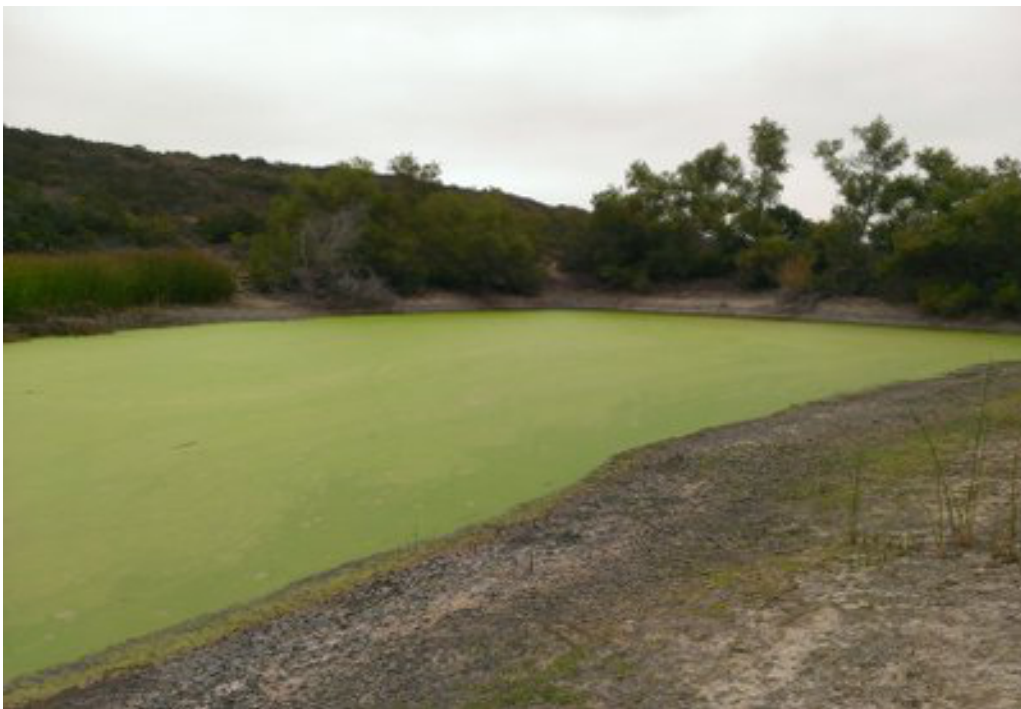
Photo 21: Tributary to Peñasquitos Creek 7, evidence of inundation: cracked substrate and riparian vegetation; Photo direction: S

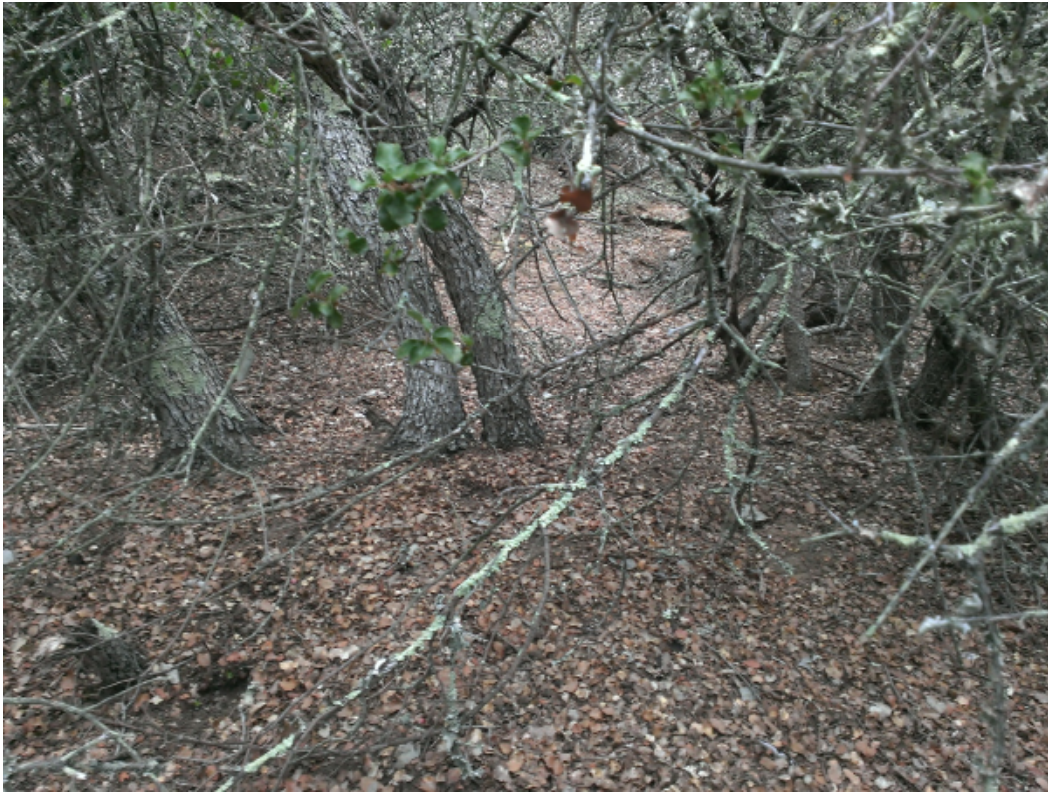
Photo 23: Tributary to Peñasquitos Creek 8, overview of narrow ephemeral channel near the eastern side of the drainage; Photo direction: NE

Vegetation associated with this drainage consists of upland vegetation and includes: non-native brome grasses, scrub oak, and chamise. Photographs of Tributary to Peñasquitos Creek 8 are included as Appendix C, Photos 23 and 24.

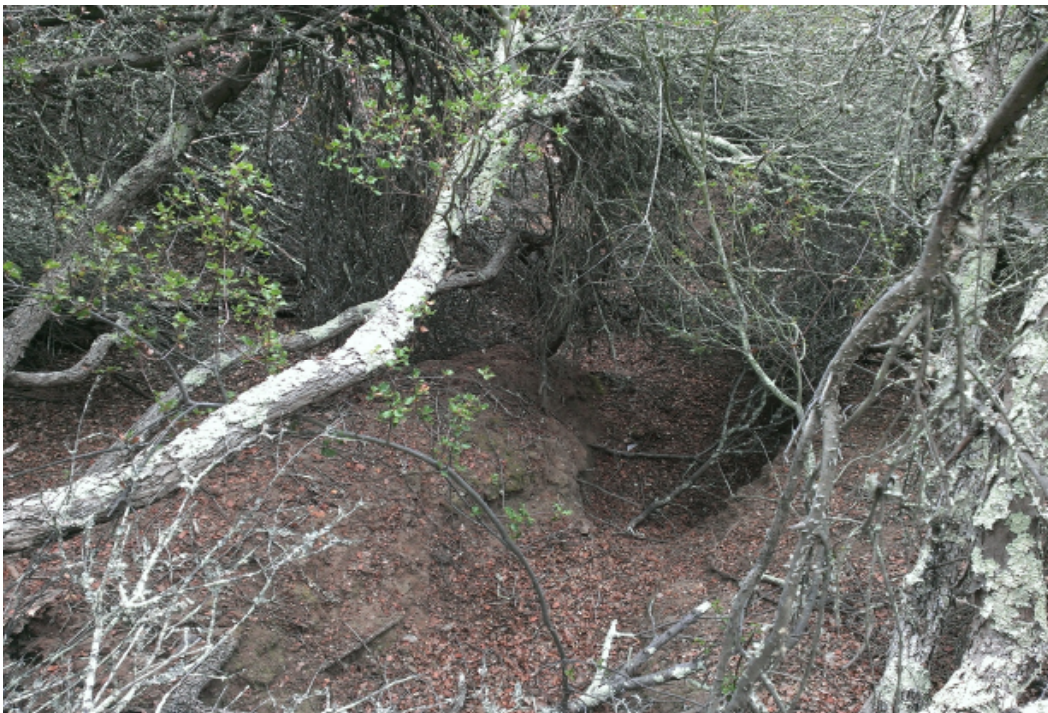
Photo 24: Tributary to Peñasquitos Creek 8, headcut and deeply incised portion of a headwater channel on the eastern side of the drainage; Photo direction: NE

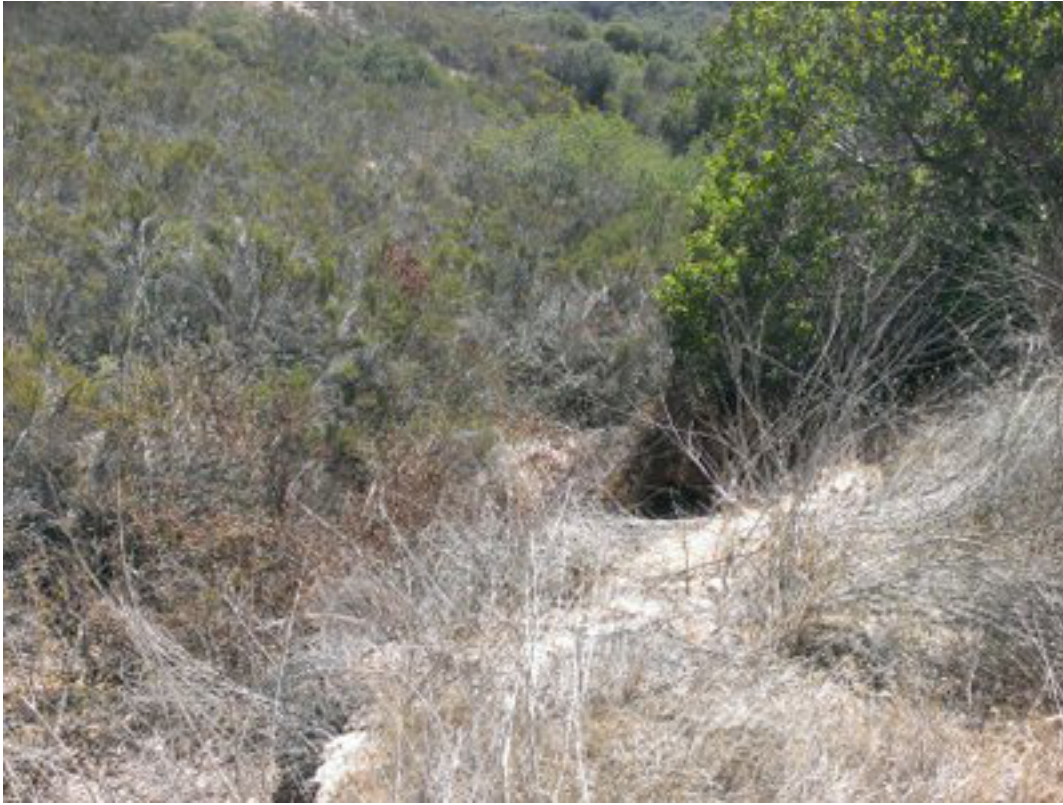
Photo 25: Tributary to Peñasquitos Creek 9, overview of the top of the headwaters of the northeastern section of the drainage; Photo direction: SW

Vegetation associated with this drainage consists of upland vegetation and includes: non-native brome grasses, scrub oak, and chamise. Photographs of Tributary to Peñasquitos Creek 9 are included as Appendix C, Photos 25, 26, 27, and 28.

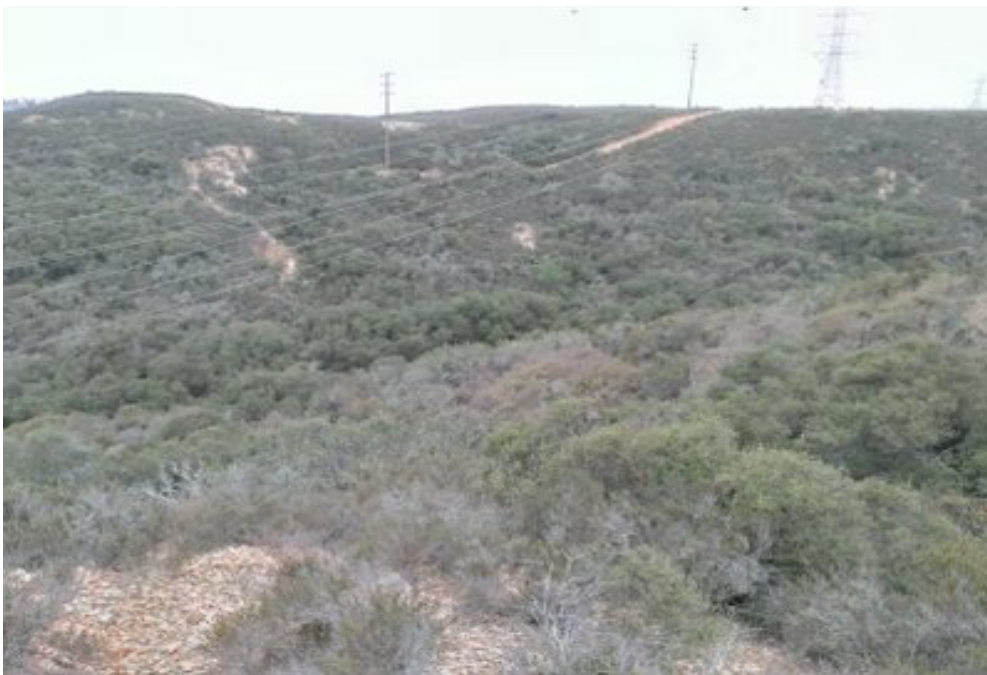
Photo 26: Tributary to Peñasquitos Creek 9, overview of the headwaters of the western section of the drainage, photo facing across channel; Photo direction: W

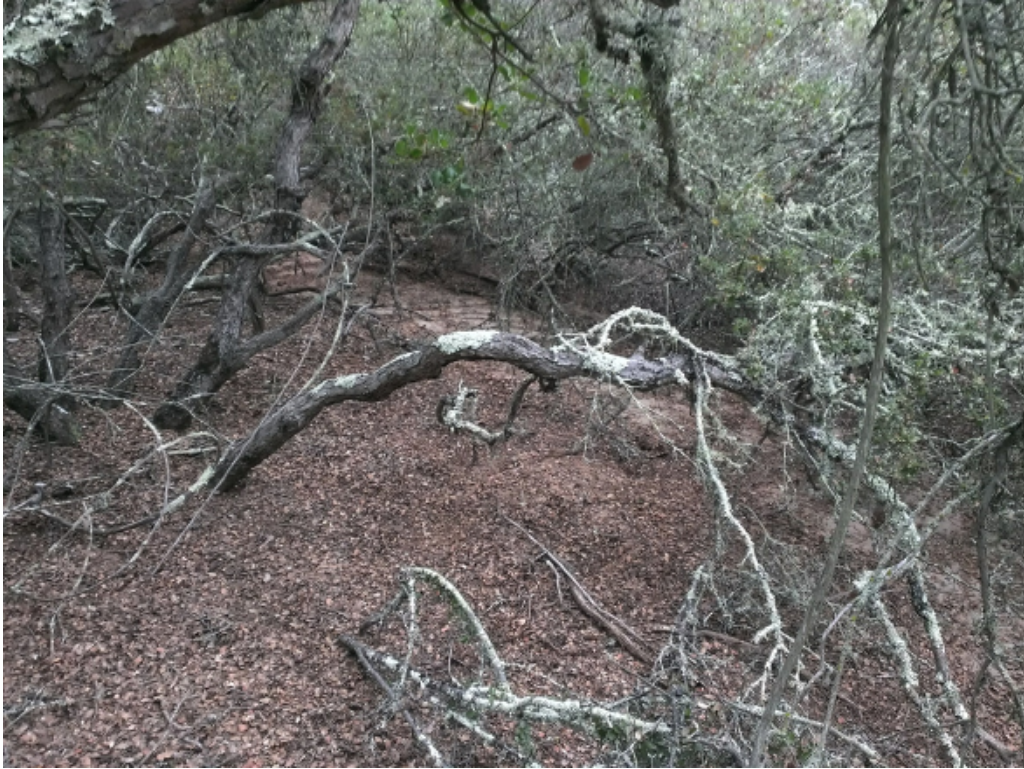
Photo 27: Tributary to Peñasquitos Creek 9, clay and sand substrate in mainstem tributary in the western section of the drainage; Photo direction: SW

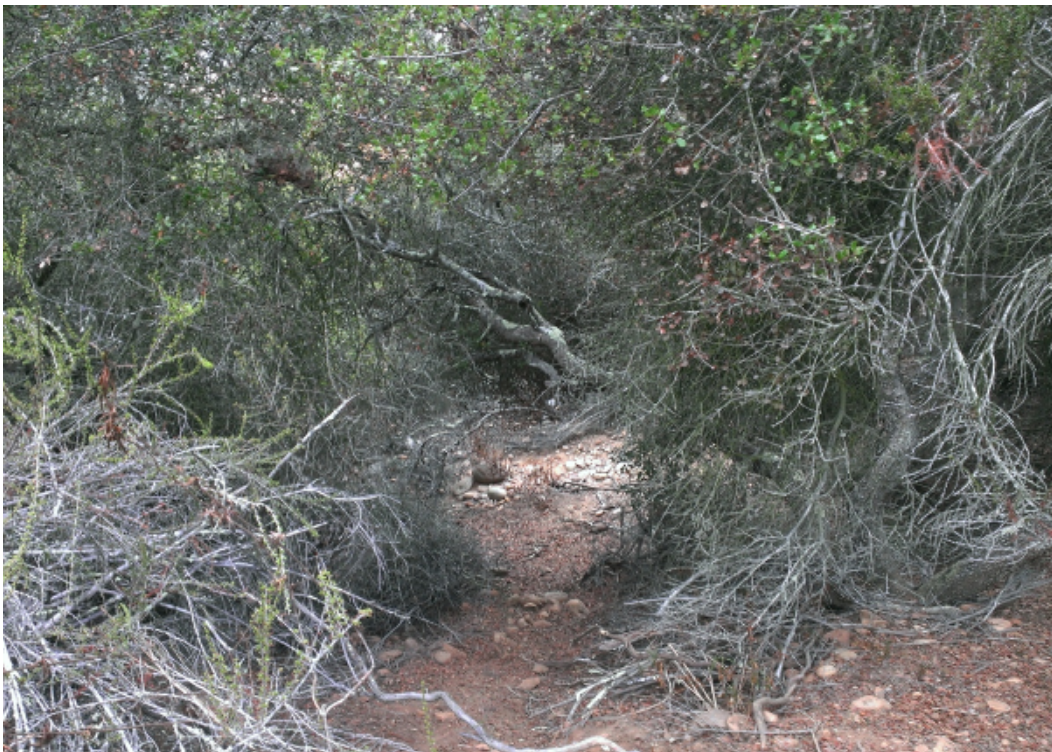
Photo 28: Tributary to Peñasquitos Creek 9, sand and cobble substrate in ephemeral headwaters on the western side of the drainage; Photo direction: N

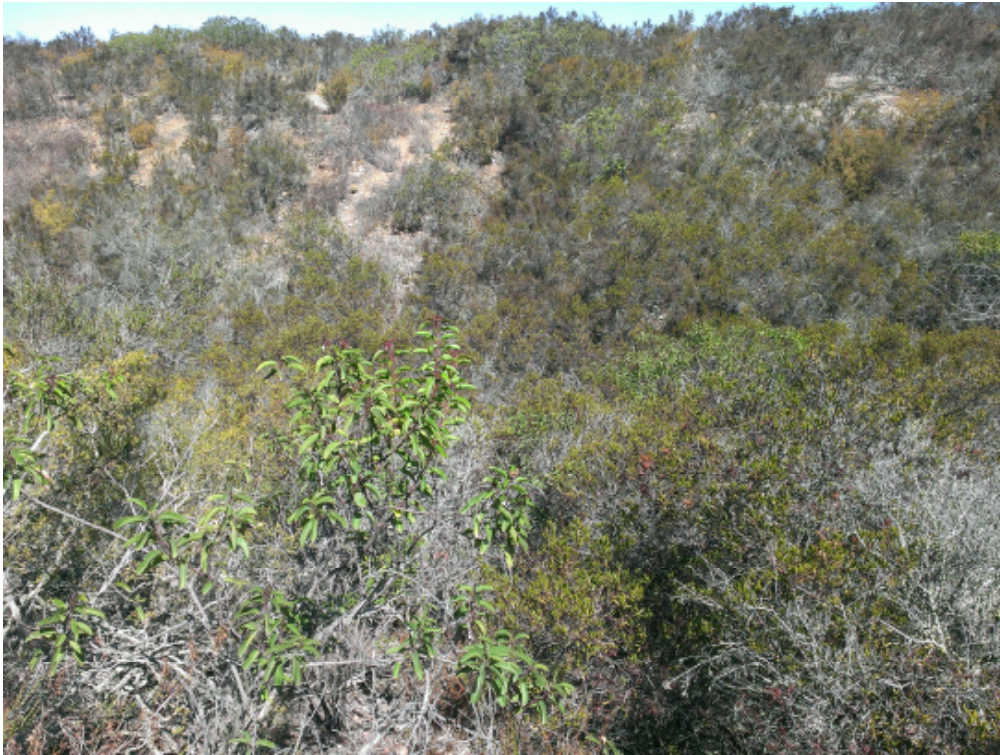
Photo 29: Tributary to Deer Canyon 1, looking across high-gradient headwaters in the southern portion of the drainage; Photo direction: N

This drainage is dominated by dense, upland vegetation. Vegetation includes chamise, scrub oak, black sage, laurel sumac, and manzanita. Photographs of Tributary to Deer Canyon 1 are included as Appendix C, Photos 29, 30, and 31.

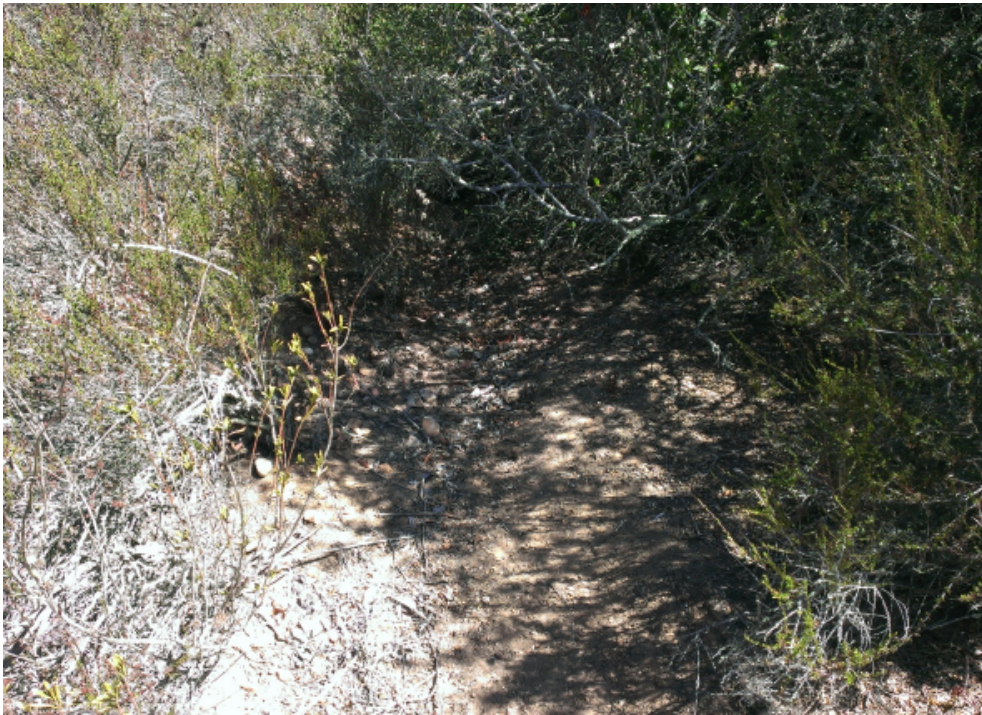
Photo 30: Tributary to Deer Canyon 1, sandy substrate in the southwestern headwaters of the drainage

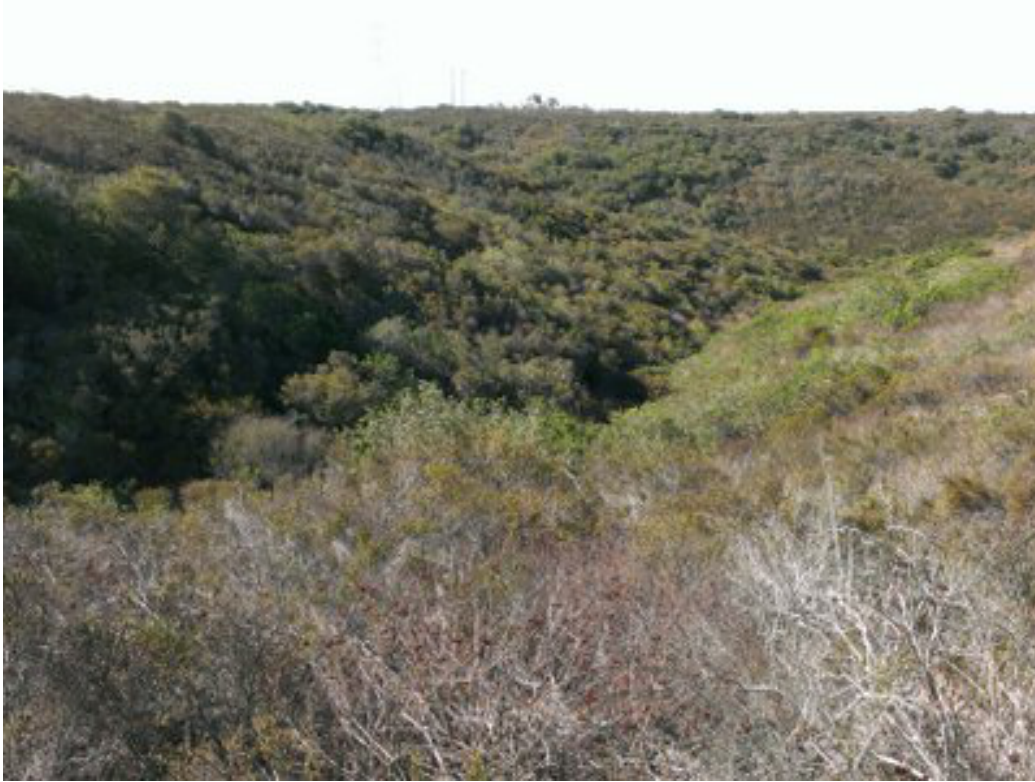
Photo 31: Tributary to Deer Canyon 1, looking across high-gradient headwaters in the northern section of the drainage; Photo direction: S

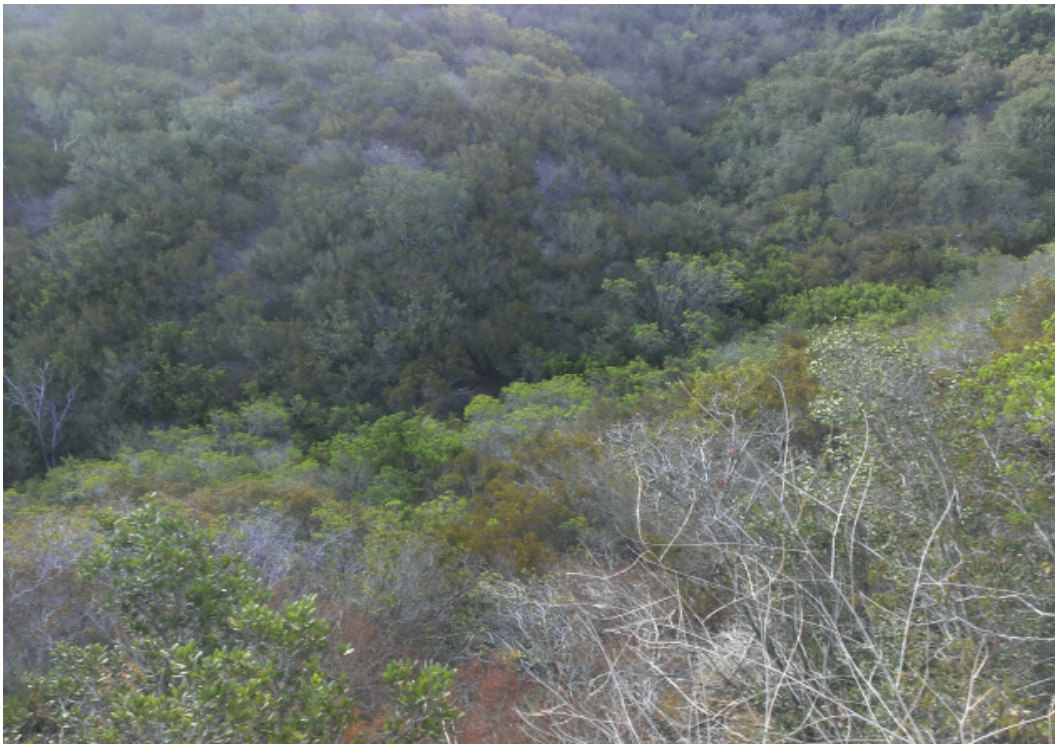
Photo 32: Tributary to Deer Canyon 2, looking across high-gradient headwaters in the western side of the

drainage; Photo direction: N

This drainage is dominated by dense, upland vegetation. Vegetation includes chamise, scrub oak, black sage, laurel sumac (*Malosma laurina*, UPL), and manzanita (*Arctostaphylos* sp., UPL). Photographs of Tributary to Deer Canyon 1 are included as Appendix C, Photos 32 and 33.

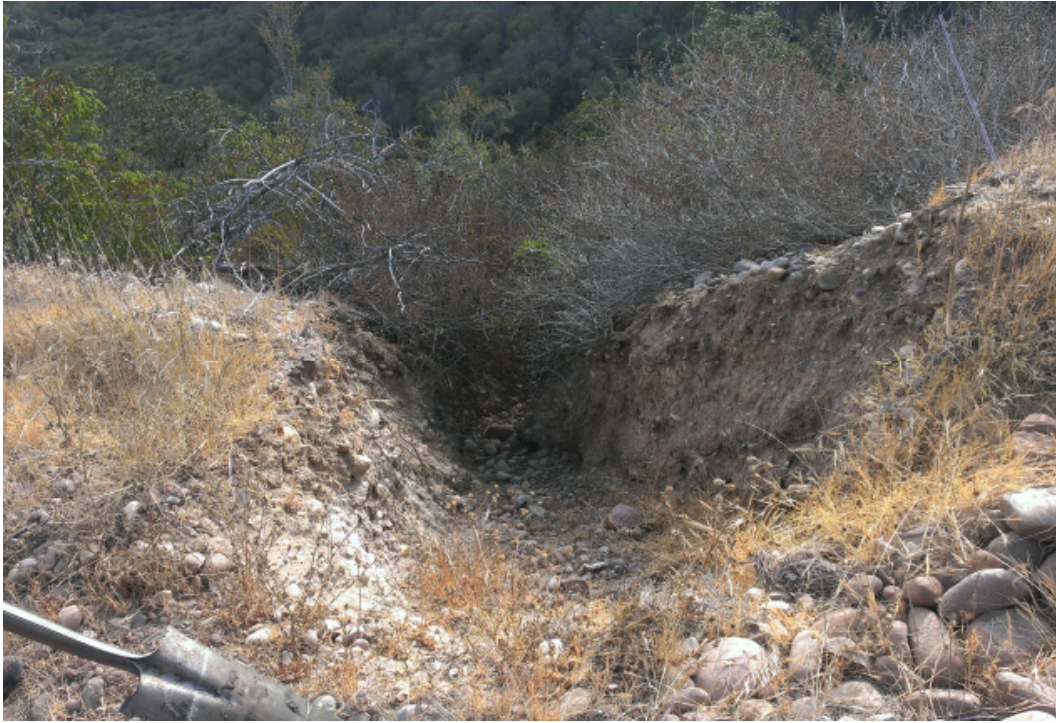
Photo 33: Tributary to Deer Canyon 2, substrate of first order tributary at headcut on northeastern side of the drainage; Photo direction: E

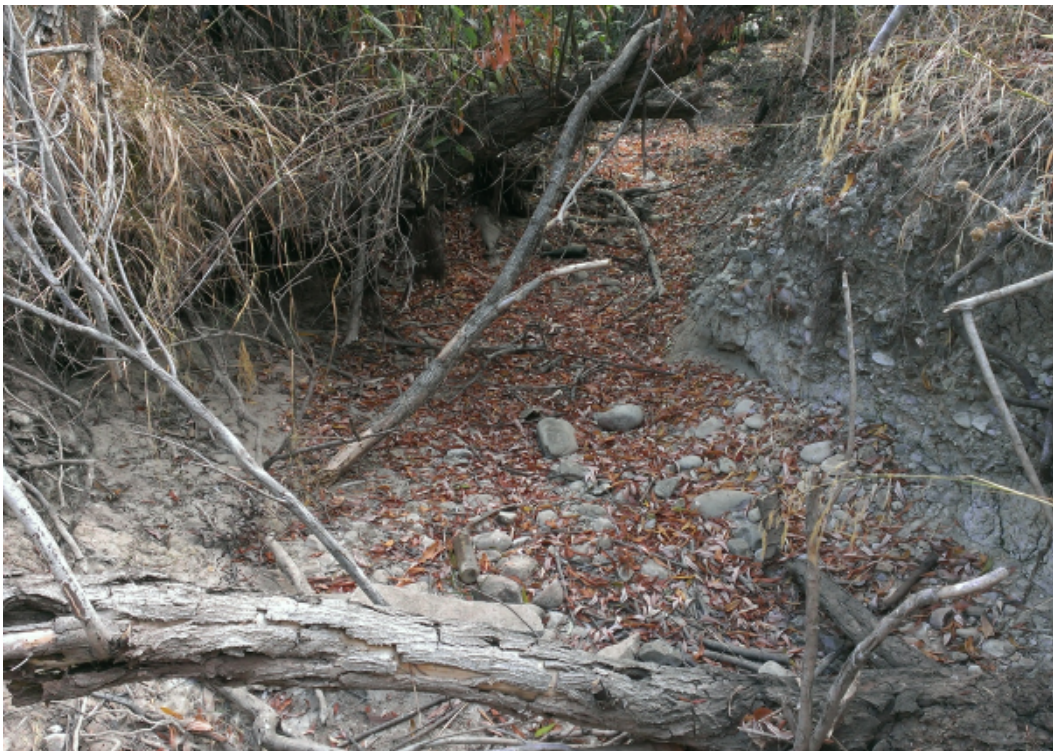
Photo 39: McGonigle Canyon Creek, overview of riparian and ornamental vegetation; Photo direction: S

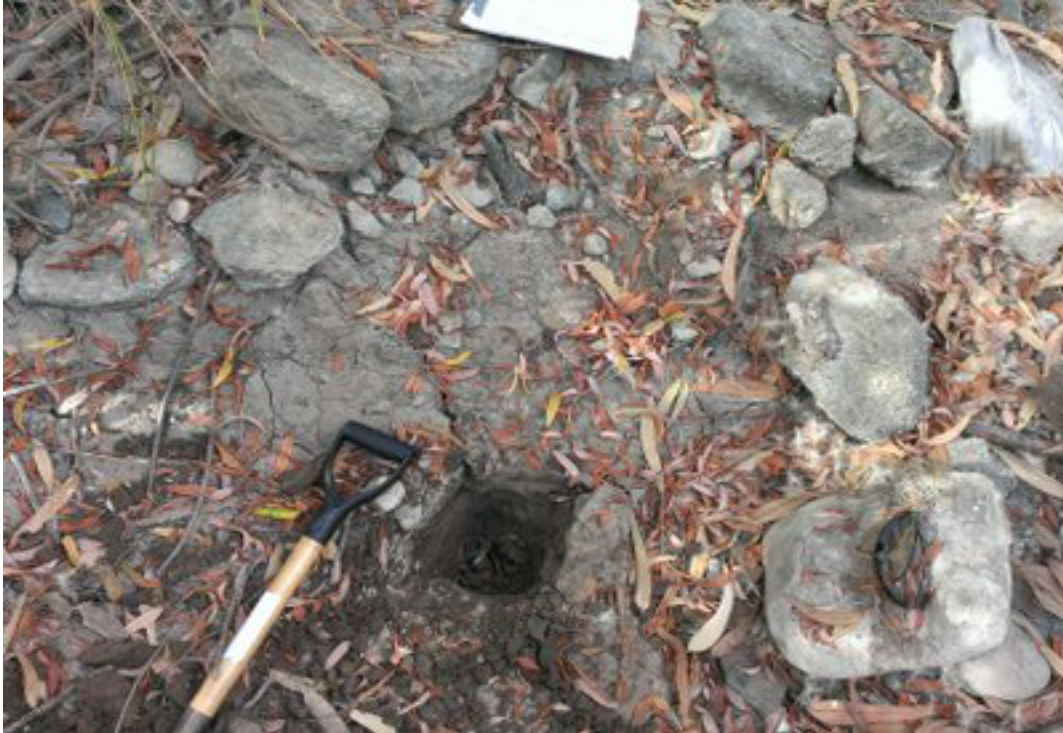
Photo 40: McGonigle Canyon Creek, deeply-incised channel and substrate consisting of large cobbles.

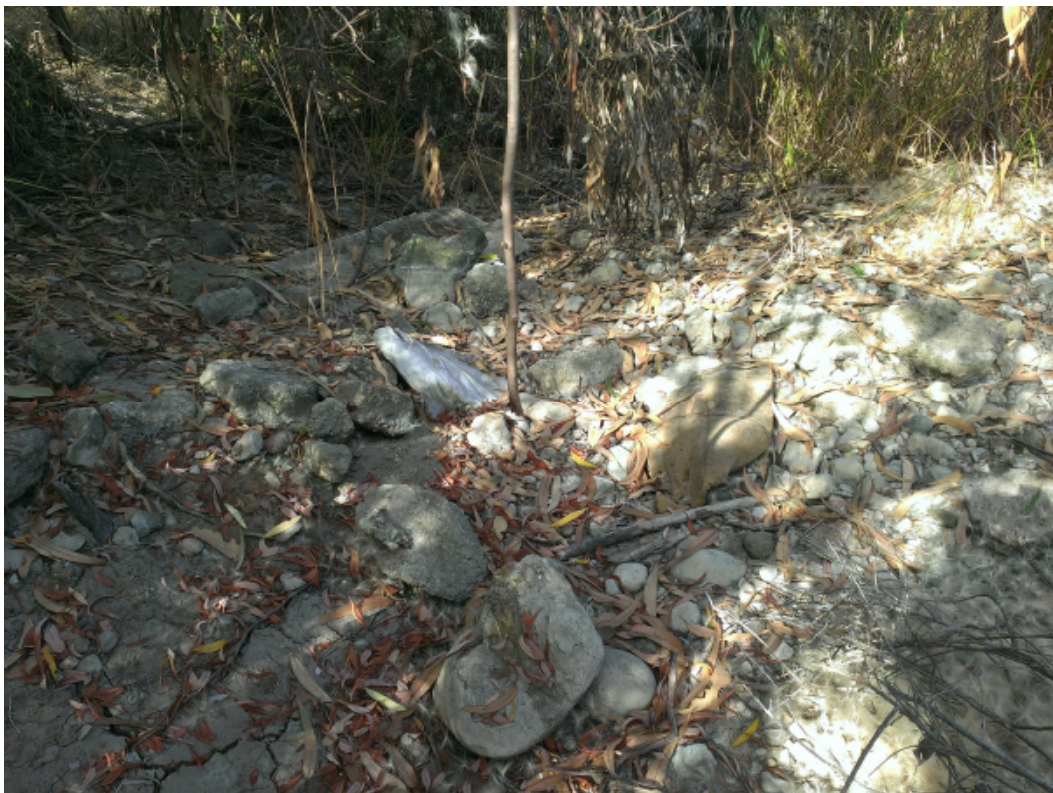
**Photo 41:** McGonigle Canyon Creek, substrate and soil sample location

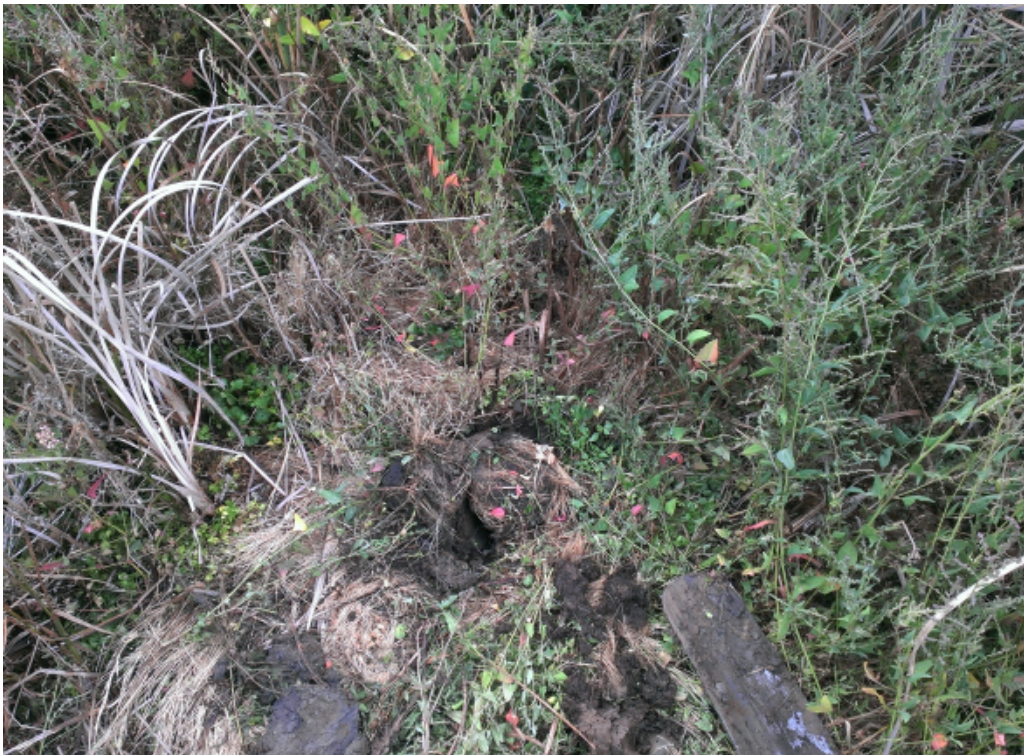
Photo 43: Tributary to McGonigle Canyon Creek 1, overview of dense vegetation along the channel; Photo direction: SE

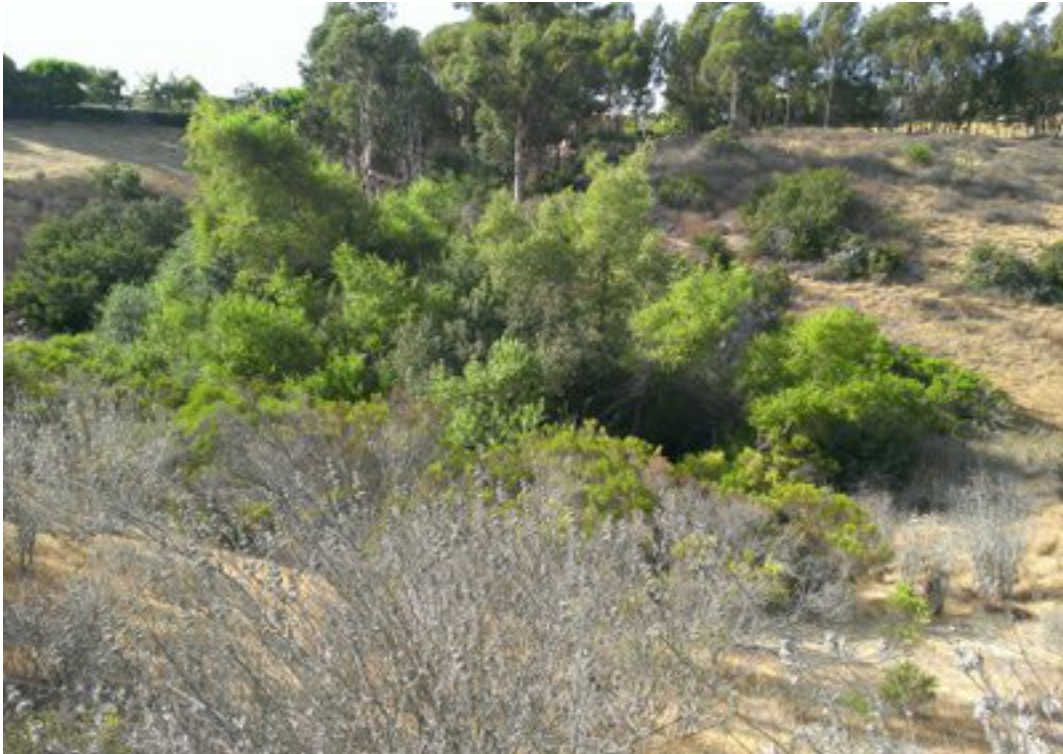
Photo 44: Tributary to McGonigle Canyon Creek 1, substrate and hydric soil sample location at Site 5

Upland vegetation associated with this drainage includes non-native grasses, Mexican elderberry (*Sambucus nigra* ssp. *caerulea*, FAC) and bluegum eucalyptus. Riparian vegetation, a mix of mule fat and southern willow scrub, was dominated by red willow (*Salix laevigata*, FACW) and mule fat. Wetland vegetation was dominated by emergent broadleaf cattail with sparse black willow. Photographs of Tributary to McGonigle Canyon Creek 2 are included as Appendix C, Photos 45, 46, and 47.

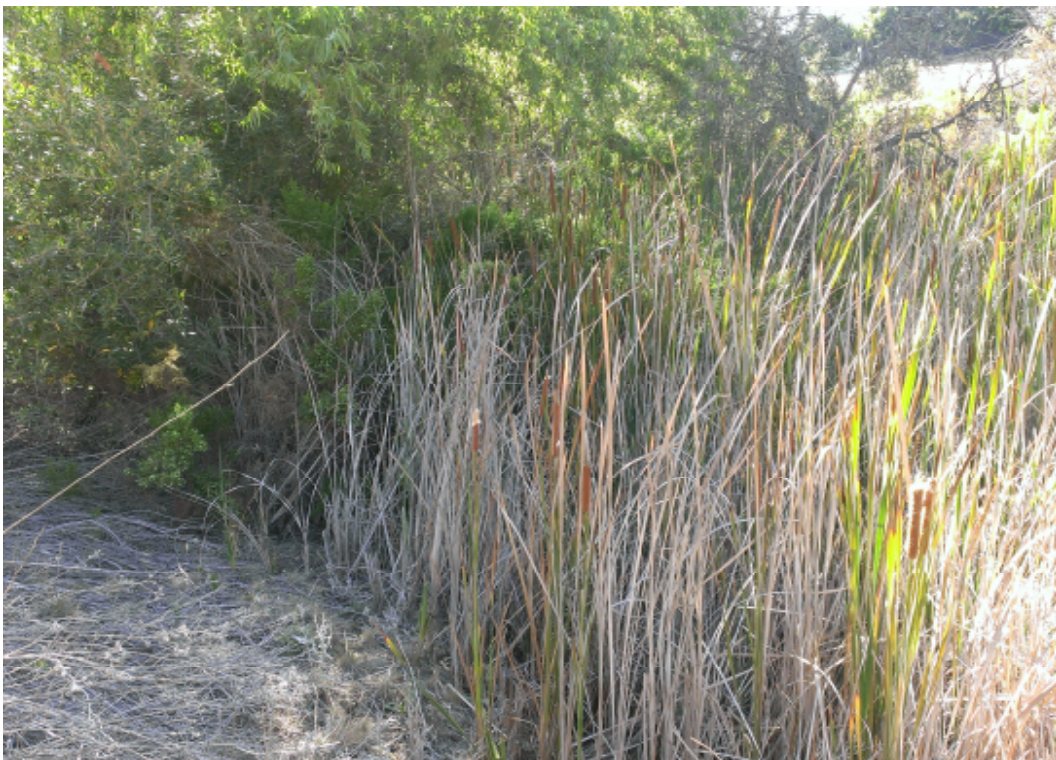
Photo 45: Tributary to McGonigle Canyon Creek 2, overview of depression that the mainstem tributary flows into; Photo direction: NW

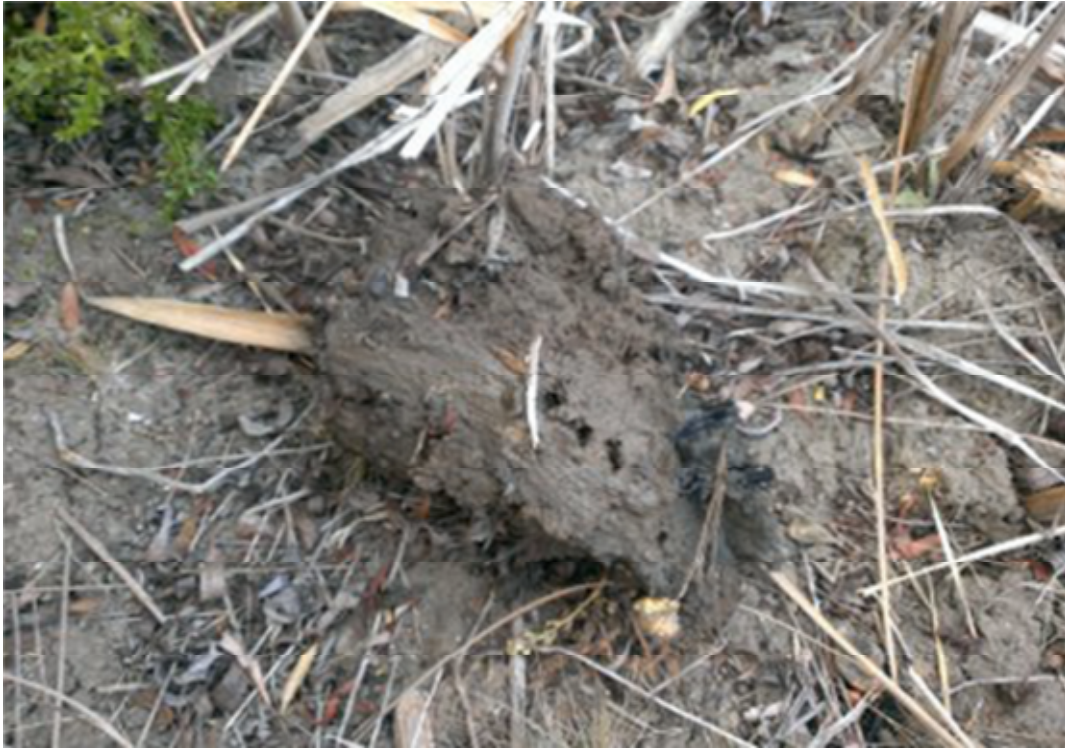
Photo 46: Tributary to McGonigle Canyon Creek 2, clay substrate and riparian vegetation in channel near hydric soil sample location

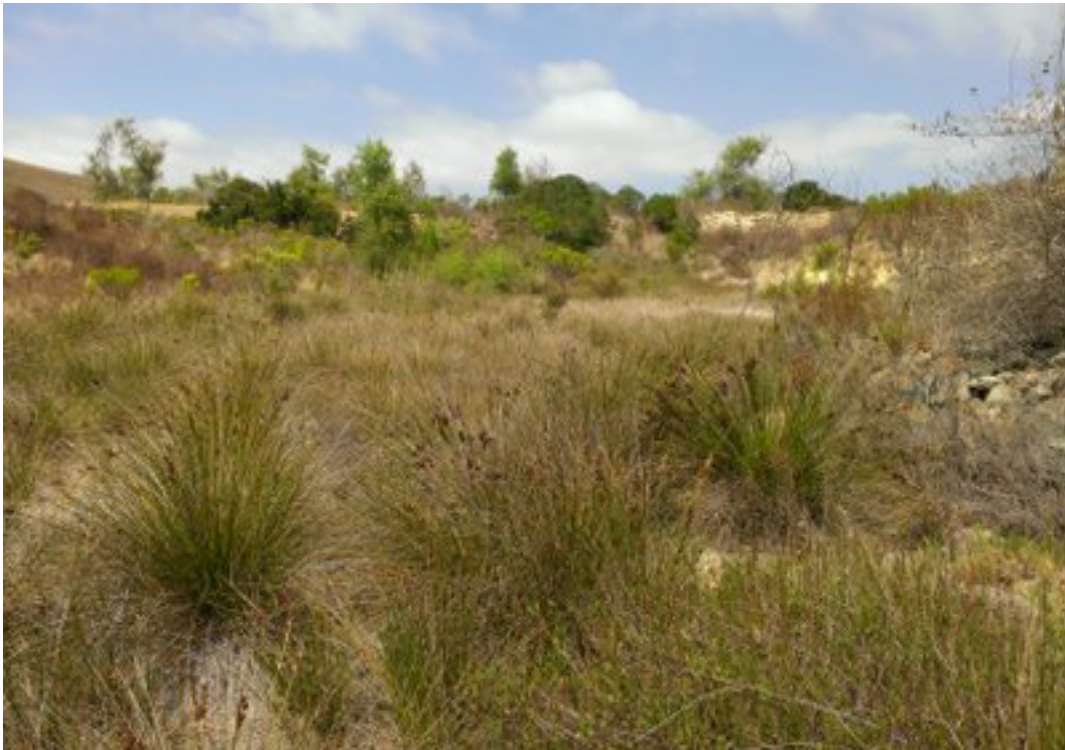
Photo 47: Tributary to McGonigle Canyon Creek 2, clay substrate and hydric soil sample from Site 3

Vegetation associated with the drainage was almost entirely composed of riparian and facultative species. Riparian and wetland vegetation associated with this drainage includes spiny rush (*Juncus acutus*, FACW), broadleaf cattail, San Diego marsh elder (*Iva hayesiana*, FACW), arroyo willow, black willow, mugwort (*Artemisia douglasiana*, FAC), ragweed (*Ambrosia psilostachya*, FACU), rabbitsfoot grass (*Polypogon monspeliensis*, FACW), and mule fat. Photographs of Tributary to McGonigle Canyon Creek 3 are included as Appendix C, Photos 48 and 49.

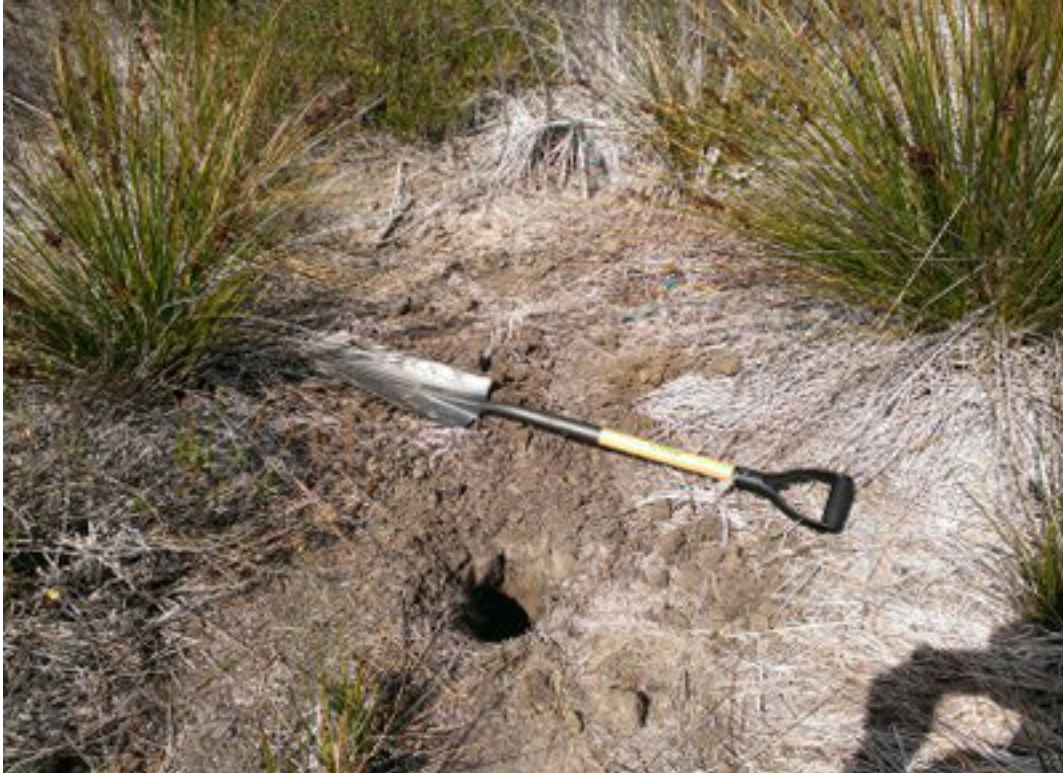
Photo 48: Tributary to McGonigle Canyon Creek 3, overview of Juncus acutus dominated wetland ; Photo direction: NE
