**BIOLOGICAL TECHNICAL REPORT**  
**SYCAMORE TO PEÑASQUITOS 230 KILOVOLT TRANSMISSION LINE PROJECT**  
**CITY OF SAN DIEGO**  
**SAN DIEGO COUNTY, CALIFORNIA**

**SAN DIEGO GAS & ELECTRIC COMPANY**  
8315 Century Park Court, CP21E  
San Diego, California 92123  
Contact: Rob Fletcher

**BUSBY BIOLOGICAL SERVICES, INC.**  
4629 Cass Street, #192  
San Diego, California 92109  
Contact: Melissa Busby

April 2014

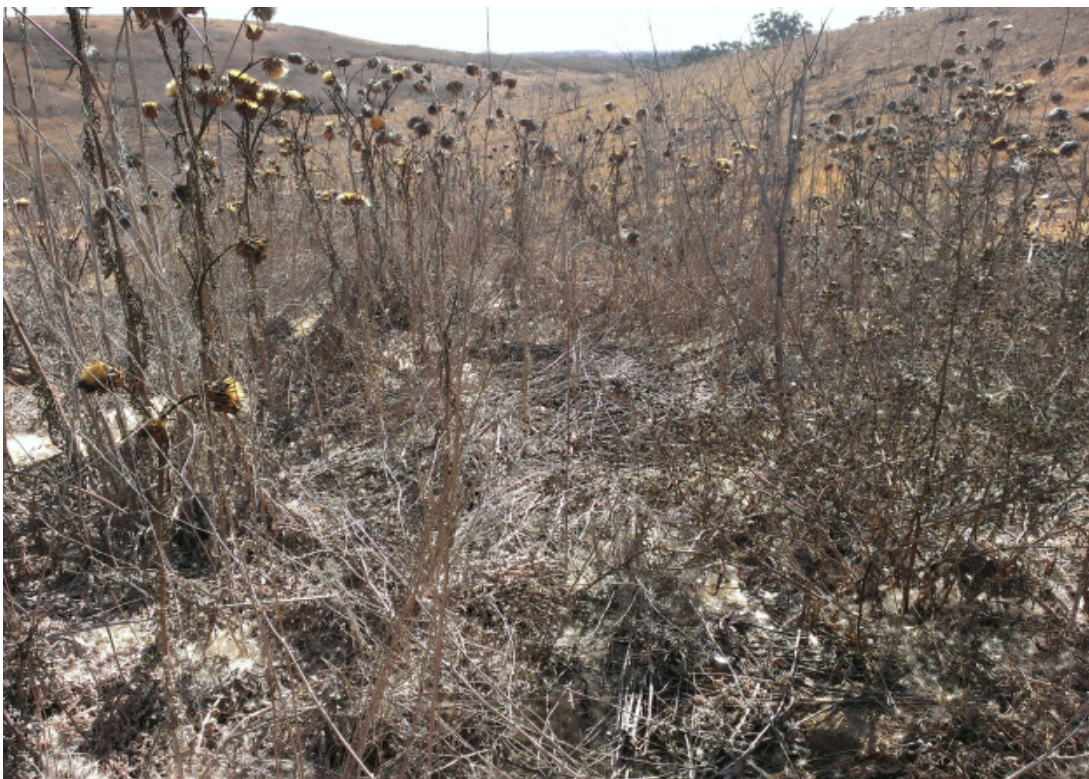
Photo 49: Tributary to McGonigle Canyon Creek 3, clay substrate and sample location for Site 2

Non-native grasses and other upland ruderal vegetation are associated with this drainage. Riparian vegetation was also present along the intermittent channel. This vegetation includes tamarisk and cattail. Photographs of Tributary to McGonigle Canyon Creek 4 are included as Appendix C, Photos 50, 51, and 52.

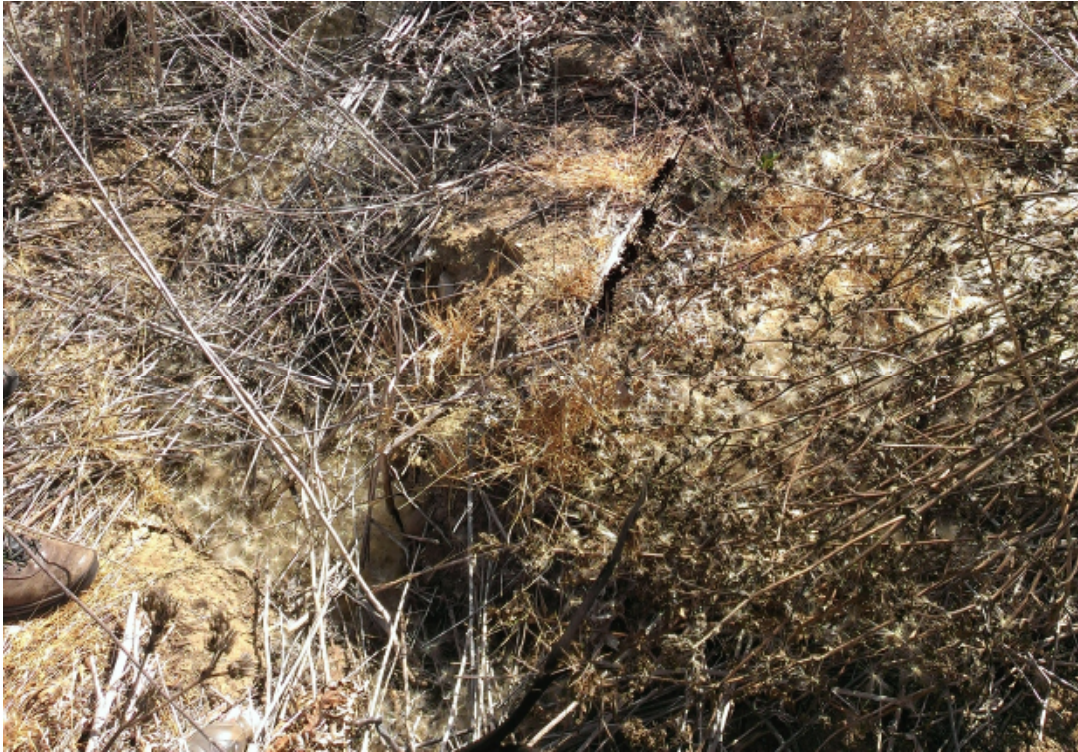
Photo 50: Tributary to McGonigle Canyon Creek 4, overview from top of headwaters looking downstream; Photo direction: SW

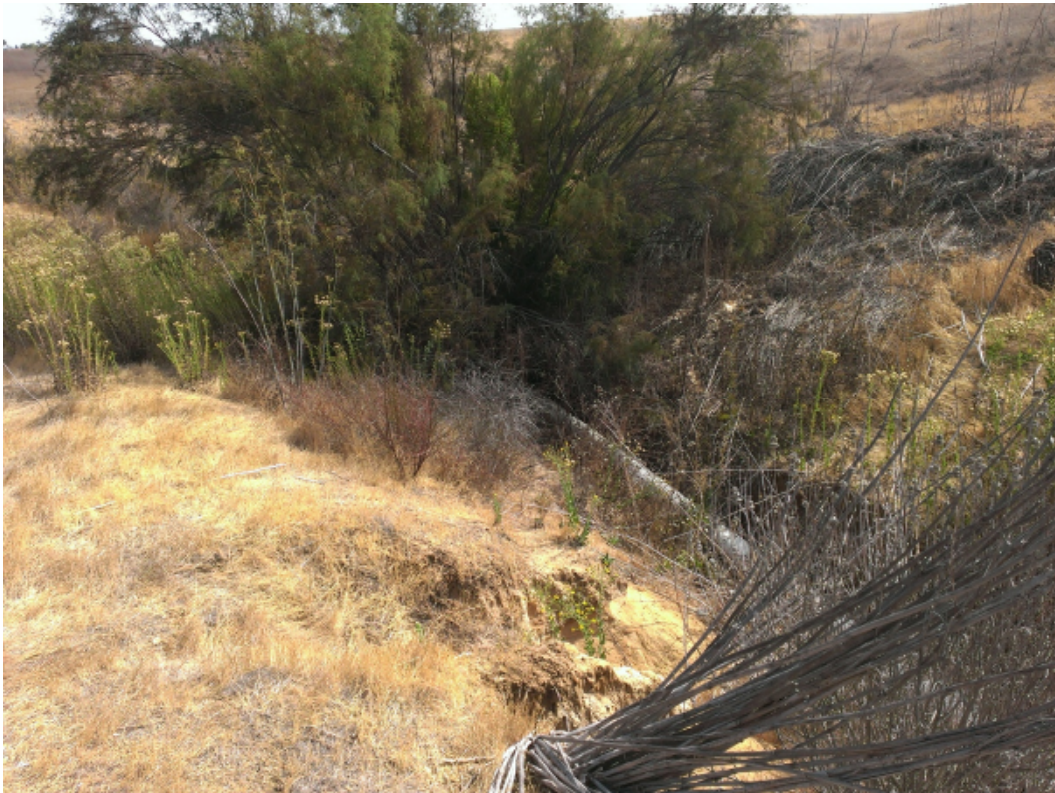
Photo 51: Tributary to McGonigle Canyon Creek 4, sandy substrate of narrow, incised channel

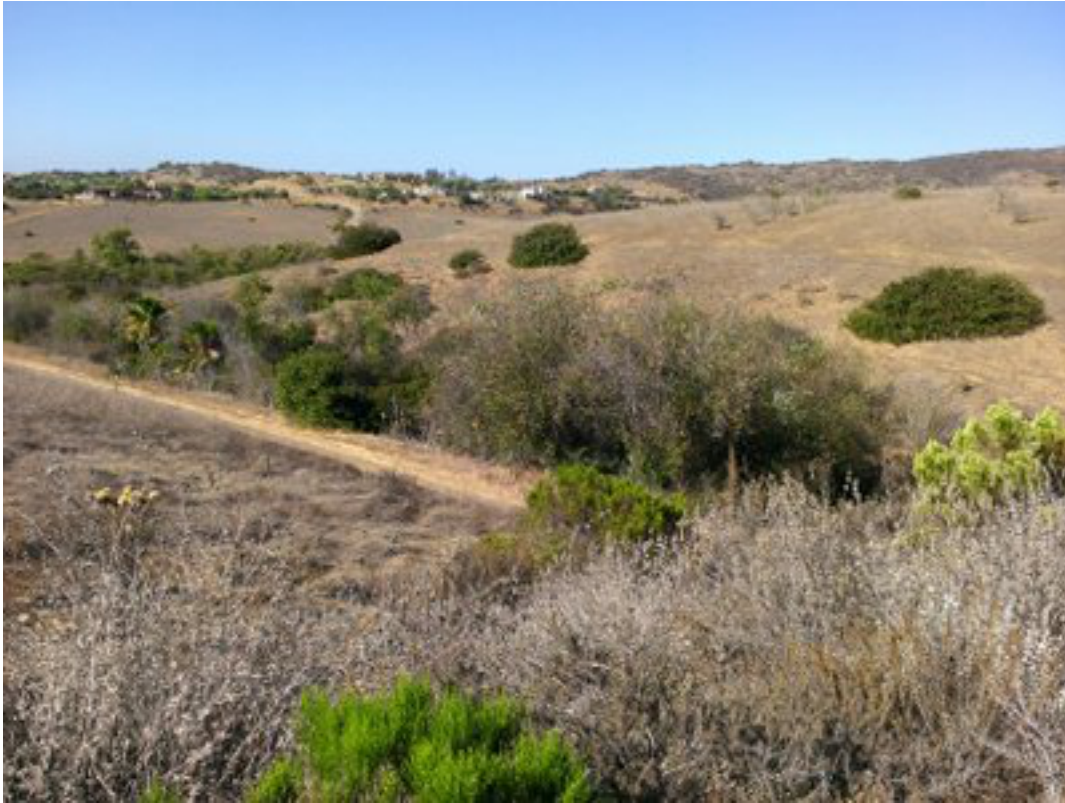
Photo 52: Tributary to McGonigle Canyon Creek 4, overview of narrow channel looking downstream and riparian vegetation growing in channel; Photo direction: SW

Vegetation associated with the drainage includes open grassland and dense vegetation in the riparian area. Upland vegetation includes laurel sumac and lemonade berry. Riparian vegetation includes arroyo willow, mule fat, and black willow. Photographs of Tributary to La Zanja Canyon 1 are included as Appendix C, Photos 53, 54, 55, and 56.

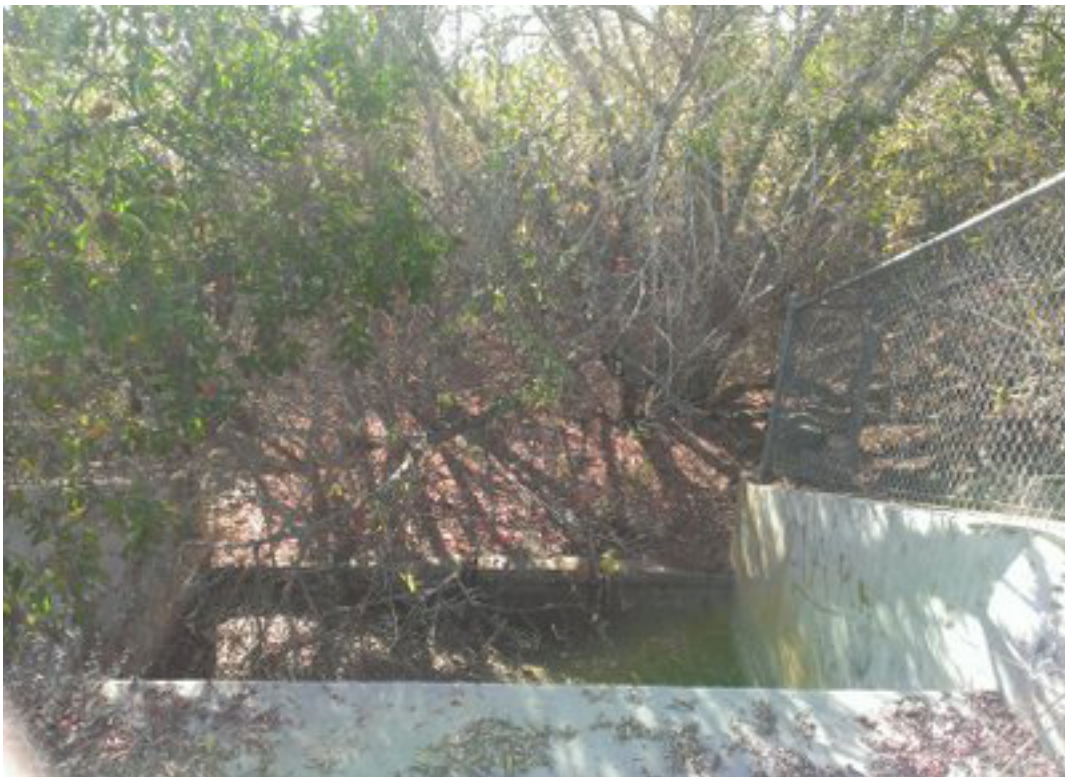
Photo 53: Tributary to La Zanja Canyon 1, overview of main channel, looking downstream; Photo direction: NE

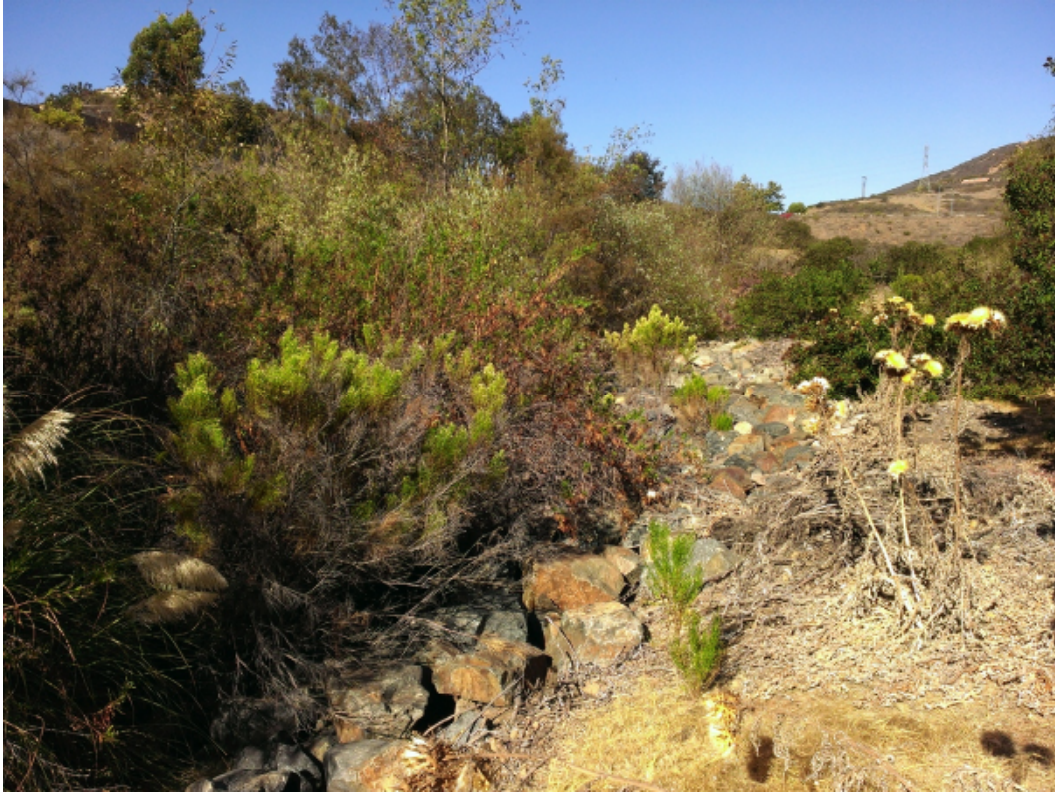
Photo 54: Tributary to La Zanja Canyon 1, culvert outlet and cobble substrate near culvert and on channel bottom

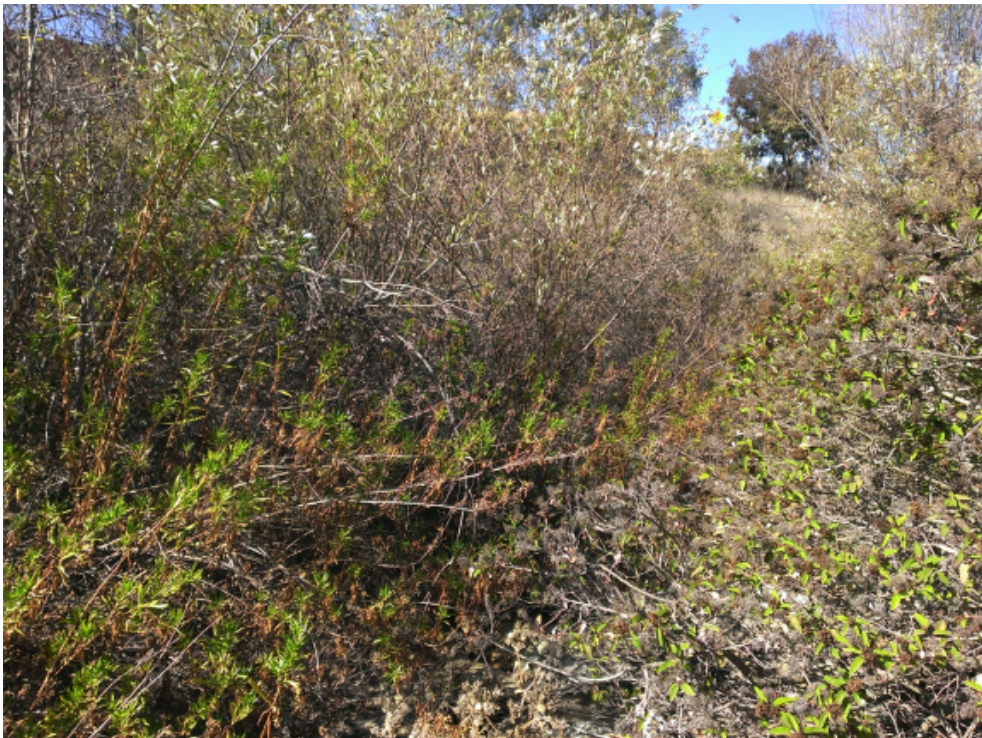
Photo 55: Tributary to La Zanja Canyon 1, rip-rap substrate in the higher-gradient western side of the drainage near a residential development; Photo direction: E

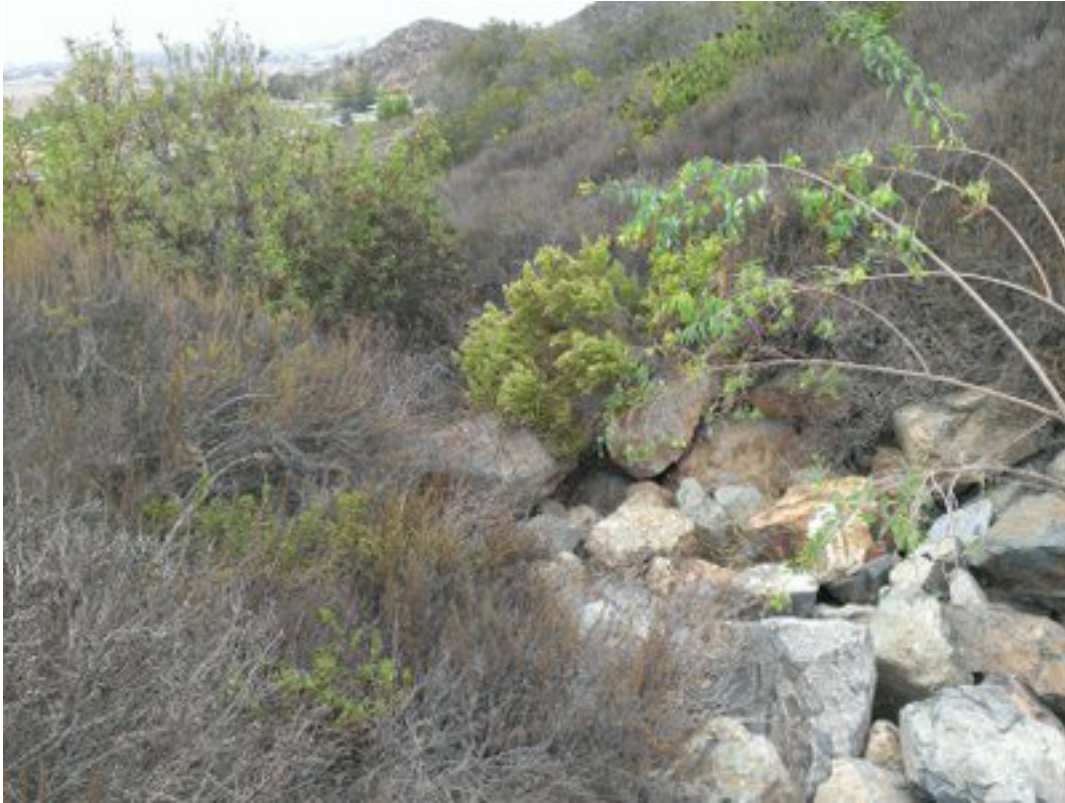
Photo 56: Tributary to La Zanja Canyon 1, riparian vegetation in the higher-gradient western side of the drainage near a residential development; Photo direction: NE

Vegetation associated with the drainage includes California sagebrush (*Artemisia californica*, UPL), California brittlebrush (*Encelia californica*, UPL), and laurel sumac. Photographs of Tributary to La Zanja Canyon 2 are included as Appendix C, Photos 57 and 58.

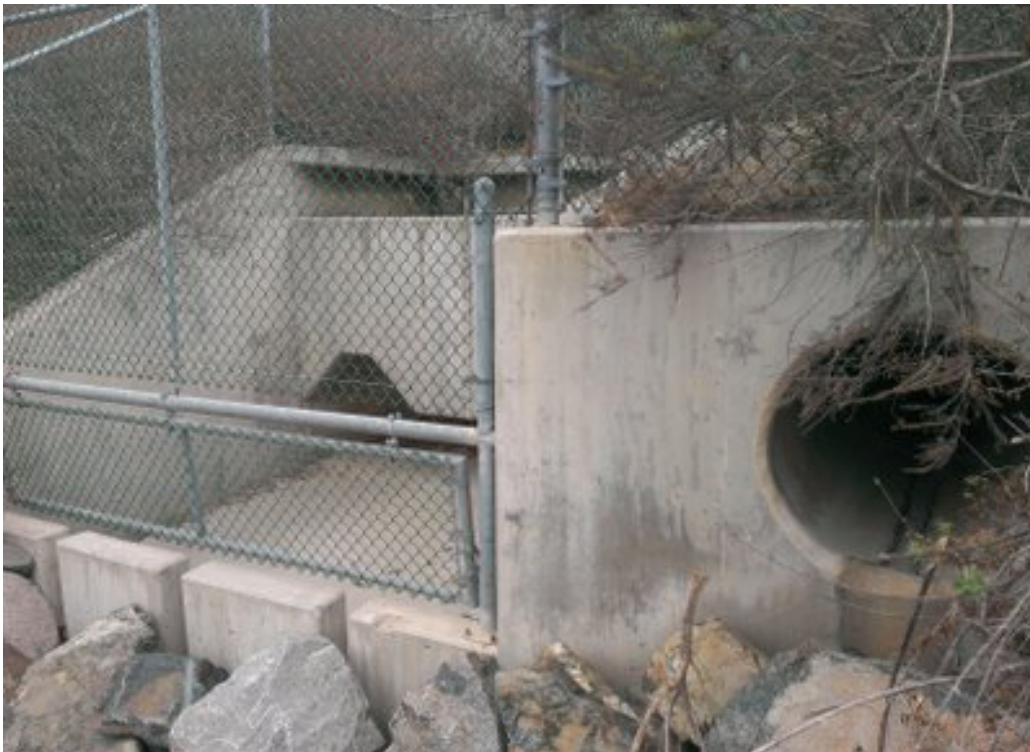
Photo 57: Tributary to La Zanja Canyon 2, overview of channel and substrate at culvert outlet, looking downstream; Photo direction: NW

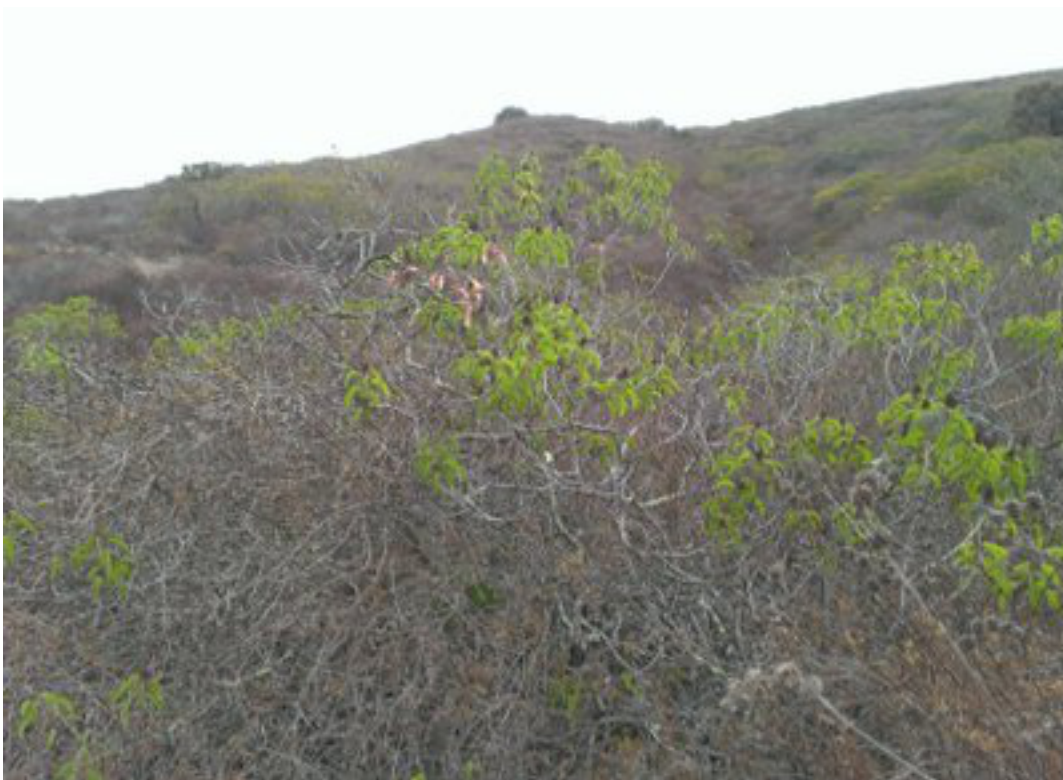
Photo 58: Tributary La Zanja Canyon 2, culvert outfall at top of stream; Photo direction: E

Vegetation associated with the drainage includes broom baccharis (*Baccharis sarothroides*), black sage, laurel sumac, and buckwheat. Riparian vegetation includes red willow, California bulrush, and mule fat. Photographs of Tributary to McGonigle Canyon Creek 5 are included as Appendix C, Photos 59 and 60.

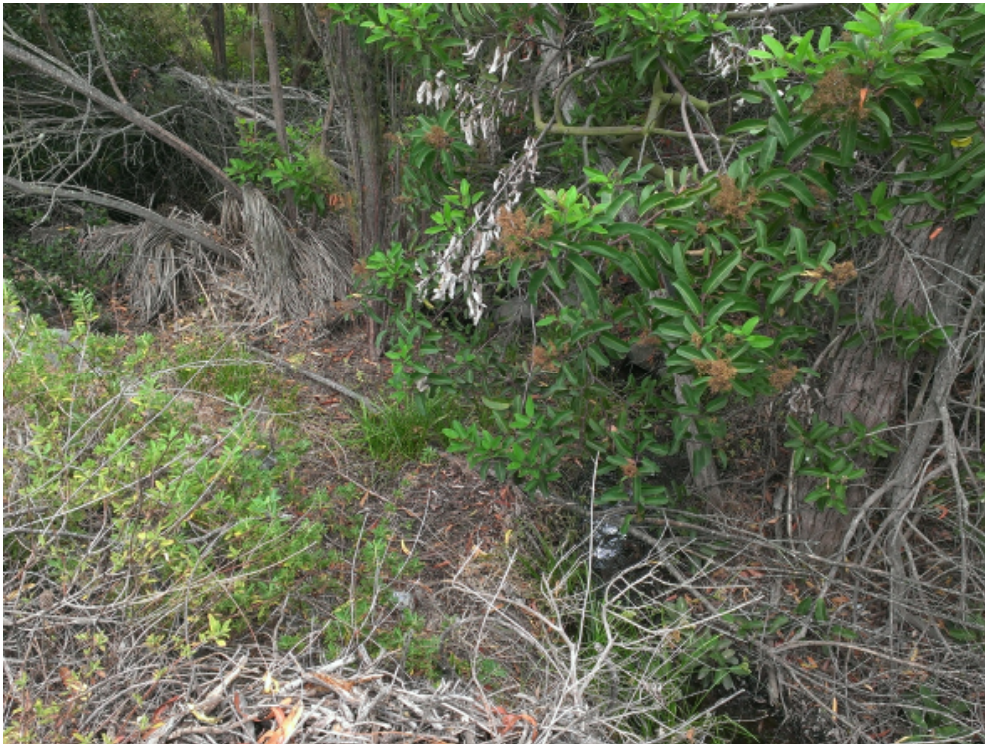
Photo 59: Tributary to McGonigle Canyon Creek 5, looking across high-gradient ephemeral in the northeastern section of the drainage; Photo direction: NE

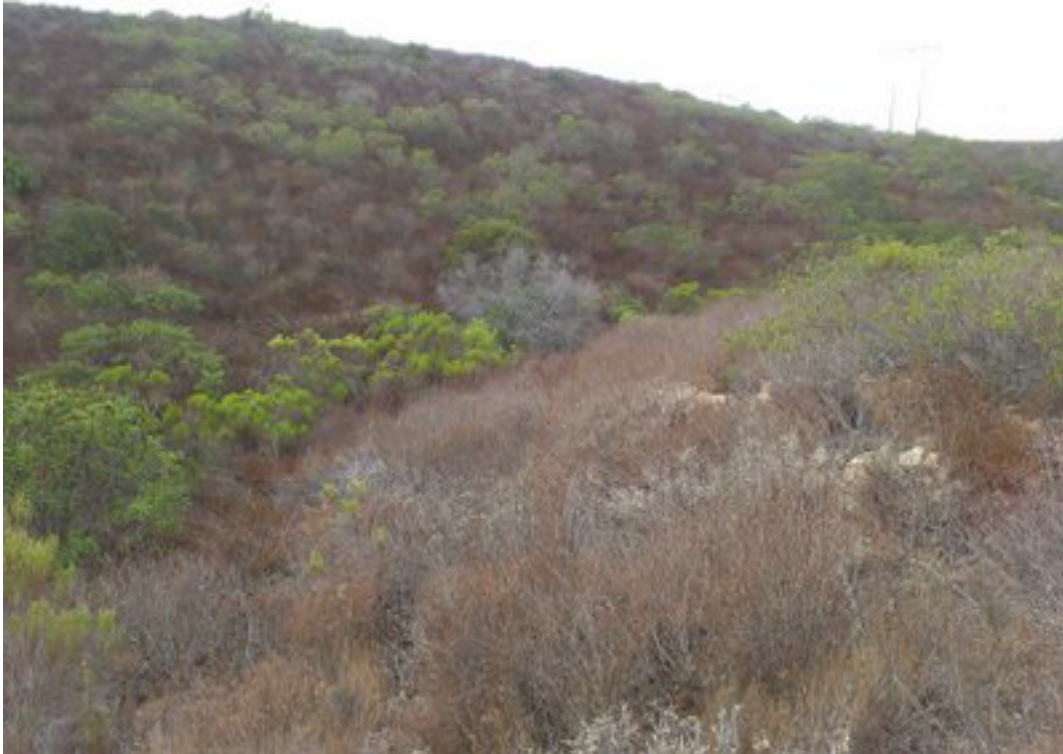
Photo 60: Tributary to McGonigle Canyon Creek 5, substrate and incised channel containing water from nuisance flow; Photo direction: E

Vegetation associated with the drainage includes dense chaparral dominated by chamise and broom baccharis. No riparian vegetation is present. Photographs of Black Mountain Features are included as Appendix C, Photos 61 and 62.

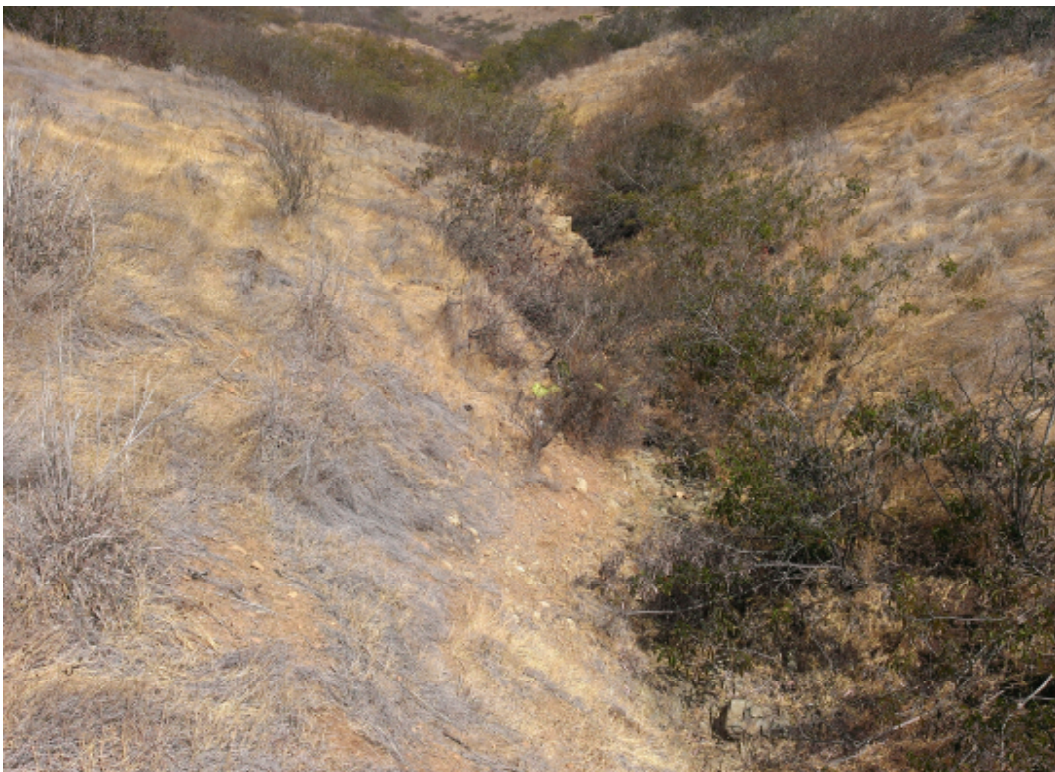
Photo 61: Black Mountain Features, overview of incised headwater drainage, looking downstream; Photo direction: SE

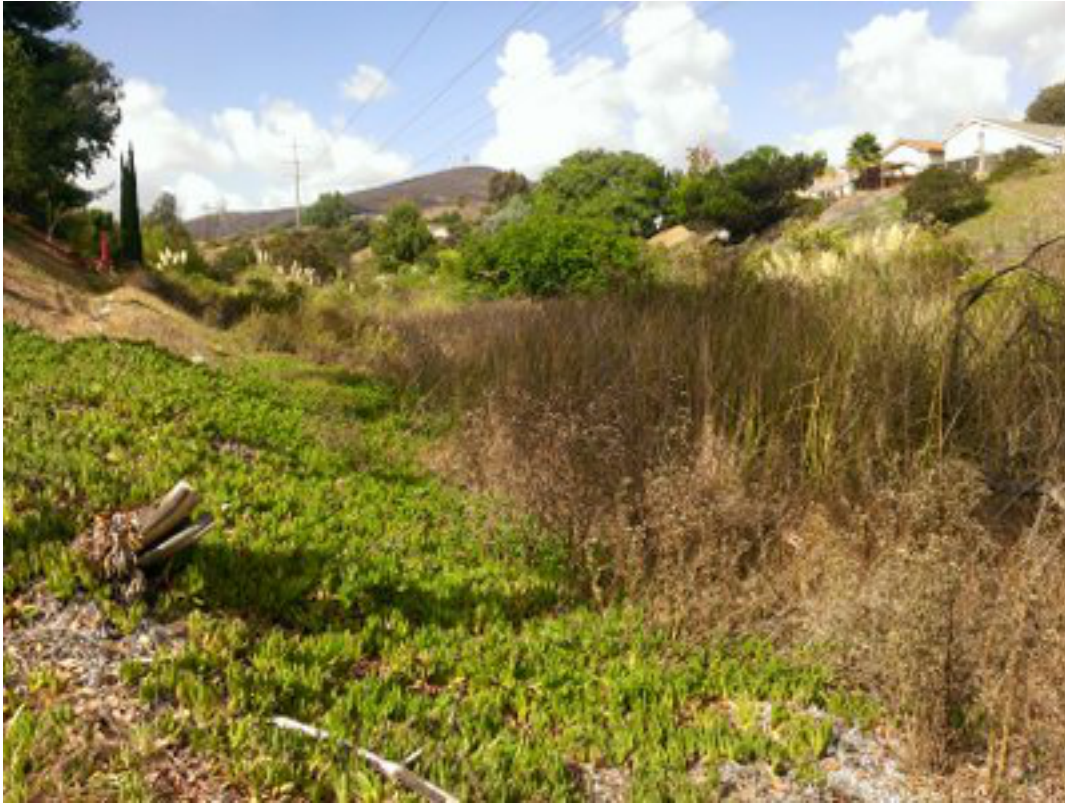
Photo 62: Black Mountain Features, gravel and sand substrate of narrow headwater in the southern section of the drainage; Photo direction: E

Riparian and wetland vegetation, of equal extent, was dominated by: tamarisk and American bulrush with intrusions of pampas grass (*Cortaderia selloana*, FACU). Photographs of Los Peñasquitos Mesa Features 1 are included as Appendix C, Photos 63 and 64.

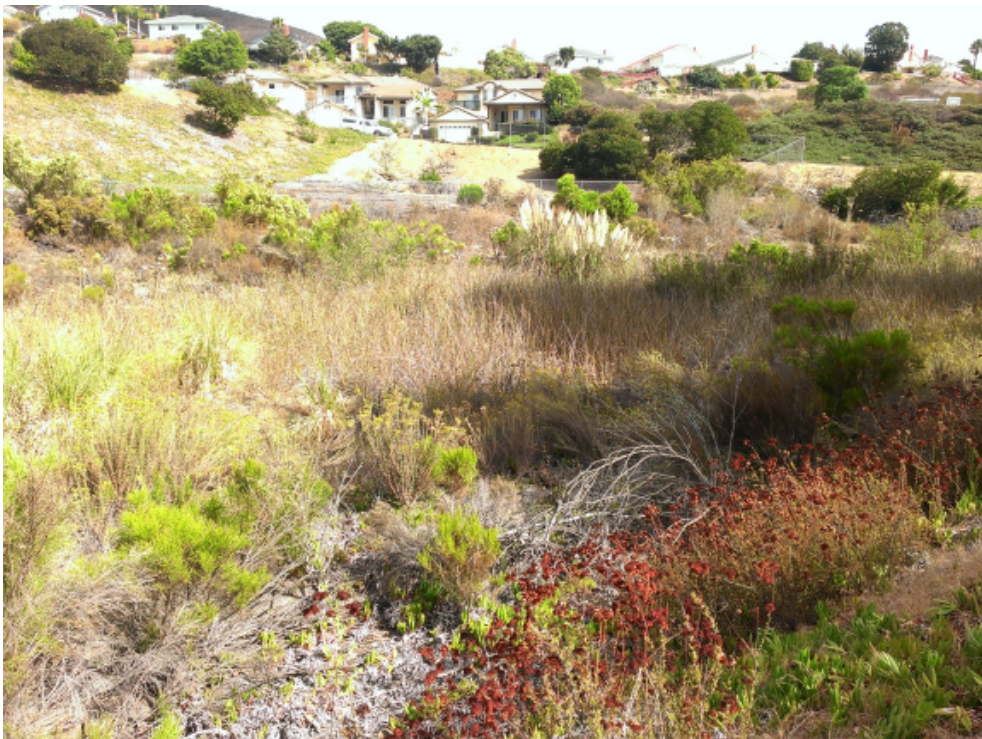
Photo 63: Los Peñasquitos Mesa Features 1, interface of wetland and upland vegetation; Photo direction: N

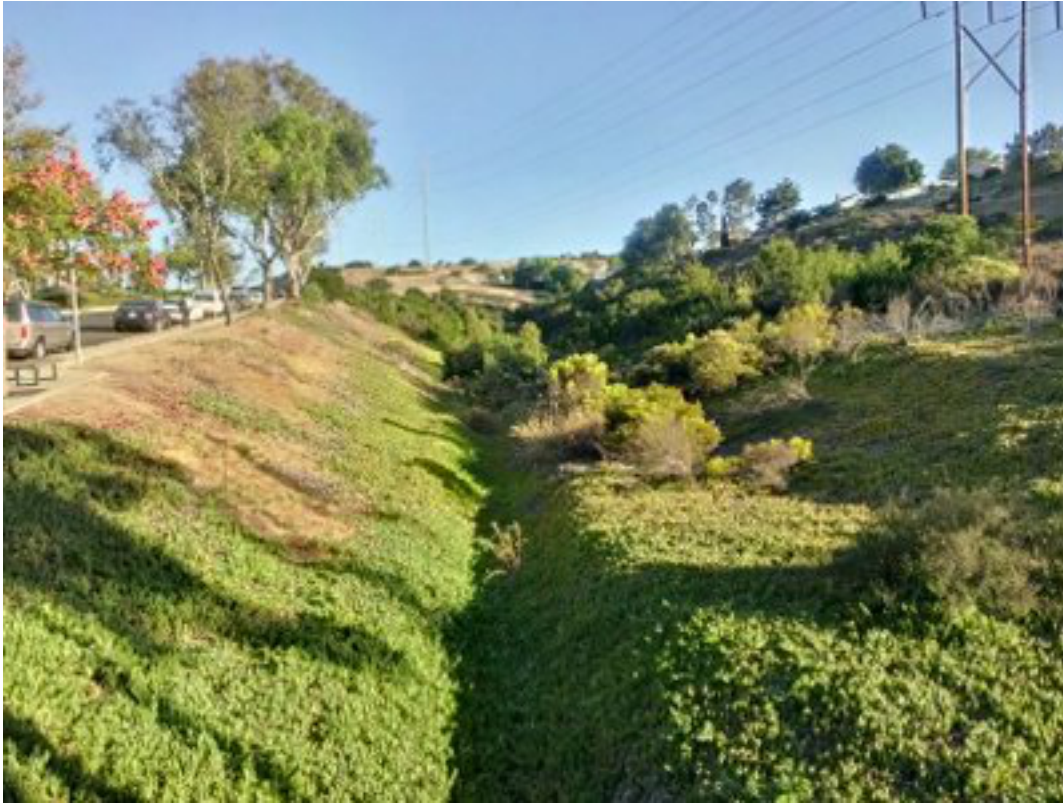
Photo 64: Los Peñasquitos Mesa Features 1, overview of wetland area; Photo direction: SE

Upland vegetation associated with this drainage includes ice-plant, broom baccharis and artichoke thistle (*Cynara cardunculus*, UPL). Riparian vegetation was characterized by mule fat scrub with a single tamarisk also present in the channel. A photograph of Los Peñasquitos Mesa Features 2 is included as Appendix C, Photo 65.

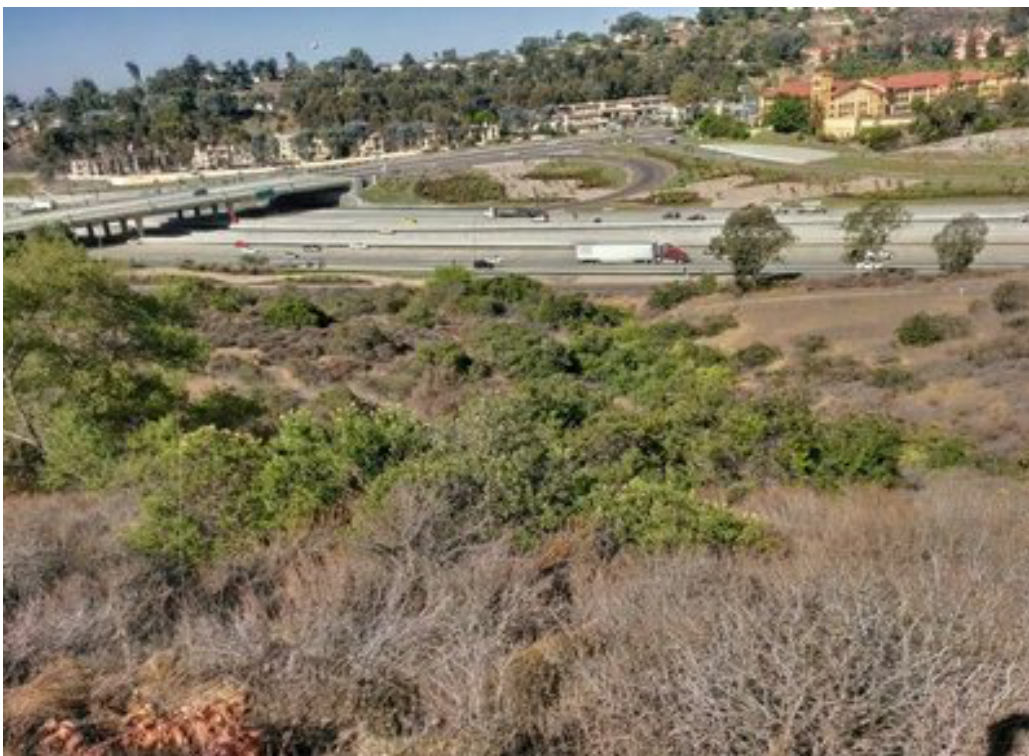
Photo 65: Los Peñasquitos Mesa Features 2, overview of iceplant-lined channel; Photo direction: N

Riparian vegetation associated with this feature includes broadleaf cattail, iris-leaf juncus (*Juncus xiphioides*, OBL), sedges (*Cyperus* sp., FACW), tamarisk, red willow, and mule fat. A photograph of Los Peñasquitos Mesa Features 3 is included as Appendix C, Photo 66.

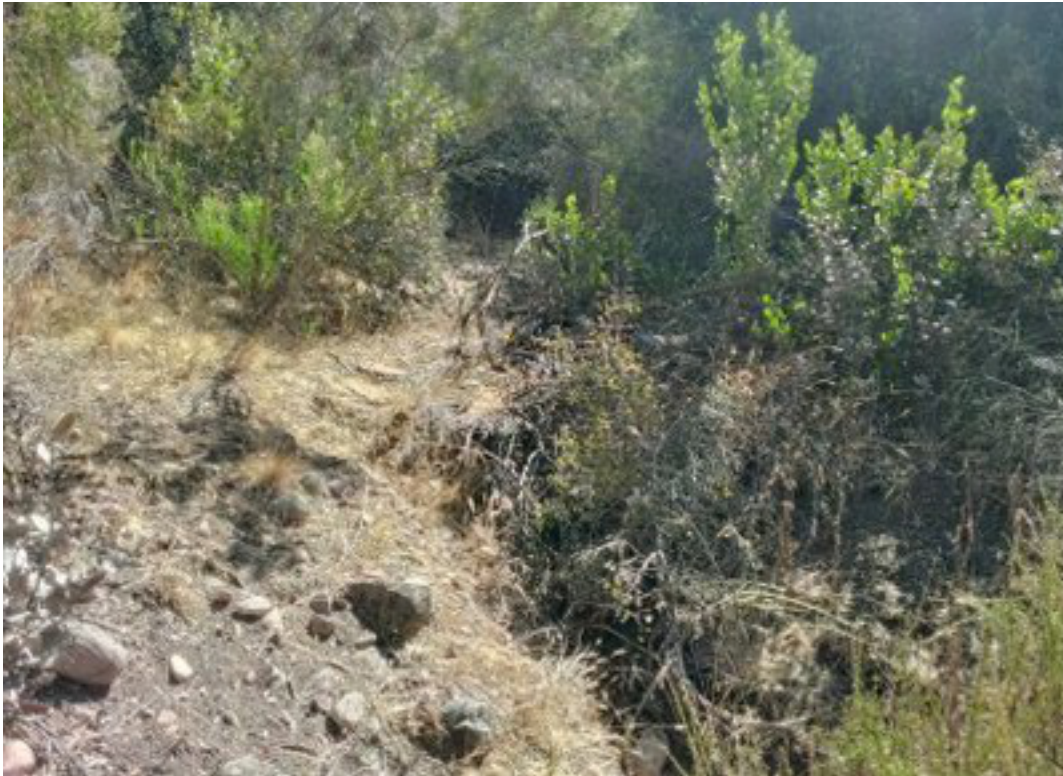
Photo 66: Los Peñasquitos Mesa Features 3, downstream overview of headwater channel in the southern portion of the drainage; Photo direction: NW

Vegetation associated with this drainage consists mostly of upland vegetation and includes: non-native brome grasses, laurel sumac, redberry, coast live oak (*Quercus agrifolia*, UPL), broom baccharis, and California sagebrush. Photographs of Tributary to Peñasquitos Creek 10 are included as Appendix C, Photos 67 and 68.

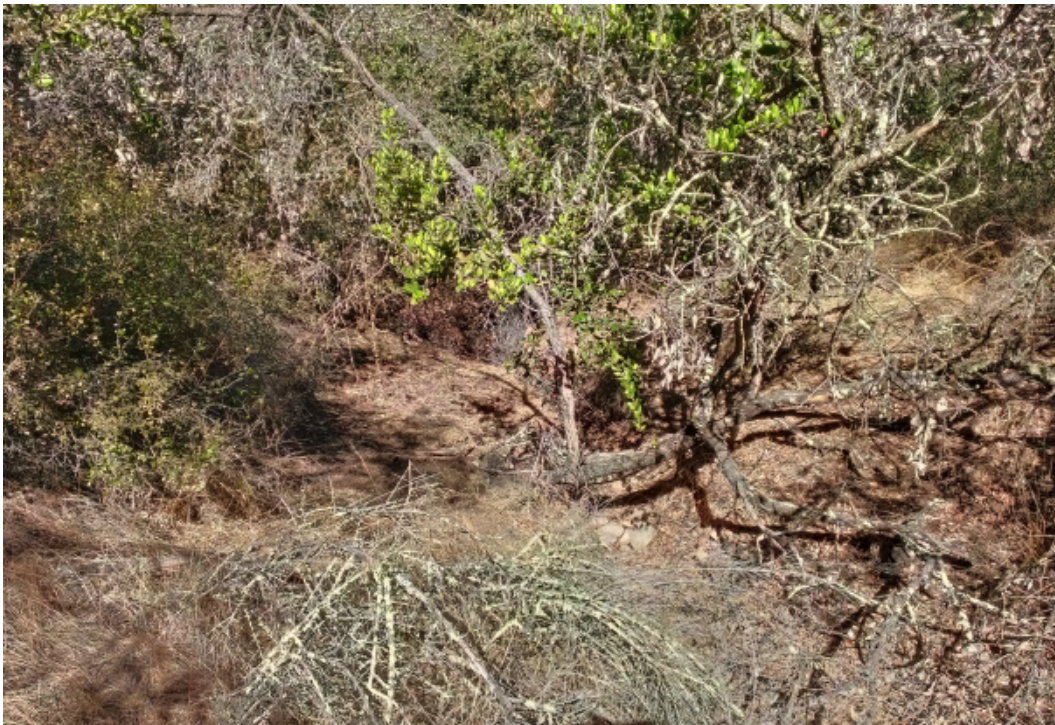
Photo 67: Tributary to Peñasquitos Creek 10, overview of headwaters at top of drainage; Photo direction: N

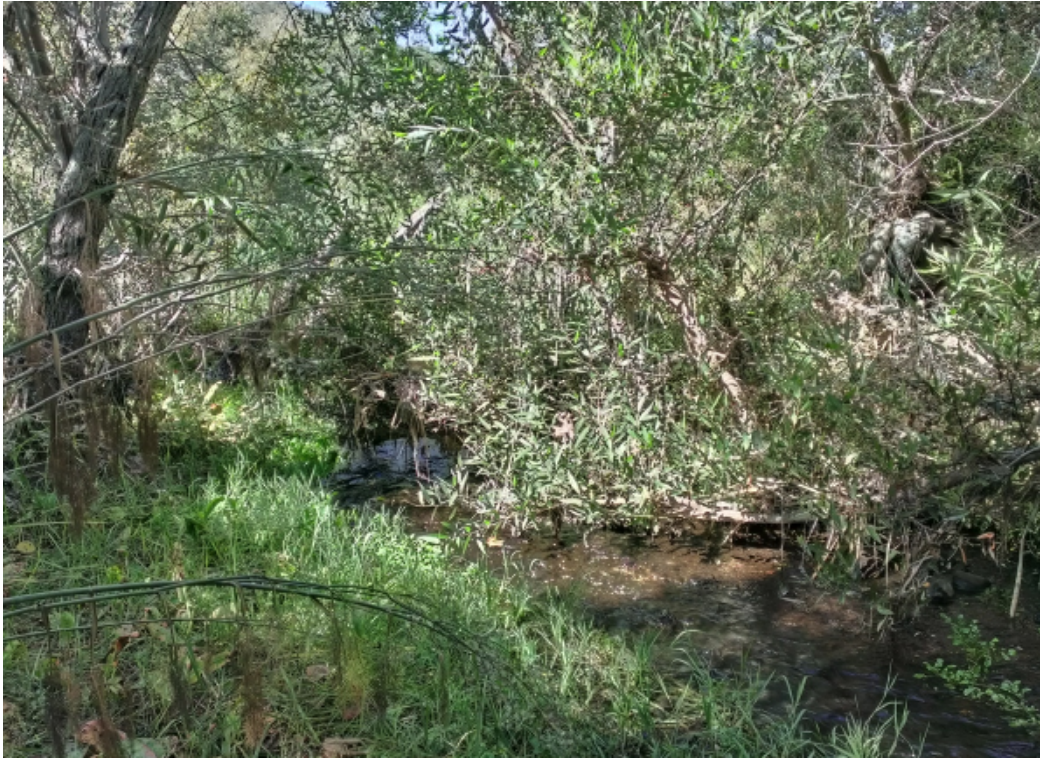
Photo 68: Tributary to Peñasquitos Creek 10, sand and cobble substrate in headwaters

Vegetation associated with this drainage is composed of dense coast live oak vegetation at the edges as well as riparian vegetation in the drainage interior. Riparian vegetation, best characterized as sycamore woodland, is dominated by sycamore (*Platanus racemosa*, FAC) with scattered arroyo willow, black willow, and poison oak. Wetland vegetation occurs in areas of low flow and is dominated by cattail and bulrush with scattered arroyo willow, black willow, and yerba mansa (*Anemopsis californica*, OBL). Photographs of Los Peñasquitos Creek are included as Appendix C, Photos 69 and 70.

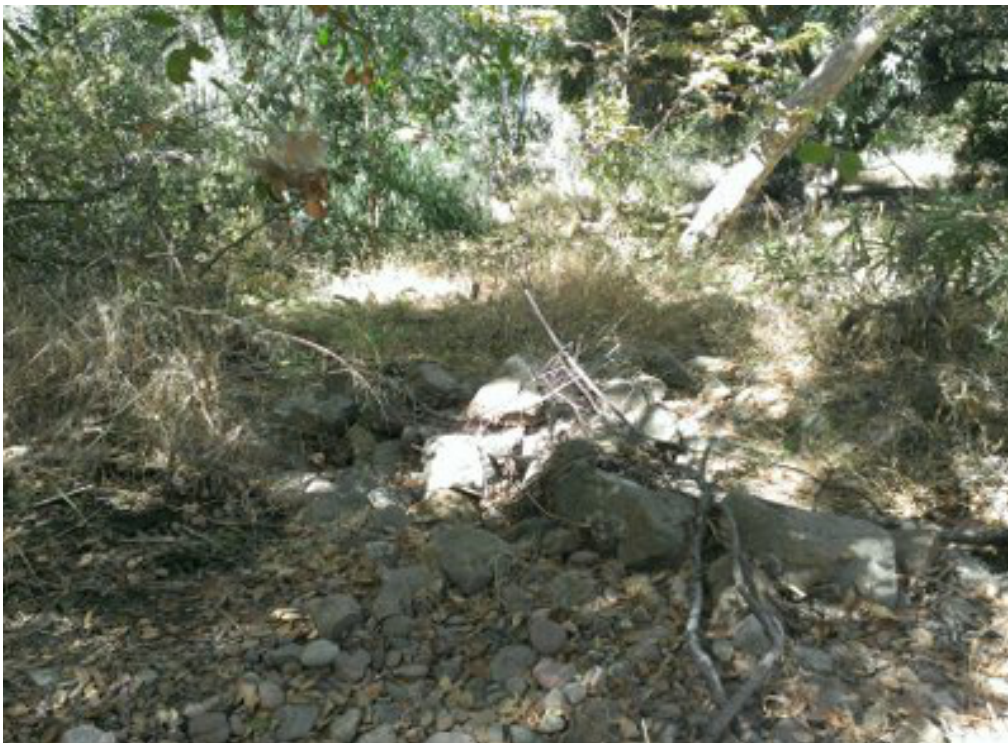
Photo 69: Los Peñasquitos Creek, wetted area, cobble substrate and riparian vegetation overview; Photo direction: E

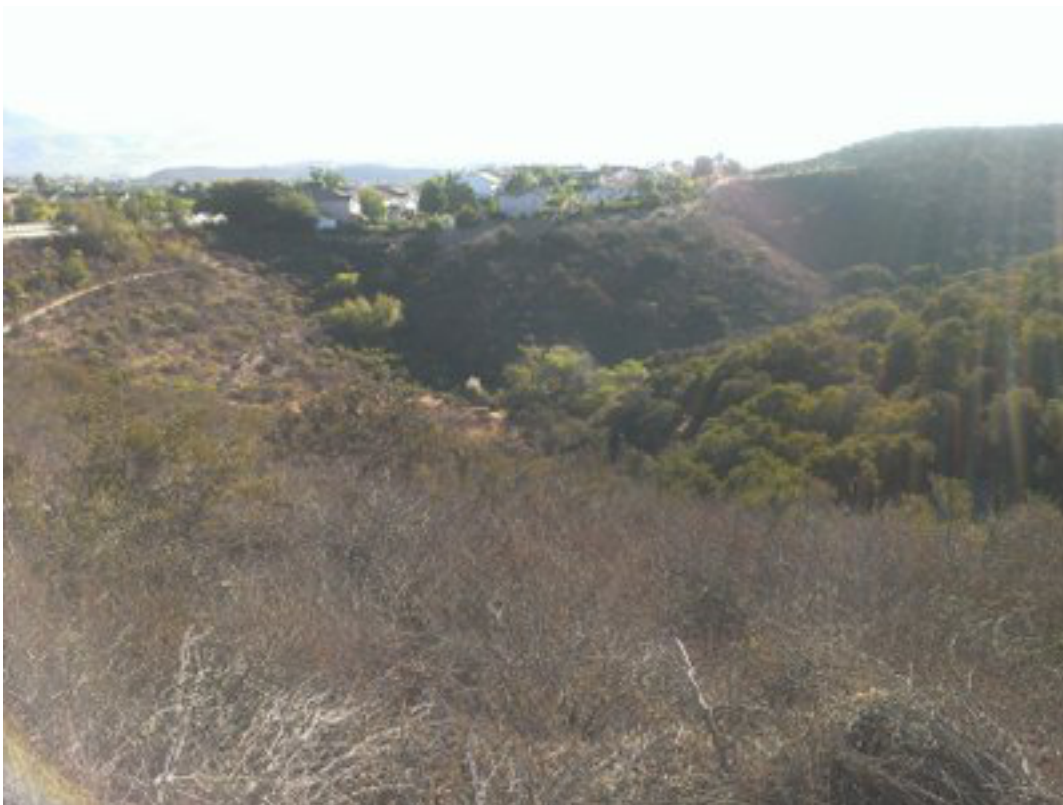
Photo 70: Los Peñasquitos Creek, substrate consisting of large cobbles downstream of debris jam

This drainage is dominated by dense, upland vegetation including chamise, scrub oak, black sage, holly-leaf cherry (*Prunus ilicifolia*, UPL), and buckbrush (*Ceanothus* sp., UPL). Riparian and wetland vegetation is present and includes red willow and mule fat. Photographs of Tributary to Peñasquitos Creek 11 are included as Appendix C, Photos 71, 72, and 73.

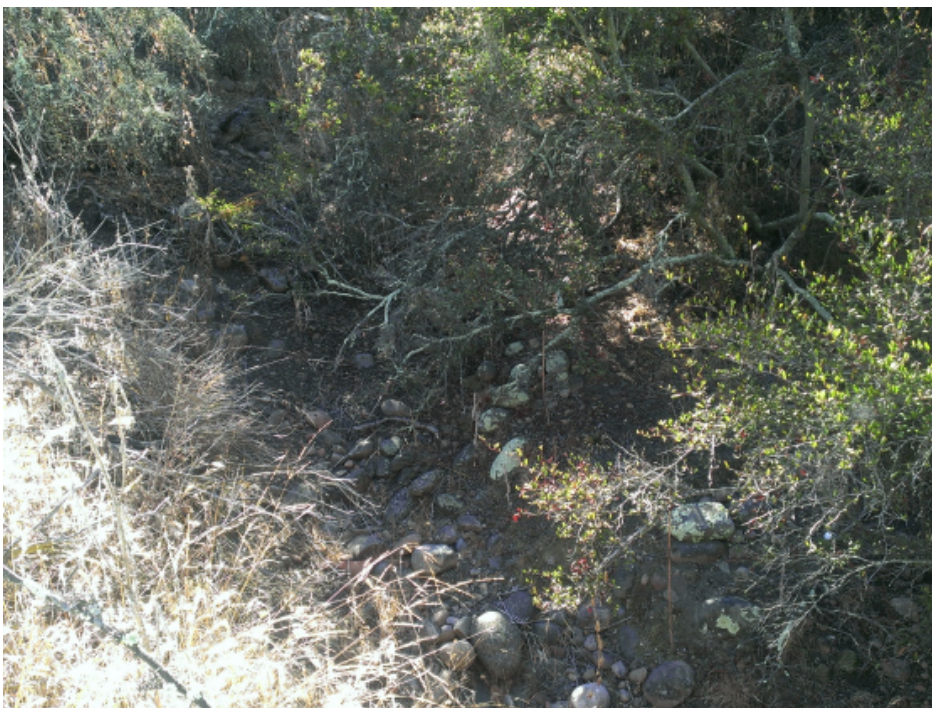
Photo 71: Tributary to Peñasquitos Creek 11, overview of top of headwater tributaries on western side of drainage; Photo direction: E

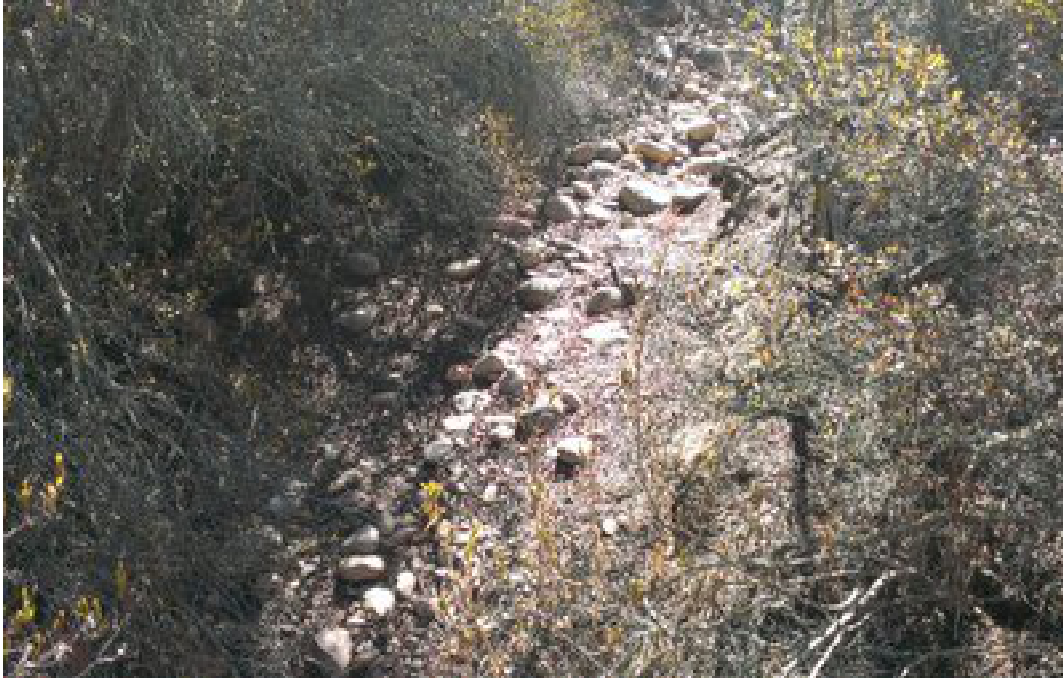
Photo 72: Tributary to Peñasquitos Creek 11, cobble substrate of narrow high gradient tributary

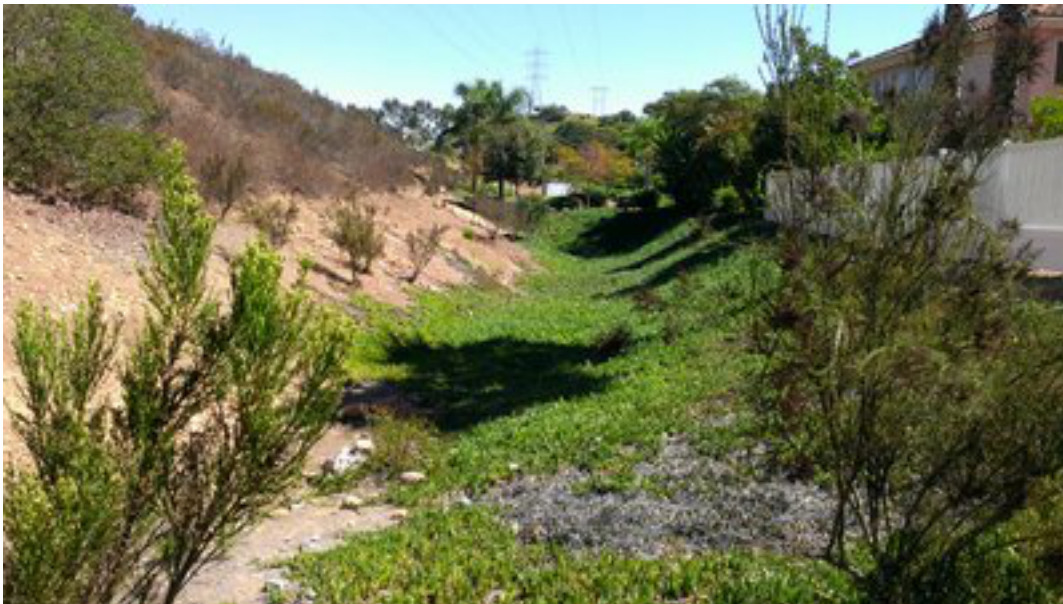
Photo 74: Cypress Canyon Feature 1, overview of iceplant-lined channel; Photo direction: NW

Vegetation associated with these features is generally upland vegetation and ornamental vegetation. Vegetation includes: non-native brome grasses, ice-plant, broom baccharis, and chamise. A stand of mule fat was present near one of the drainages but it not considered riparian vegetation. A photo of Cypress Canyon Feature 1 is included as Appendix C, Photo 74.

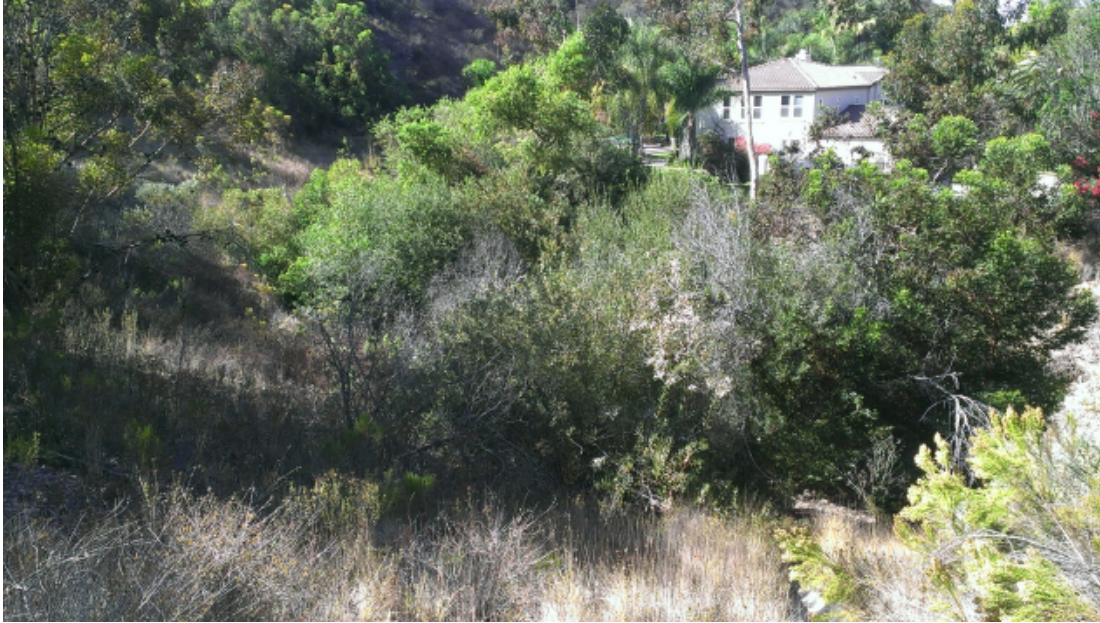
Photo 75: Cypress Canyon Feature 2, overview of depressional area; Photo direction: NW

Vegetation present in the depressional area includes: narrowleaf cattail, California bulrush, and arroyo willow. Upland vegetation present includes: ice-plant, broom baccharis and non-native brome grasses. A photo of Cypress Canyon Feature 2 is included as Appendix C, Photo 75, 76, and 77.
