**BIOLOGICAL TECHNICAL REPORT**  
**SYCAMORE TO PEÑASQUITOS 230 KILOVOLT TRANSMISSION LINE PROJECT**  
**CITY OF SAN DIEGO**  
**SAN DIEGO COUNTY, CALIFORNIA**

**SAN DIEGO GAS & ELECTRIC COMPANY**  
8315 Century Park Court, CP21E  
San Diego, California 92123  
Contact: Rob Fletcher

**BUSBY BIOLOGICAL SERVICES, INC.**  
4629 Cass Street, #192  
San Diego, California 92109  
Contact: Melissa Busby

April 2014

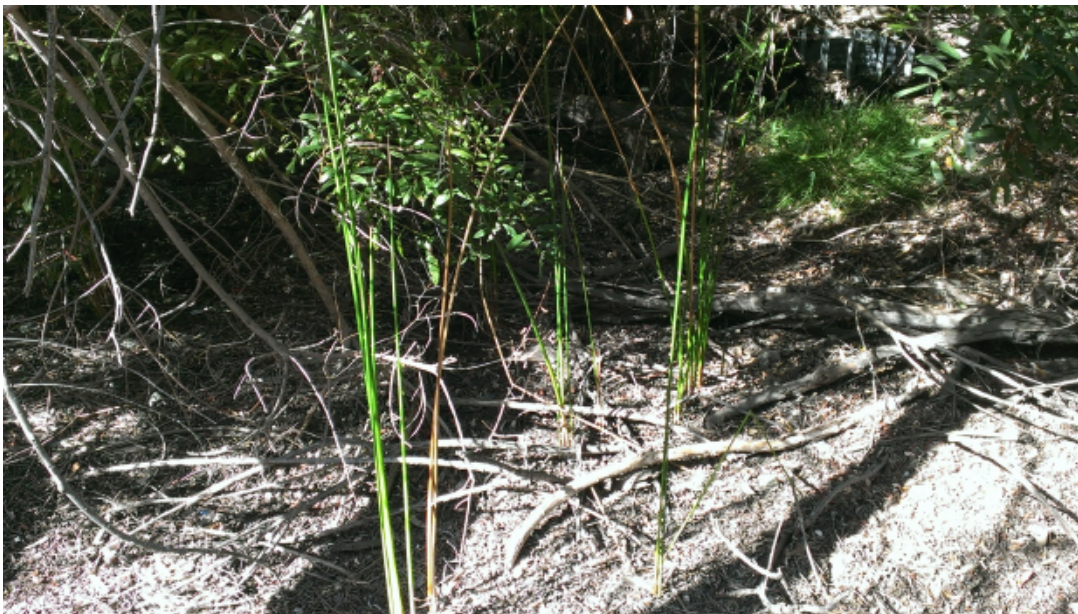
Photo 76: Cypress Canyon Feature 2, clay substrate of depressional area

Vegetation present in the depressional area includes: narrowleaf cattail, California bulrush, and arroyo willow. Upland vegetation present includes: ice-plant, broom baccharis and non-native brome grasses. A photo of Cypress Canyon Feature 2 is included as Appendix C, Photo 75, 76, and 77.

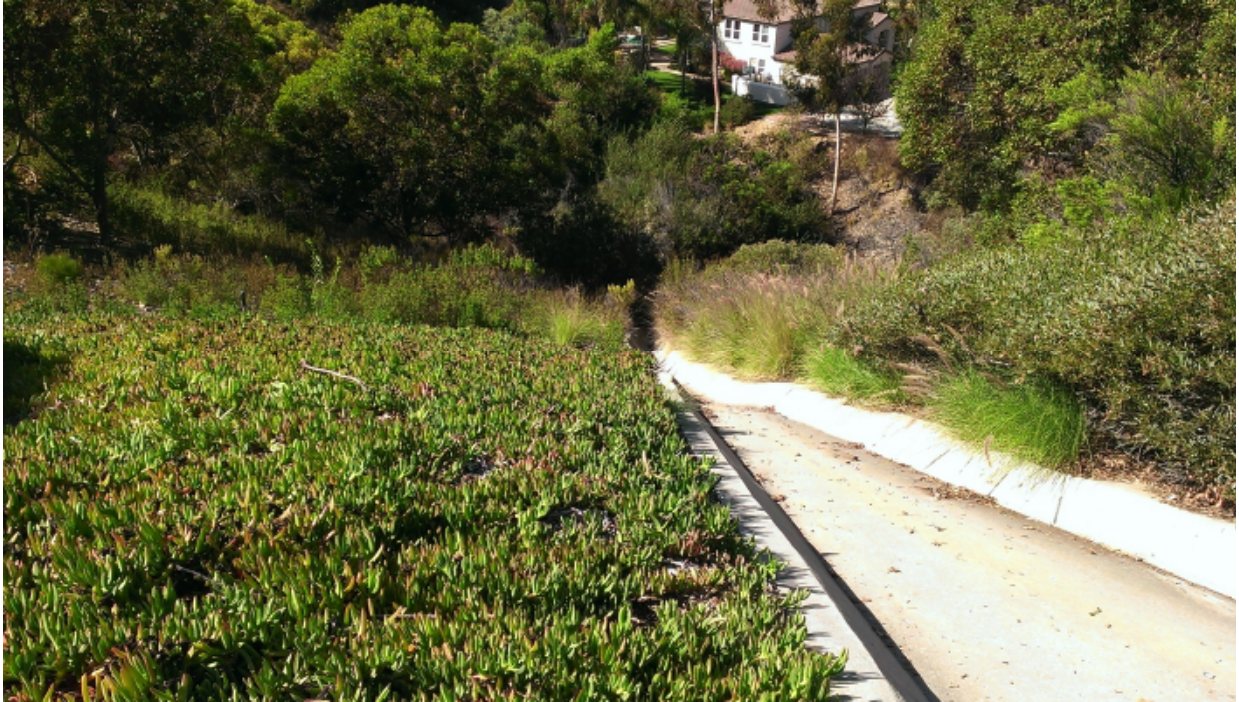
Photo 77: Cypress Canyon Feature 2, V-ditch inflow into depressional area; Photo direction: NW

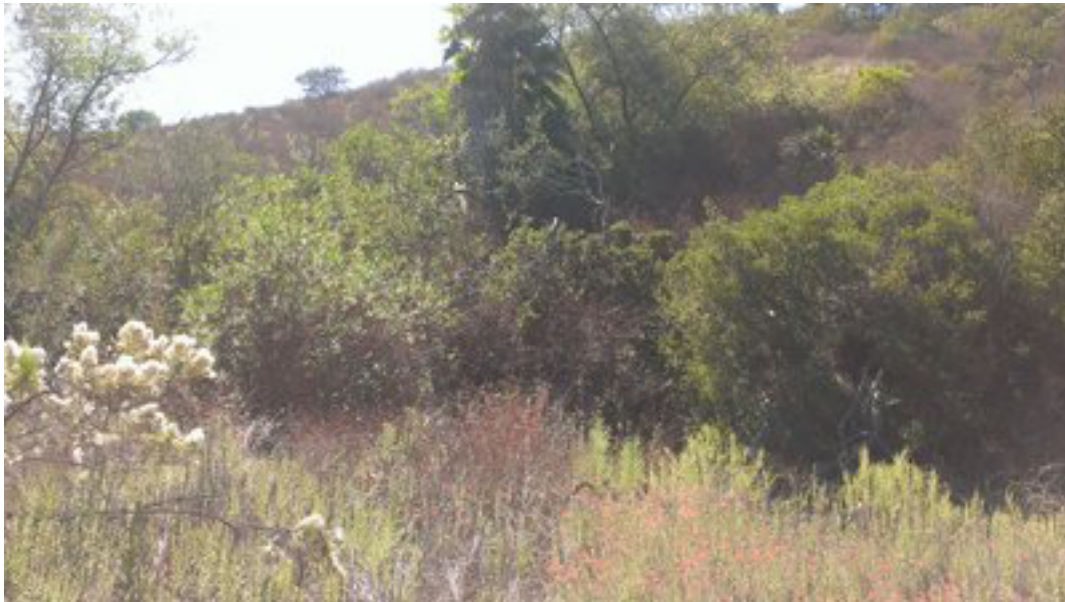
Photo 78: Tributary to Beeler Creek 1, overview of tributary on western side of the drainage; Photo direction: NW

Vegetation associated with Tributary to Beeler Creek 1 is composed of dense upland scrub oak vegetation. Riparian vegetation is present and includes mule fat, arroyo willow, ragweed, and poison oak. Photographs of Tributary to Beeler Creek 1 are included as Appendix C, Photos 78, 79, 80, and 81.

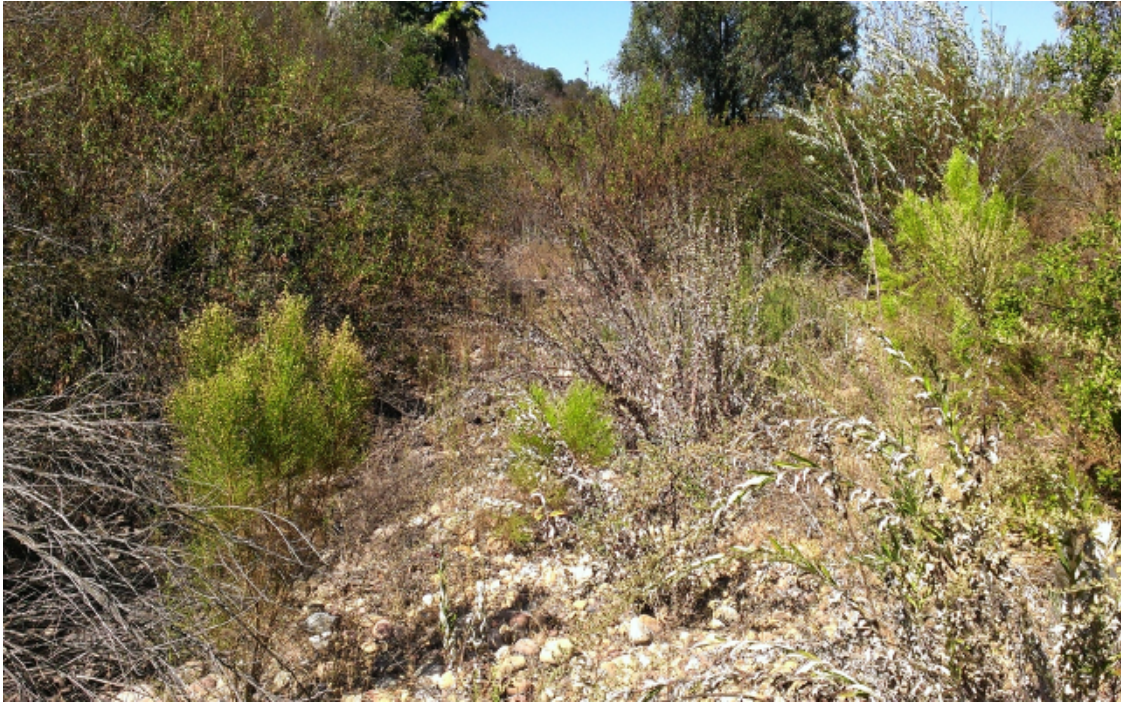
Photo 79: Tributary to Beeler Creek 1, substrate of narrow, higher-gradient channels

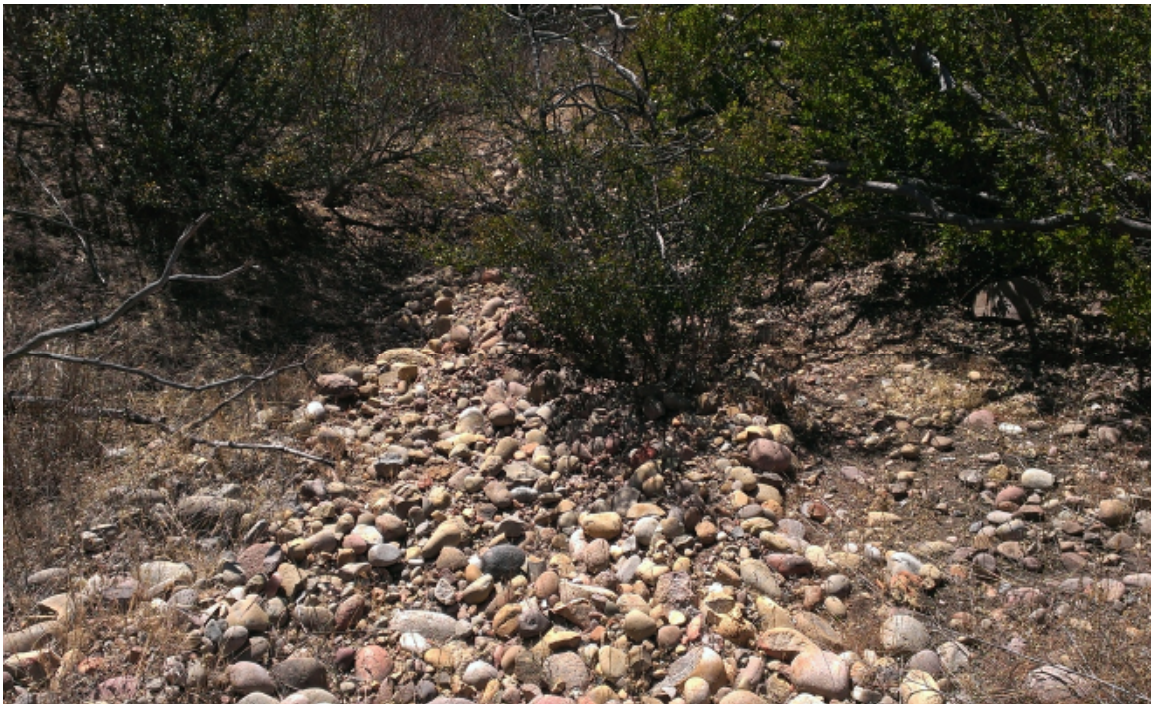
Photo 80: Tributary to Beeler Creek 1, substrate of lower gradient channel on western side of the drainage

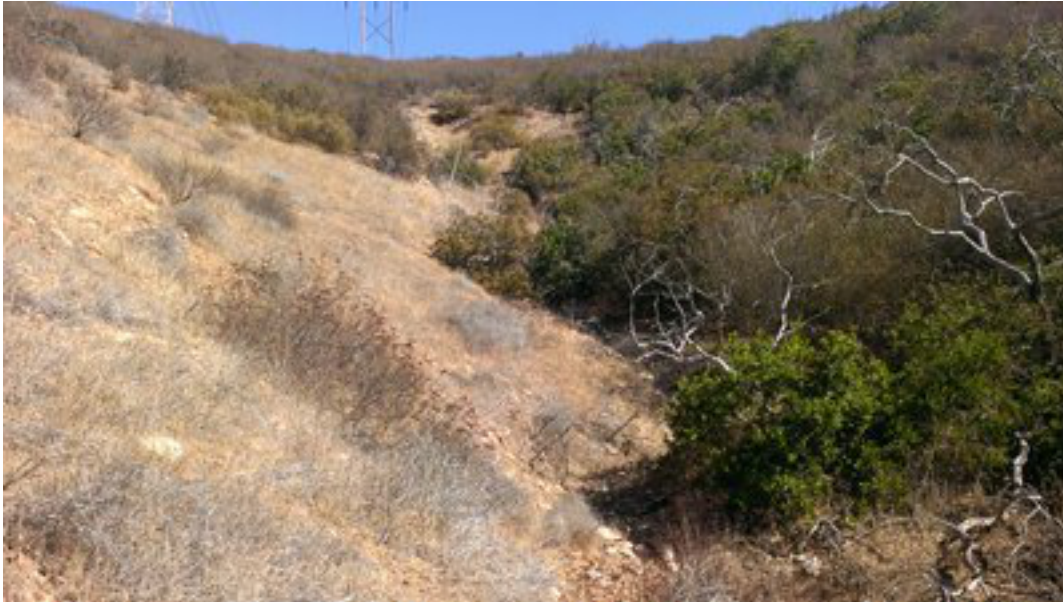
Photo 81: Tributary to Beeler Creek 1, overview of high-gradient headwater on eastern side of the drainage, looking upstream; Photo direction: SW

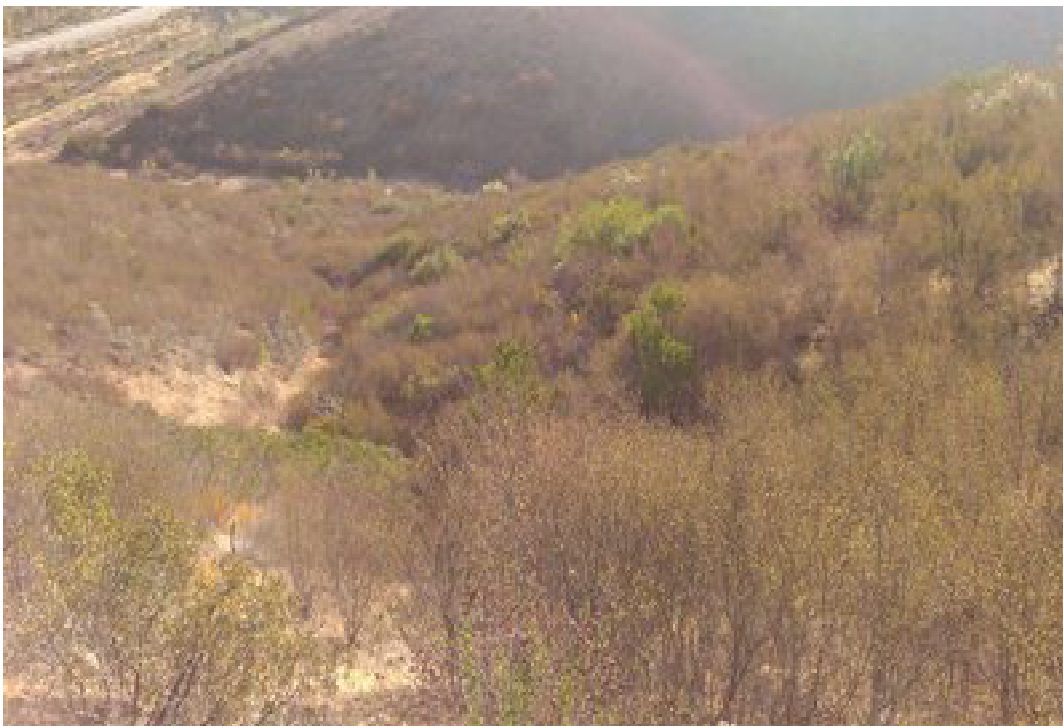
Photo 82: Tributary to Beeler Creek 2, overview of the start of a high-gradient ephemeral tributary; Photo direction: N

Vegetation associated with Tributary to Beeler Creek 2 is generally composed of dense upland scrub oak vegetation with poison oak and holly-leaf cherry. Photographs of Tributary to Beeler Creek 1 are included as Appendix C, Photos 82, 83, and 84.

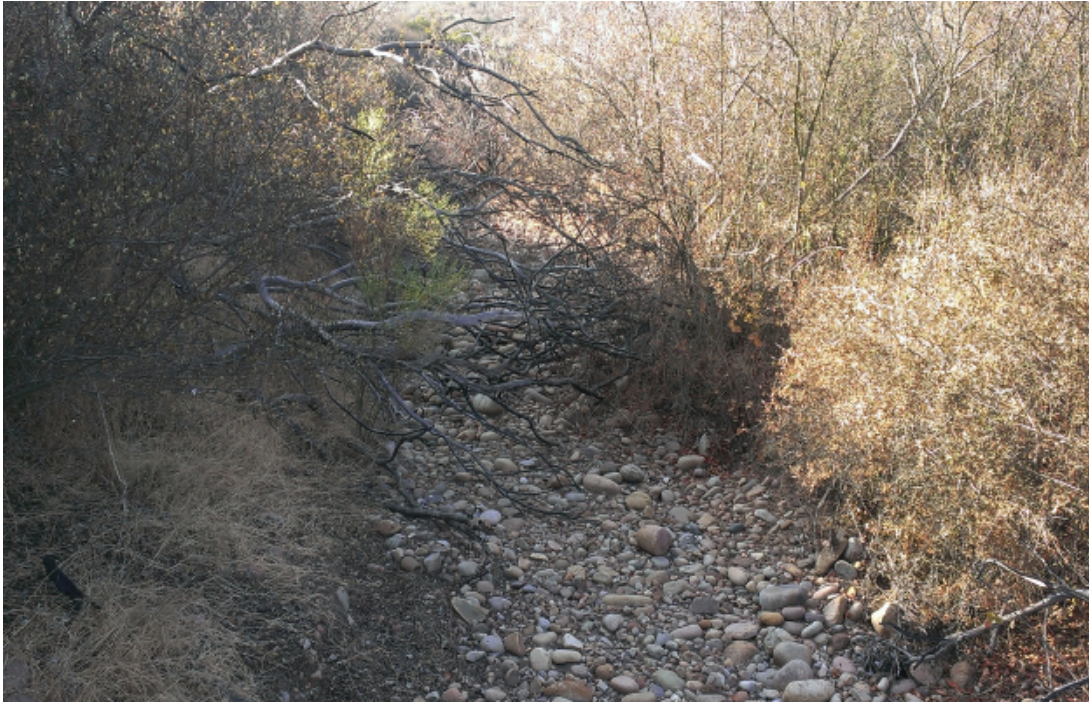
Photo 83: Tributary to Beeler Creek 2, cobble substrate of mainstem tributary in narrow section of the channel

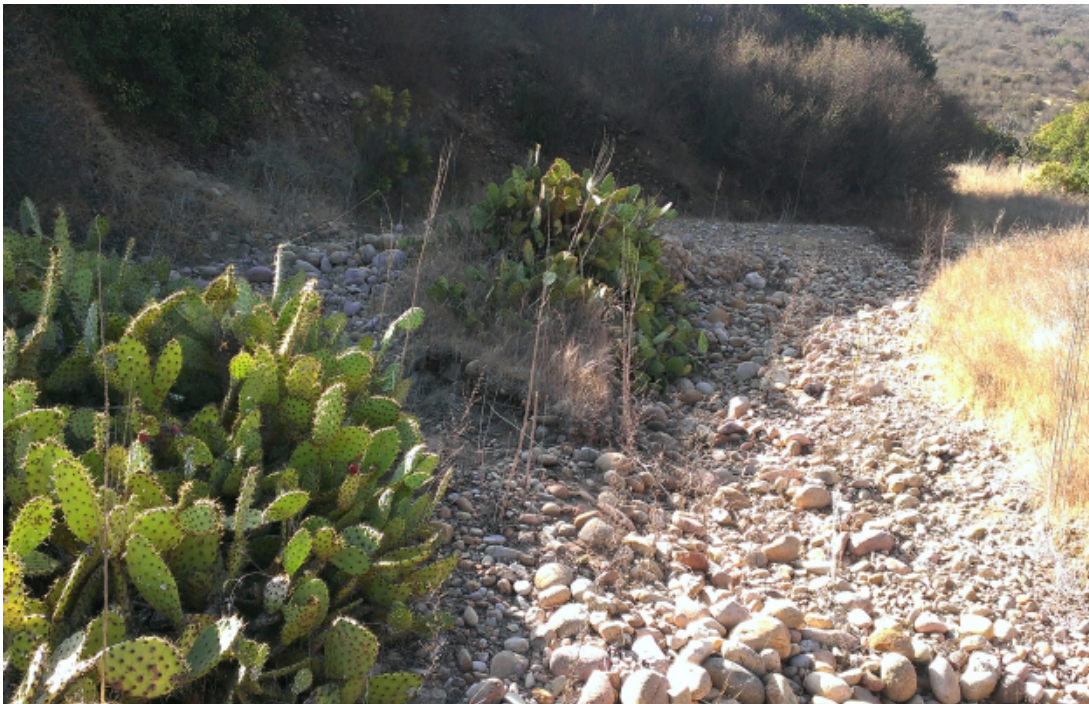
Photo 84: Tributary to Beeler Creek 2, cobble substrate of mainstem tributary in wide section of the channel;  
Photo direction: S

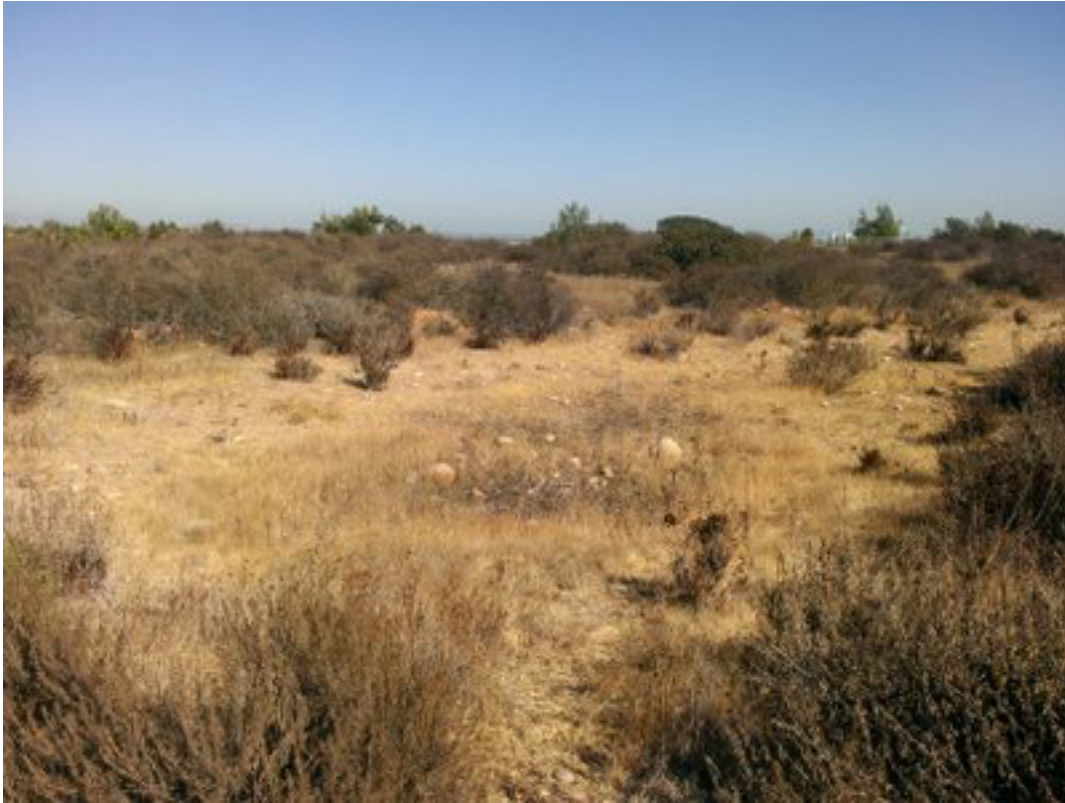
Photo 85: Vernal pool 1; Photo direction: N

While the pools appear isolated, the USFWS reported the presence of San Diego fairy shrimp in this area (USFWS 2013b). As such, under the Regional General Conditions to Nationwide Permits (USACE 1997), these pools are likely under the jurisdiction of the USACE. The potential jurisdictional boundary associated with these pools is 0.03 acre, all of which is wetland WoUS and wetland WoS. Because no State-listed threatened or endangered species were observed, these pools are not within CDFW jurisdiction. This area falls outside of the Coastal Zone and CCC jurisdiction. Photographs of Vernal Pool Complex 1 are included as Appendix C, Photos 85 and 86. Results of the survey have been mapped on Exhibit 2, Sheet 1.

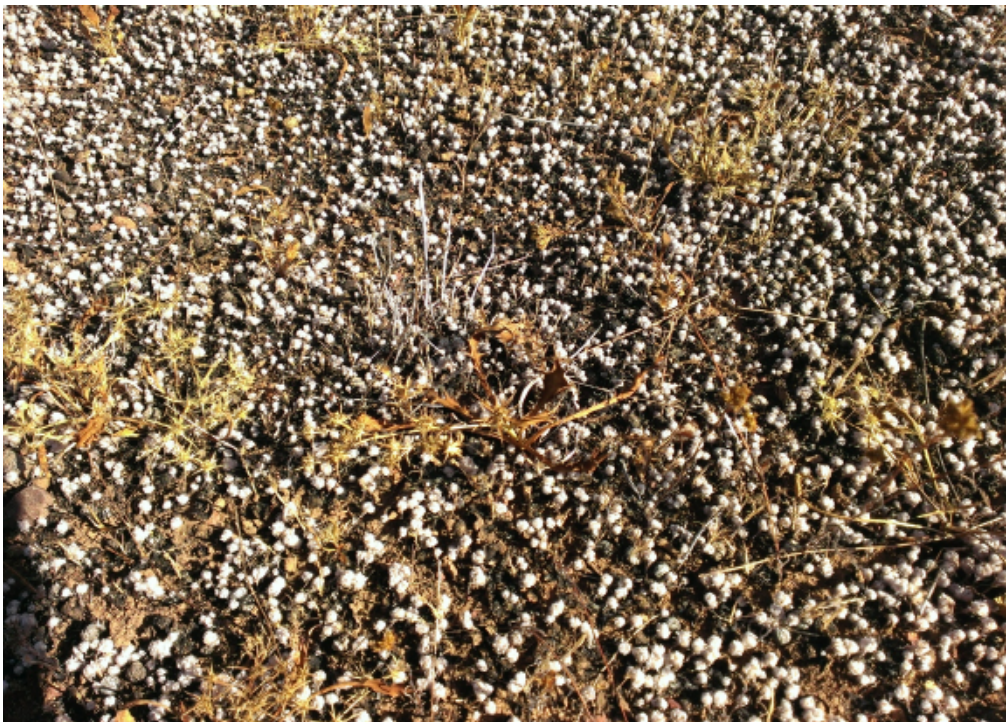
Photo 86: Vernal pool 1 substrate

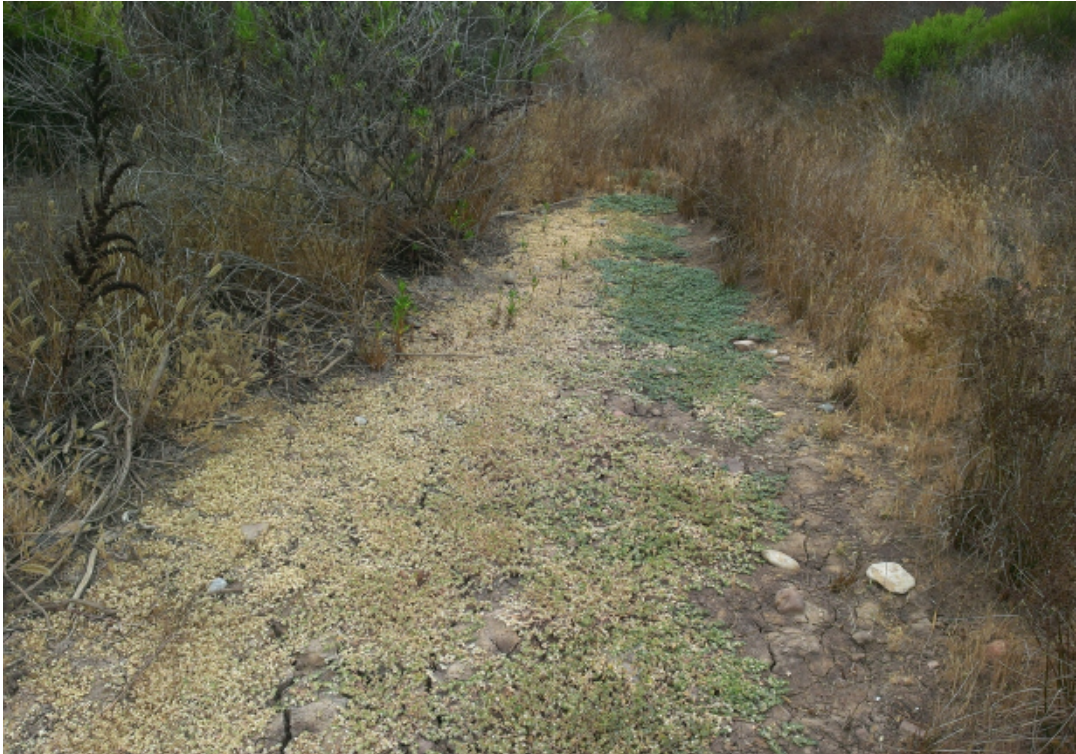
Photo 87: Vernal pool 2 substrate; Photo direction: NE

While the pools appear isolated, the USFWS reported the presence of San Diego fairy shrimp in this area (USFWS 2013b). As such, these pools are likely under the jurisdiction of the USACE. The potential jurisdictional boundary associated with the pools is 0.15 acre all of which is wetland WoUS and wetland WoS. Because no State-listed threatened or endangered species were observed, these pools are not within CDFW jurisdiction. CCC jurisdiction includes 0.15 acre of wetland all of which is ESHA. Photographs of Vernal Pool Complex 2 are included as Appendix C, Photos 87 and 88. Results of the survey have been mapped on Exhibit 2, Sheet 3 and 4.

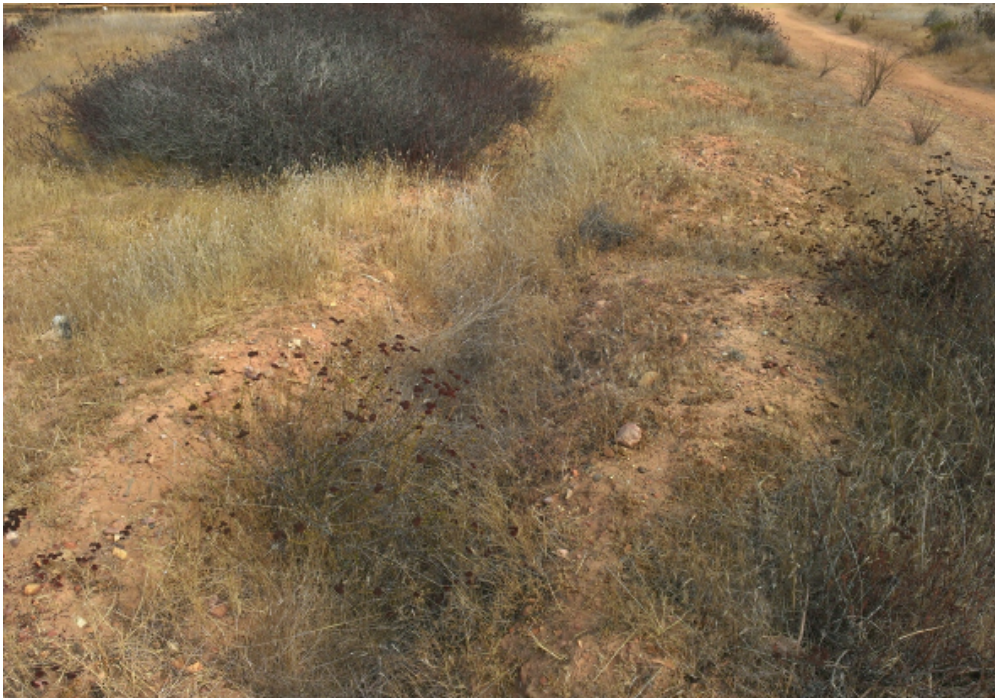
Photo 88: Vernal Pool 2; Photo direction: E

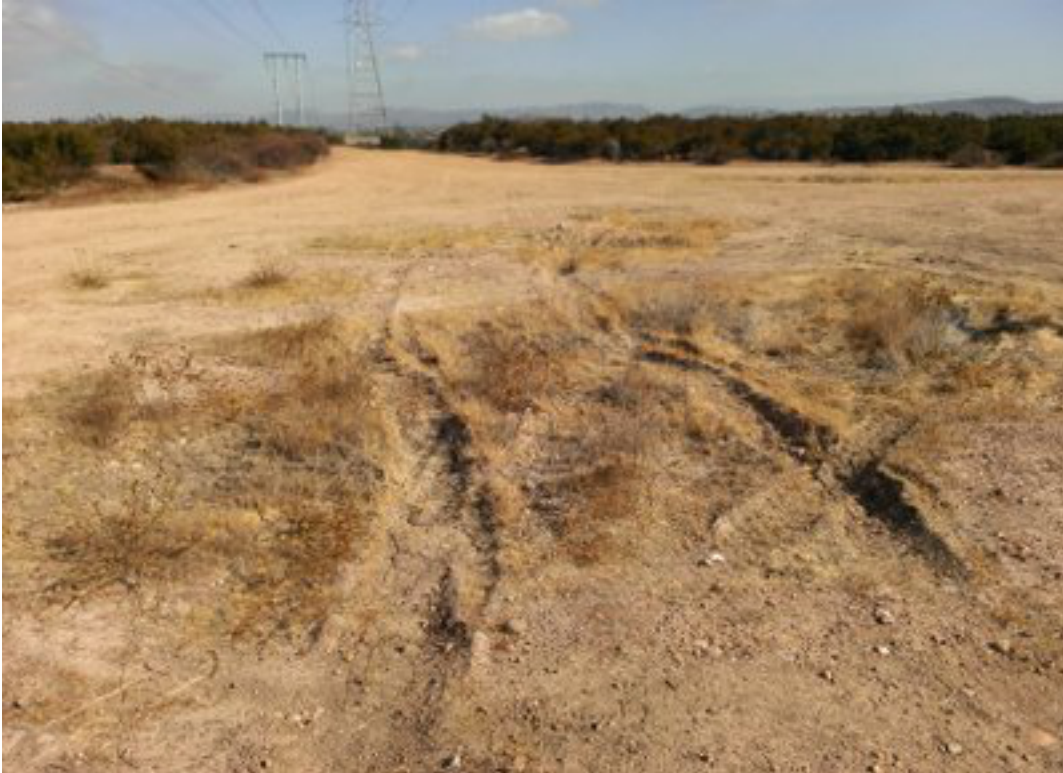
Photo 89: Vernal pool 3; Photo direction: S

While the pools appear isolated, San Diego fairy shrimp are known in this area (USFWS 2013b) and these pools fall within designated Critical Habitat for this species (50 CFR Part 17). As such, these pools are likely under the jurisdiction of the USACE. The potential jurisdictional boundary associated with the pools is 0.05 acre all of which is wetland WoUS and wetland WoS. Because no State-listed threatened or endangered species were observed, these pools are not within CDFW jurisdiction. This area falls outside of the Coastal Zone and CCC jurisdiction. Photographs of Vernal Pool Complex 3 are included as Appendix C, Photos 89 and 90. Results of the survey have been mapped on Exhibit 2, Sheet 8.

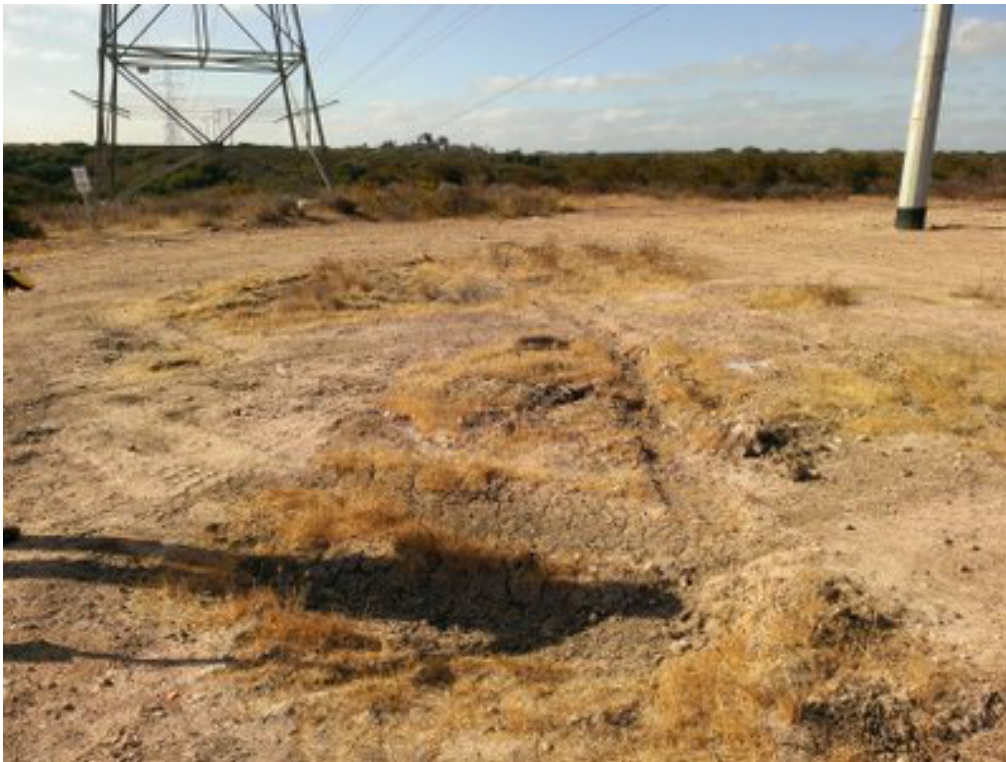
Photo 90: Vernal pool 3; Photo direction: N

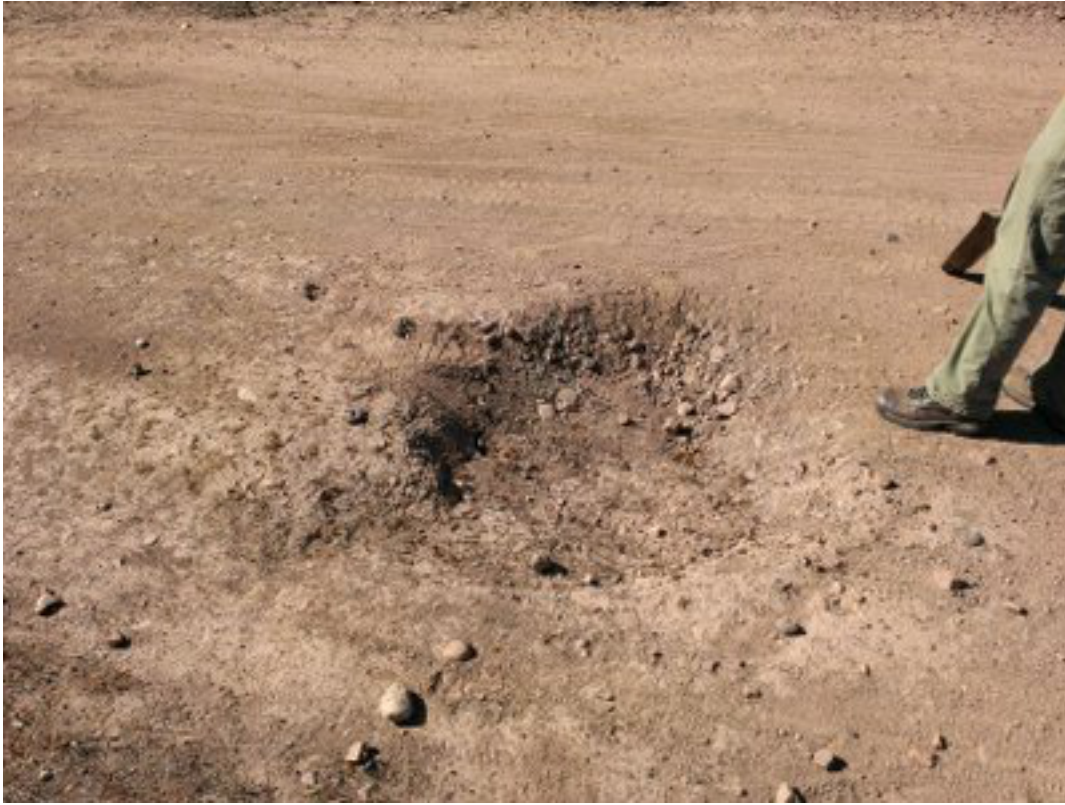
Photo 91: Unvegetated road rut

Numerous road ruts were present on nearby dirt access roads. These ruts have the potential to support vernal pool species and appear to have a hard substrate similar to vernal pools, but at the time of the survey were dry and contained no vegetation. Eight road ruts, totaling <0.01 acre, occur within 500 feet of known San Diego fairy shrimp species locations or mapped critical habitat (USFWS 2013b, 50 CFR Part 17). Photographs of representative road ruts are included as Appendix C, Photos 91, 92, and 93. Results of the survey have been mapped on Exhibit 2, Sheet 3, 4, 7, and 8. It is recommended that these areas be subject to further investigation during the appropriate season to determine the viability of vernal pool species including fairy shrimp.

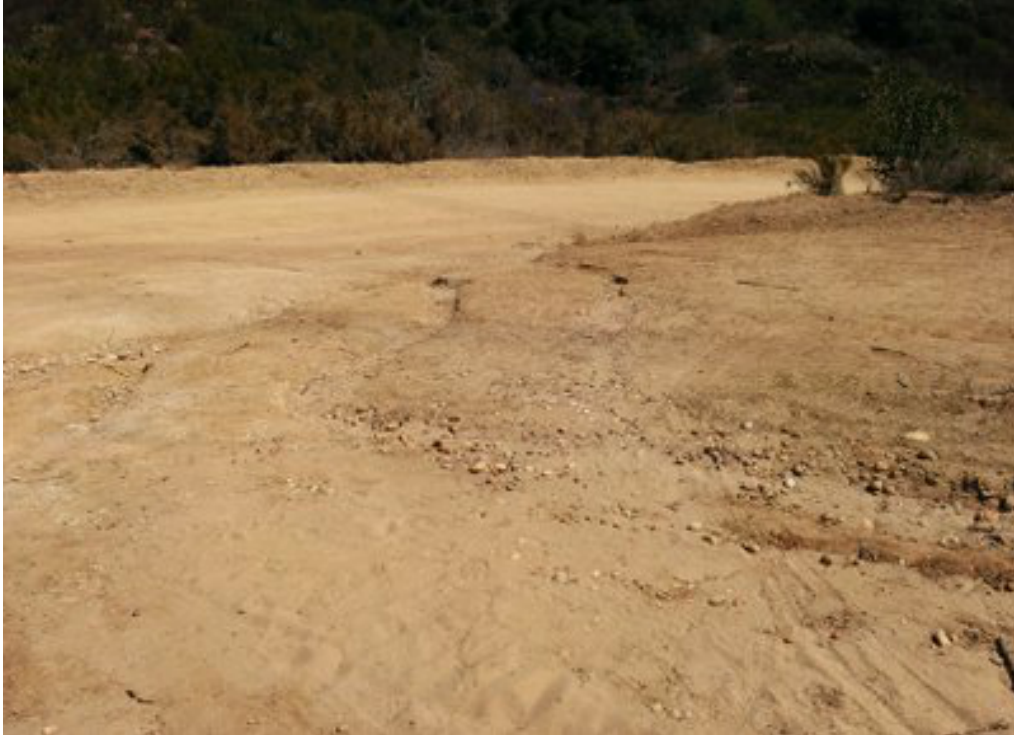
Photo 92: Unvegetated road rut

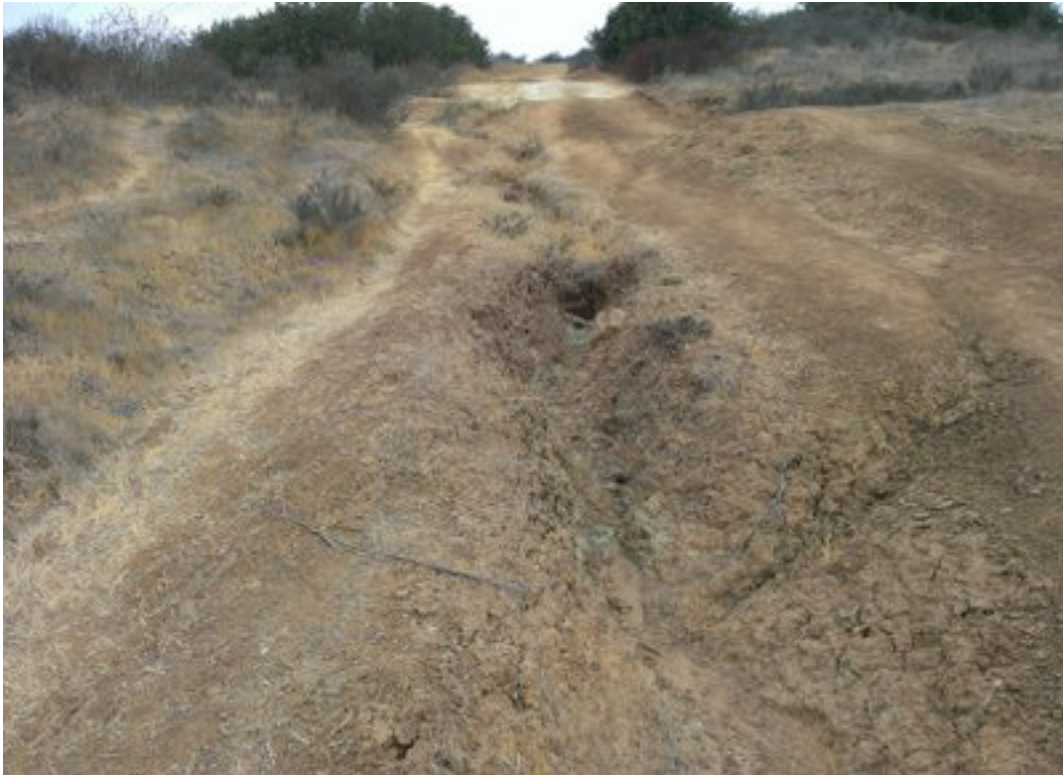
Photo 93: Vegetated road rut

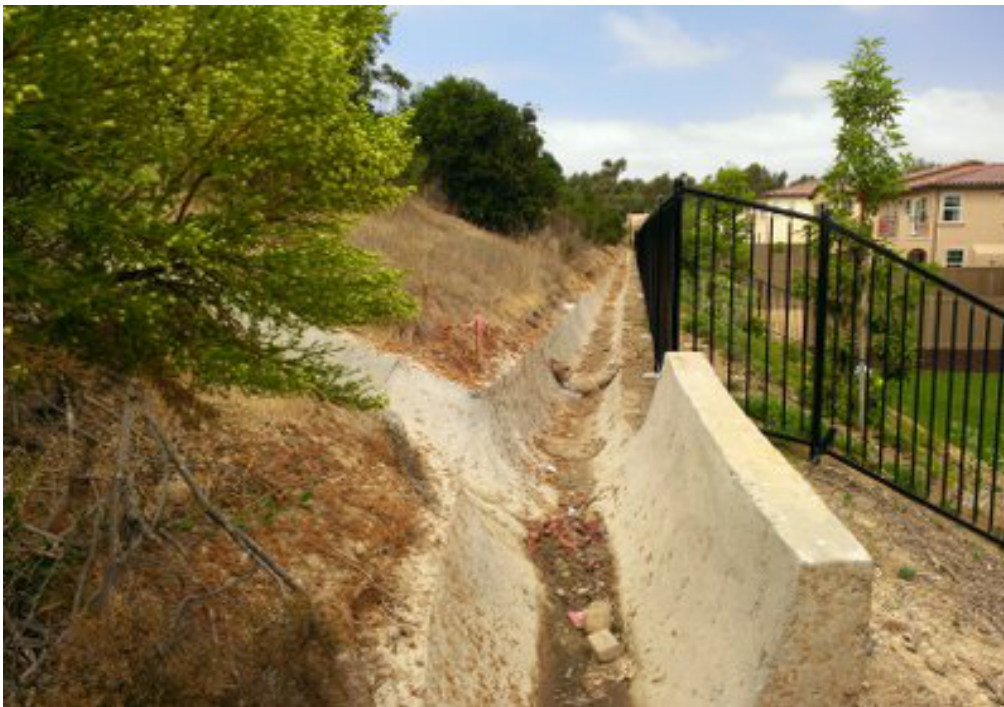
Photo 94: RWQCB exempt, MS4 erosion control V-ditch

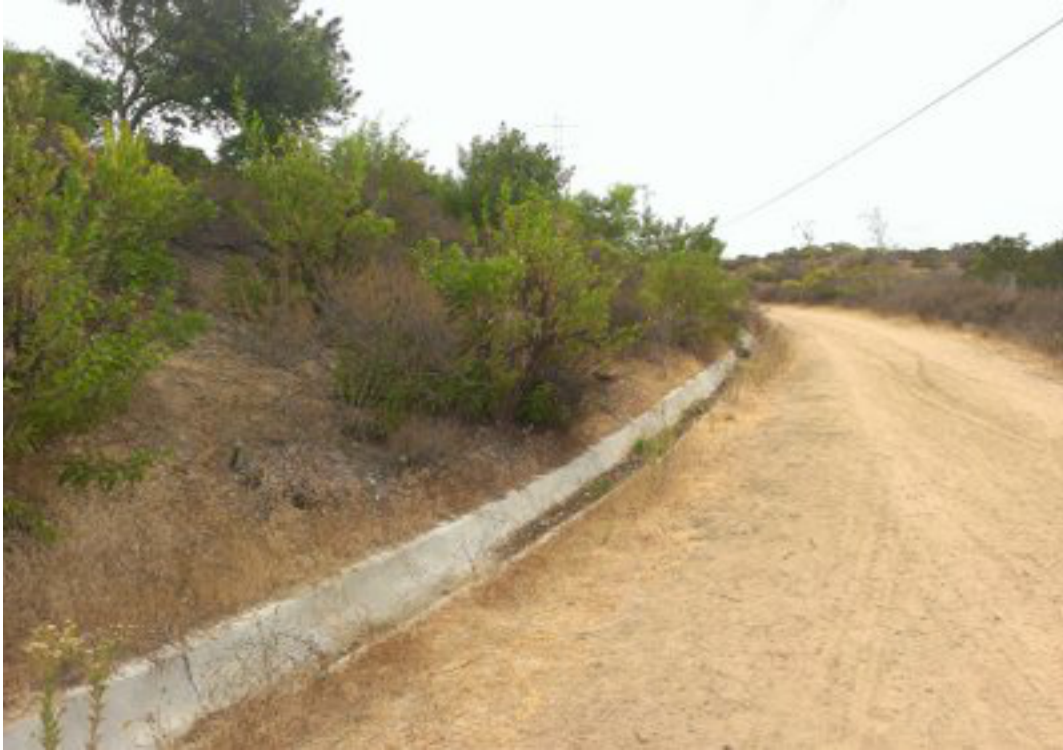
Photo 95: RWQCB exempt, MS4 erosion control V-ditch

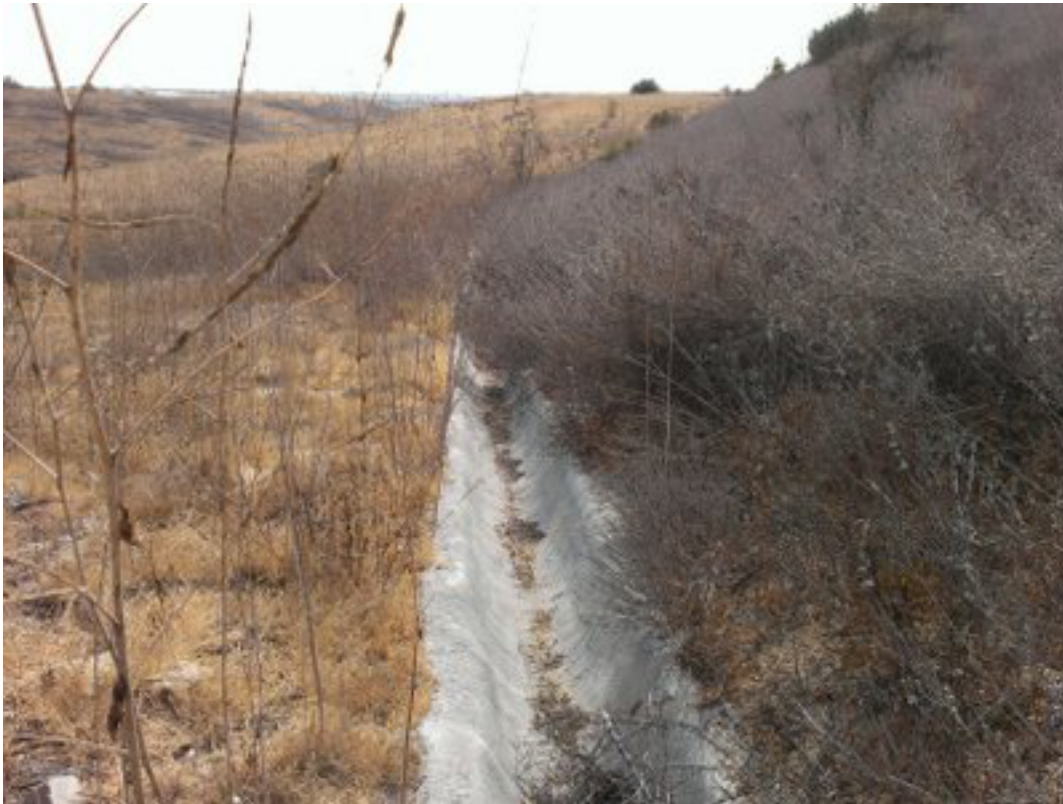
Photo 96: RWQCB exempt, MS4 erosion control V-ditch

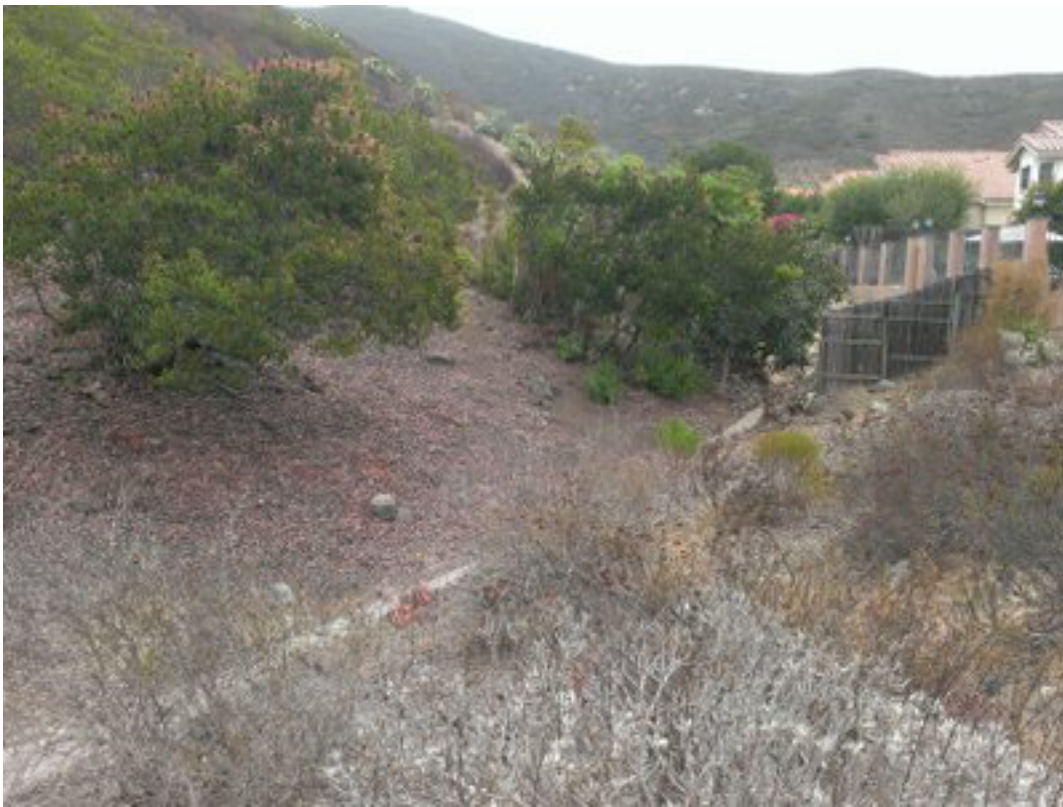
Photo 98: USACE -jurisdictional V-ditch

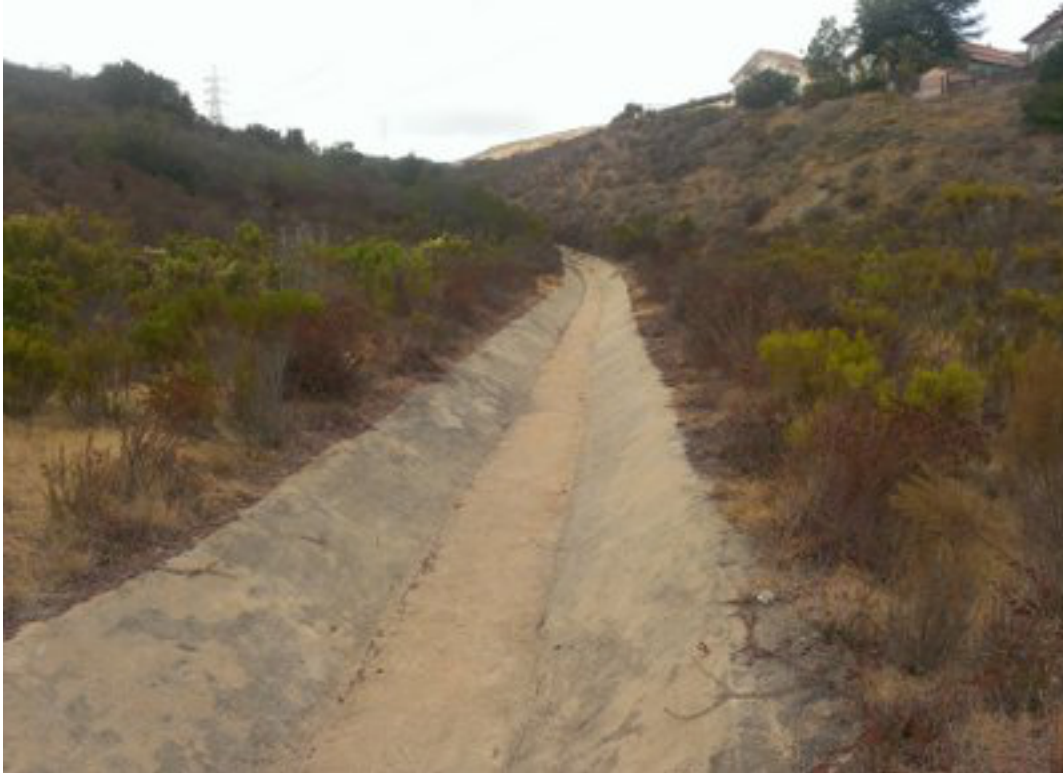
Photo 99: USACE -jurisdictional V-ditch

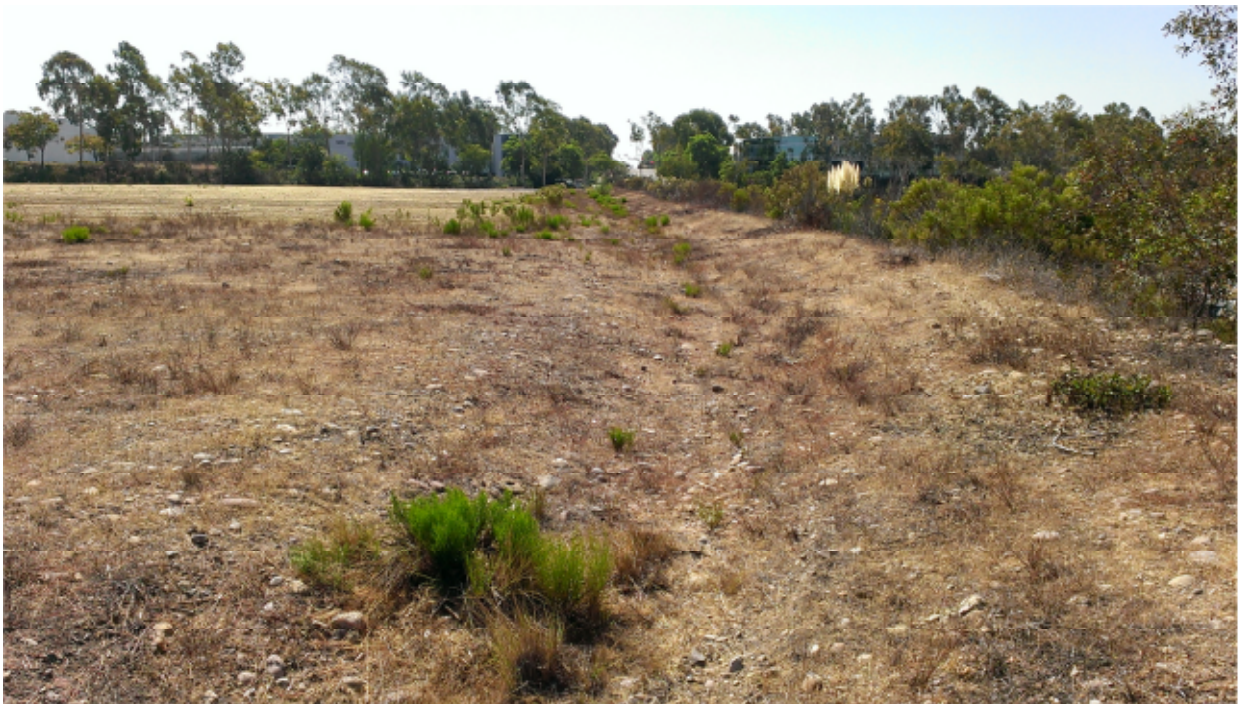
Photo 100: Stowe staging yard, erosion control ditch near the perimeter of the yard; Photo direction: S

The Stowe Staging Yard is characterized as a large vacant field near the intersection of Stowe Drive and Crosthwaite Circle. Vegetation was dominated by non-native brome grasses and short pod mustard. No potentially jurisdictional features were identified at the Stowe Yard. Photographs of the yard are included as Appendix C, Photos 100, 101, and 102.

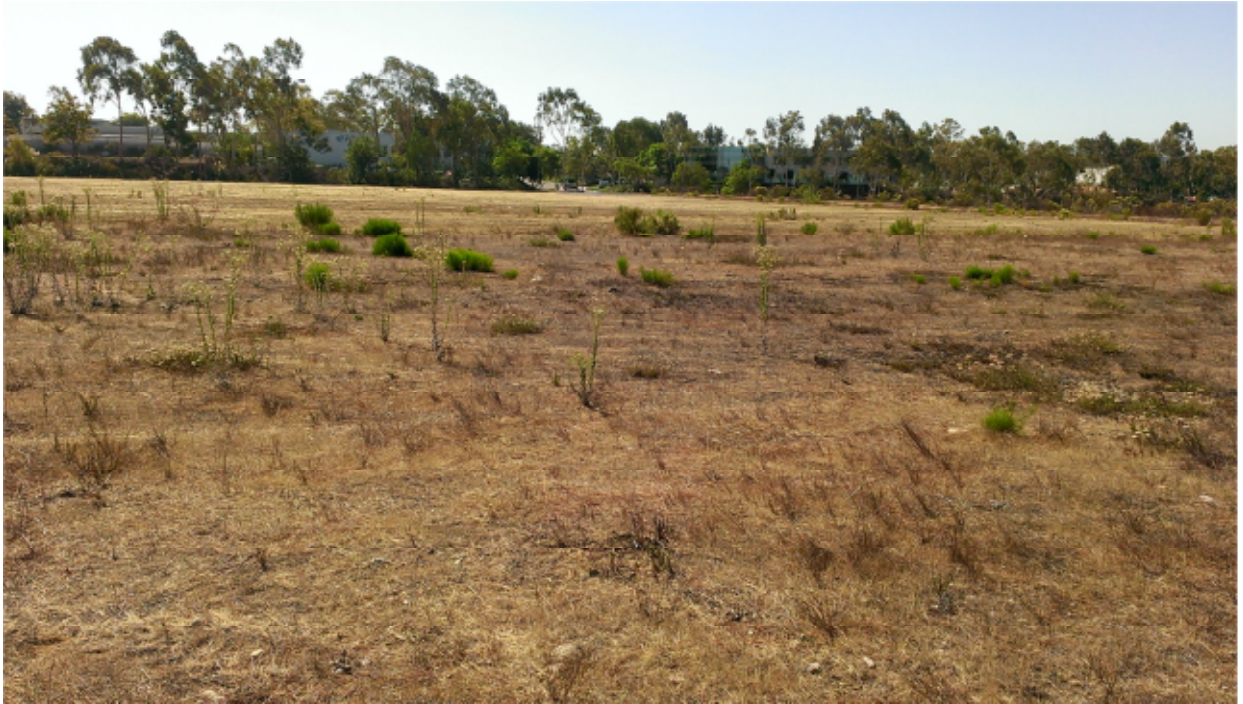
Photo 101: Stowe staging yard, overview; Photo direction: W

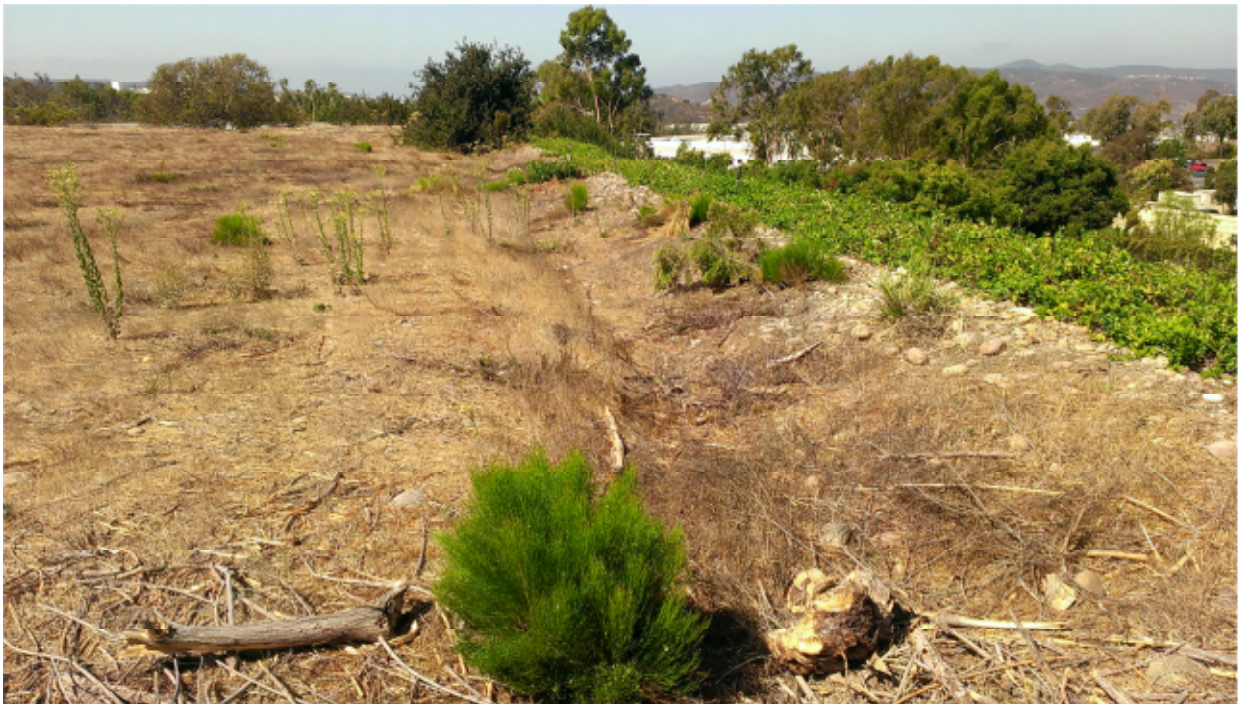
Photo 102: Stowe staging yard, erosion control ditch near the perimeter of the yard; Photo direction: NW
