**BIOLOGICAL TECHNICAL REPORT**  
**SYCAMORE TO PEÑASQUITOS 230 KILOVOLT TRANSMISSION LINE PROJECT**  
**CITY OF SAN DIEGO**  
**SAN DIEGO COUNTY, CALIFORNIA**

**SAN DIEGO GAS & ELECTRIC COMPANY**  
8315 Century Park Court, CP21E  
San Diego, California 92123  
Contact: Rob Fletcher

**BUSBY BIOLOGICAL SERVICES, INC.**  
4629 Cass Street, #192  
San Diego, California 92109  
Contact: Melissa Busby

April 2014

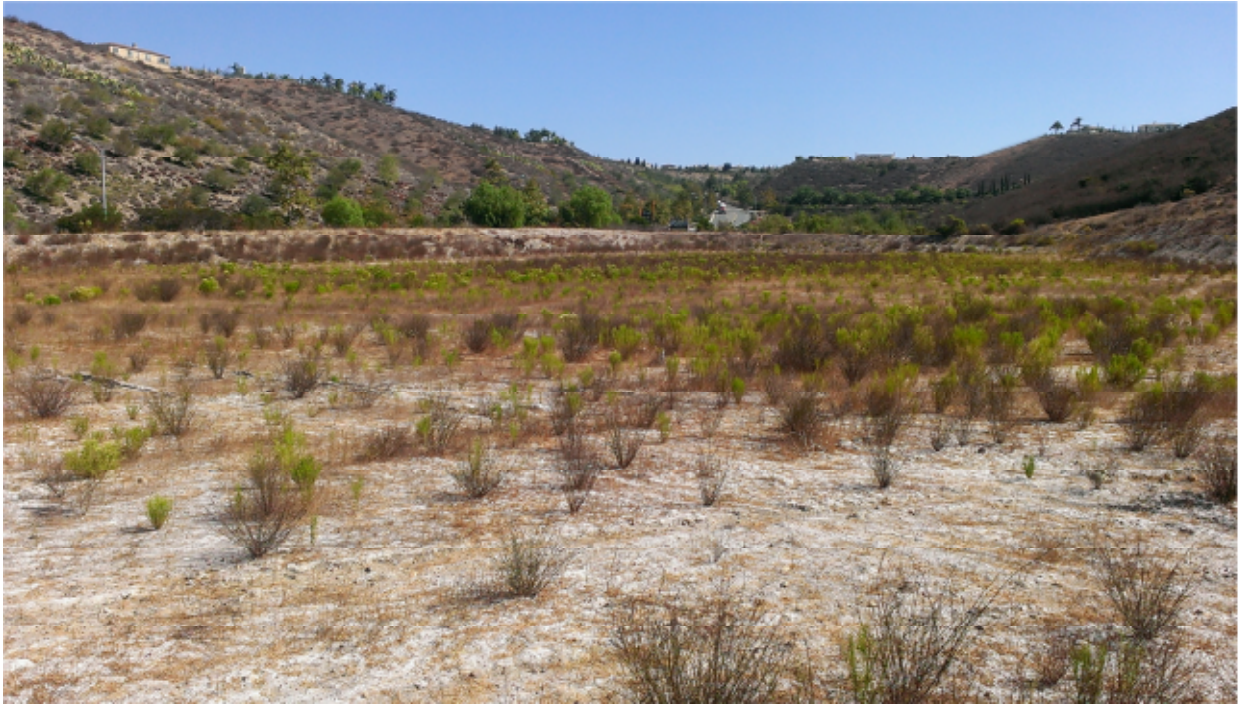
Photo 103: Stonebridge staging yard, overview; Photo direction: NE

The Stonebridge Staging Yard is characterized as a large vacant field near the intersection of Stonebridge Parkway and Deprise Cove. The area was recently hydroseeded with native vegetation. Vegetation was dominated by deerweed (*Acmispon glaber*, UPL), coyote bush (*Baccharis pilularis*, UPL), and coastal goldenbush (*Isocoma menziesii*, FAC). A small isolated debris basin is located in the northwest corner of the site near the site entrance. Additionally there is 2-foot erosion control V-ditch running along the western edge of the yard. A total of 0.08 acre of RWQCB exempt, MS4 erosion control features were observed. Photographs of the yard are included as Appendix C, Photos 103, 104, and 105.

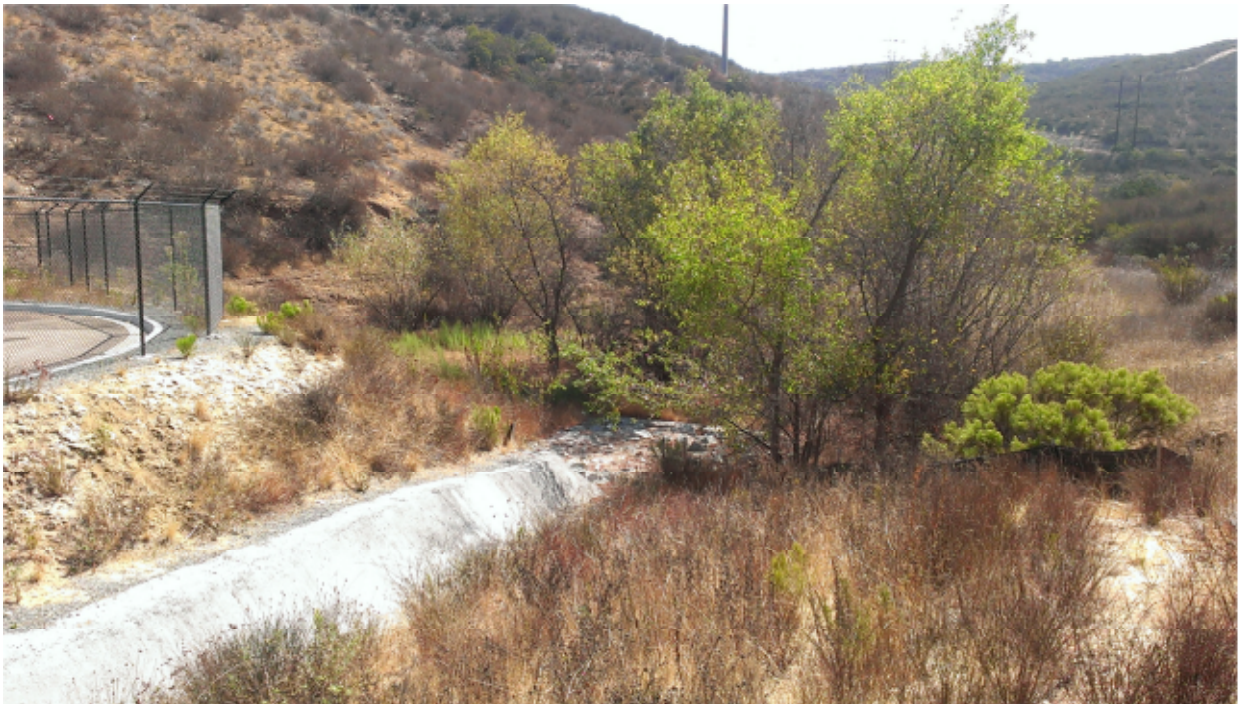
Photo 104: Stonebridge staging yard, depressional area near the perimeter of the yard; Photo direction: S

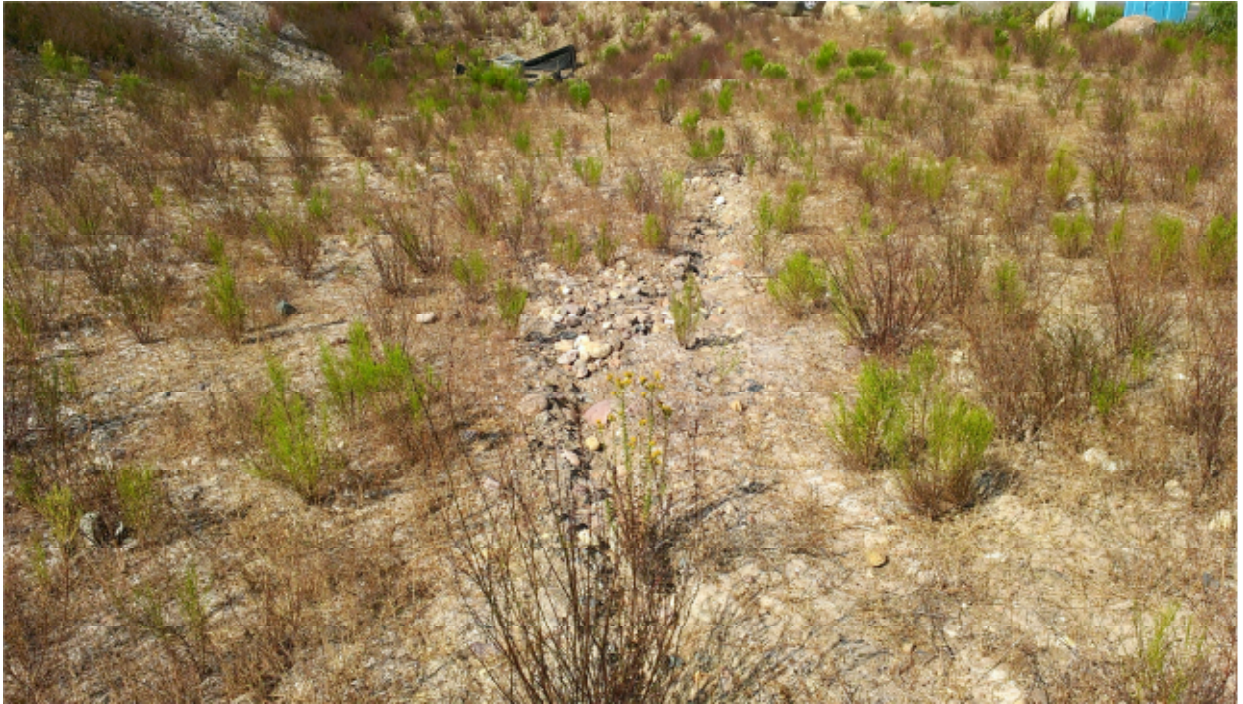
Photo 105: Stonebridge staging yard, erosional feature near the perimeter of the yard; Photo direction: W

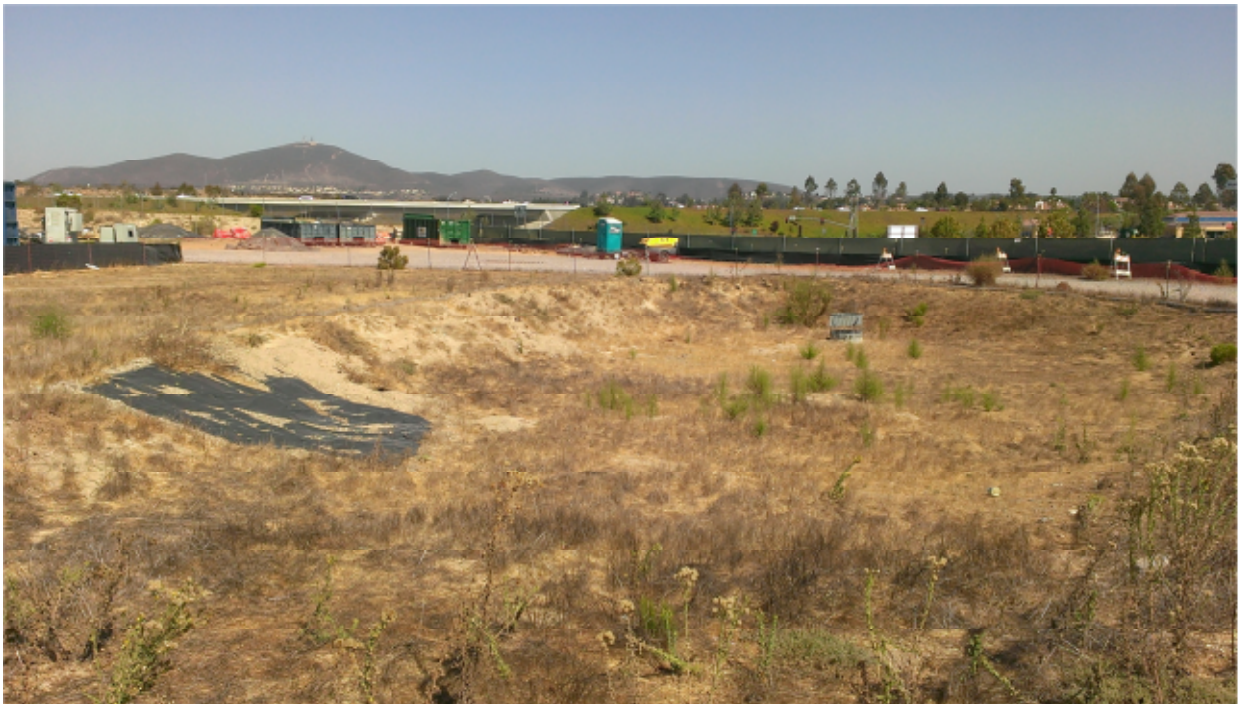
Photo 106: Torrey Santa Fe Kilroy staging yard, overview; Photo direction: N

The Torrey Santa Fe Staging Yard was only partially surveyed due to a lack of access authorization. The area that was surveyed consisted of an active staging yard with heavy equipment and materials. No potentially jurisdictional areas were observed in the area surveyed, however based on an investigation of the whole Torrey Santa Fe Staging Yard by aerial map there may be debris basins that would be RWQCB exempt, MS4 features. Further investigation of the area is recommended to determine the extent of the jurisdiction, if any, within the yard. Photographs of the yard are included as Photographs 106 and 107.

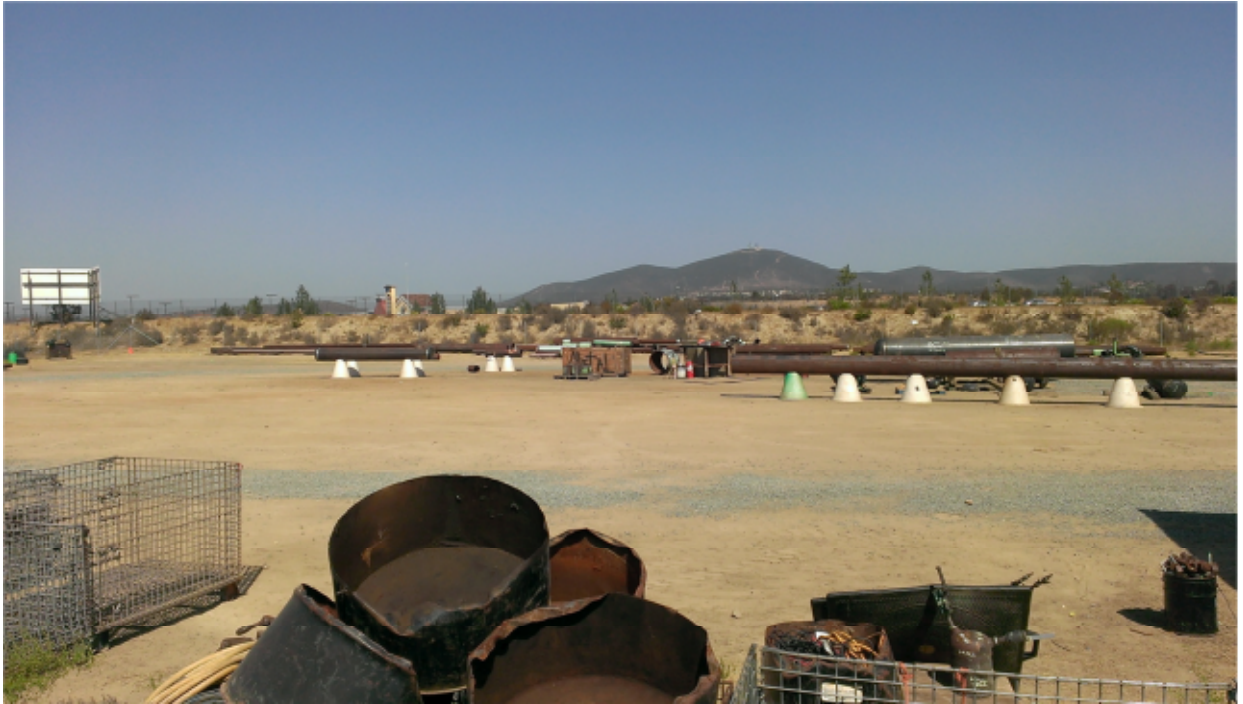
Photo 107: Torrey Santa Fe Kilroy staging yard, overview of work area adjacent to yard; Photo direction: S
