PREPARED DIRECT TESTIMONY OF
DON AKAU
ON BEHALF OF
SAN DIEGO GAS & ELECTRIC COMPANY

BEFORE THE PUBLIC UTILITIES COMMISSION
OF THE STATE OF CALIFORNIA

Vegetation Management Program

Tree Pre-inspection Procedures

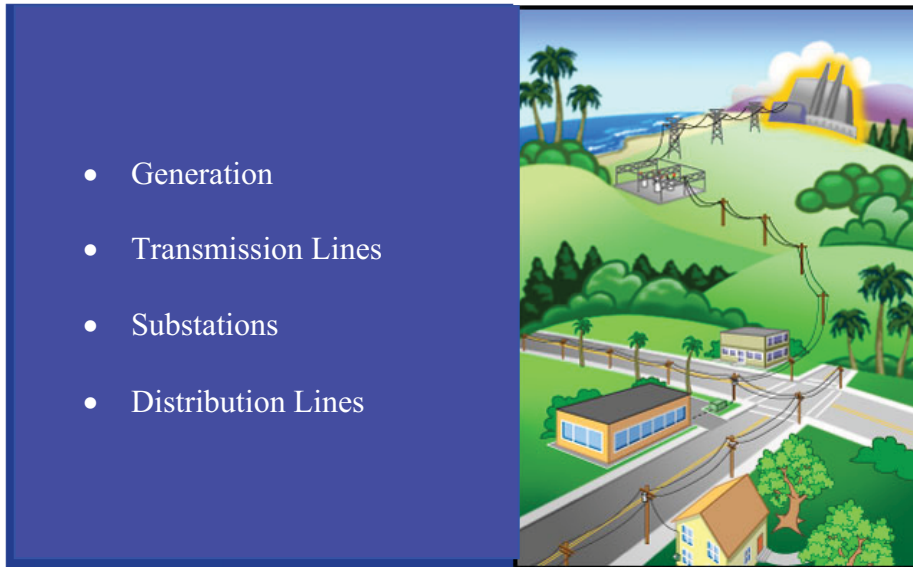
How is Electricity generated and delivered to your home?

GENERATING STATIONS or power plants are where electricity is produced by utilizing resources such as natural gas, the sun, wind and steam heat from within the earth. With the use of magnets on a spinning shaft, mechanical energy is converted to electrical energy.

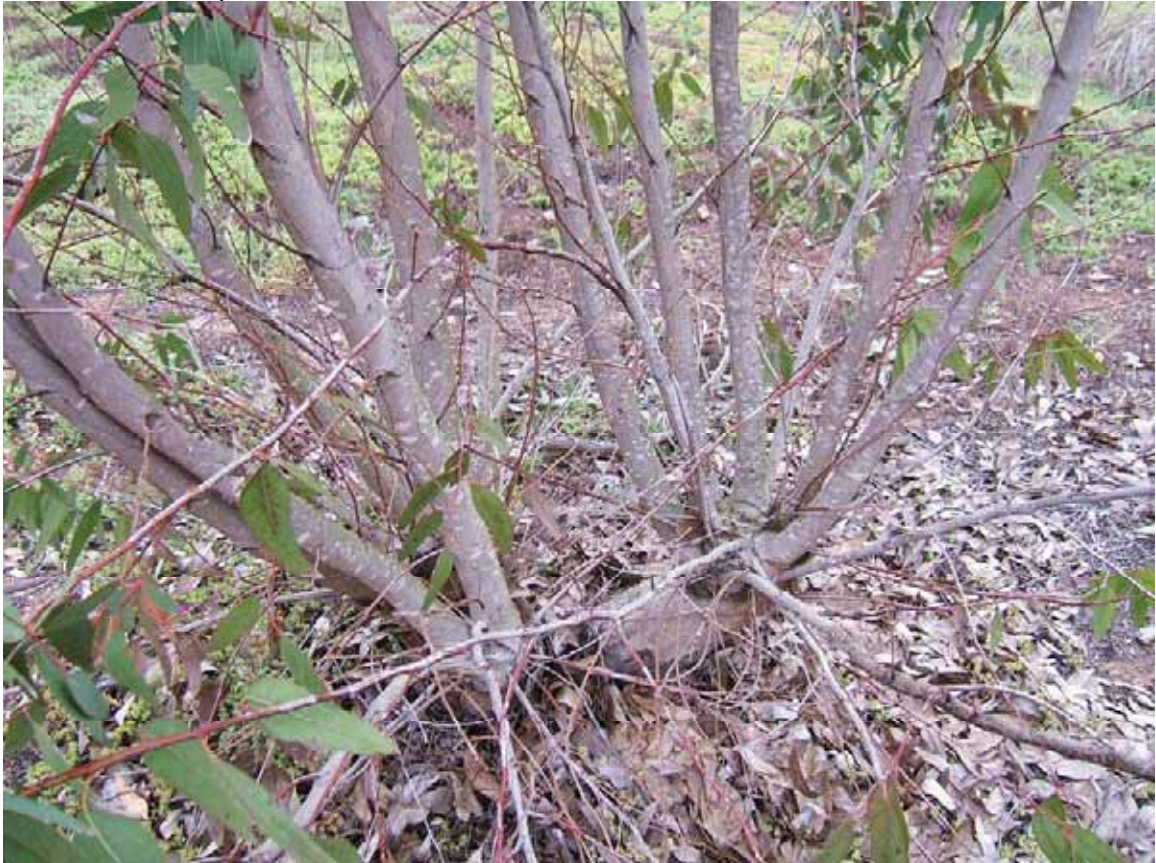
Figure 3: Brush Unit – Eucalyptus brush originating from old cut stump (each stem < 3”). In this example the unit count would be based on the total square foot area to be pruned or removed, not the total number of individual stems.

Use the appropriate brush code based on growth rate. For instance, a Melaleuca with a DBH of less than three (3) inches would be listed as “Brush Fast 5ftx5ft”.

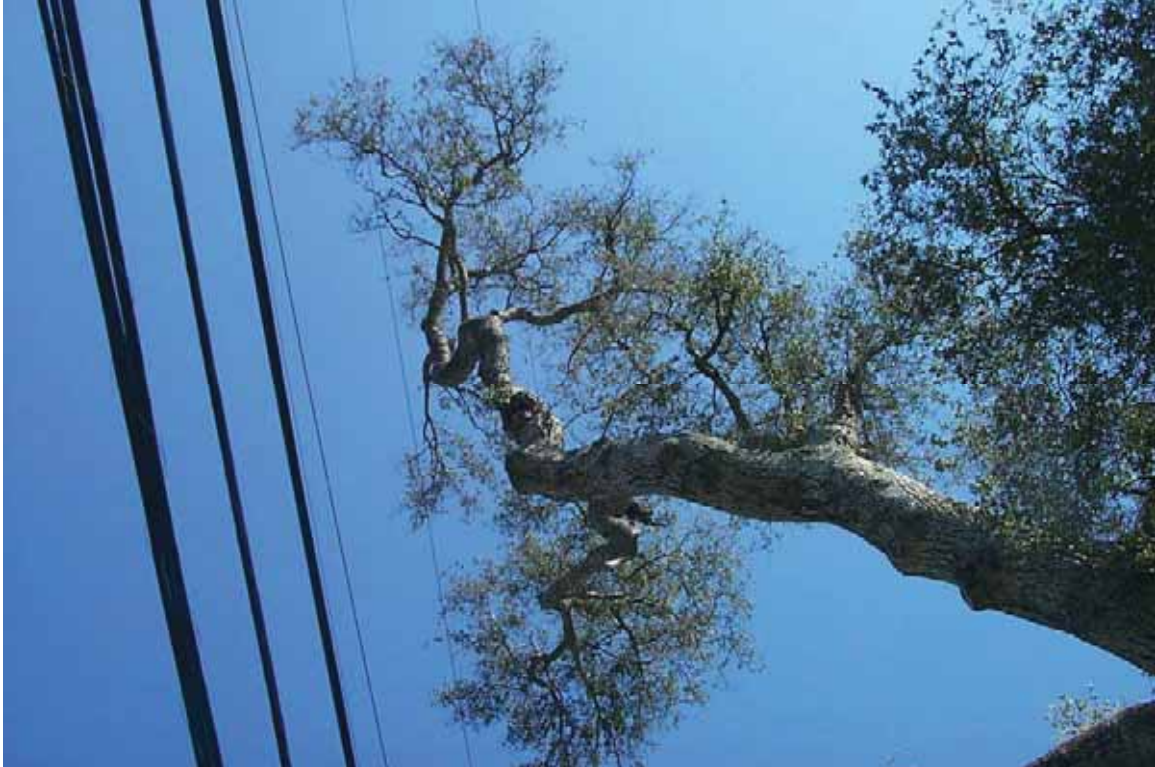
Figure 5: Direct Overhang – Oak branch crossing vertical ground-to-sky plane

As a general rule, all inventory trees that have limbs directly overhanging the vertical ground to sky plane above primary distribution and transmission conductors shall be listed for pruning. Use the canned comment, “*Remove direct overhang*”. An exception to this rule would be when a customer has refused an overhang to be removed and the Area Forester has entered these notes into the system. Follow the instructions in the record on how to proceed with the record.

If you encounter trees with **old growth overhang** (limbs greater than 6 inches in diameter that cross the ground to sky vertical plane) and there are no notes in the system, contact the Area Forester for instructions on how to proceed with the record.

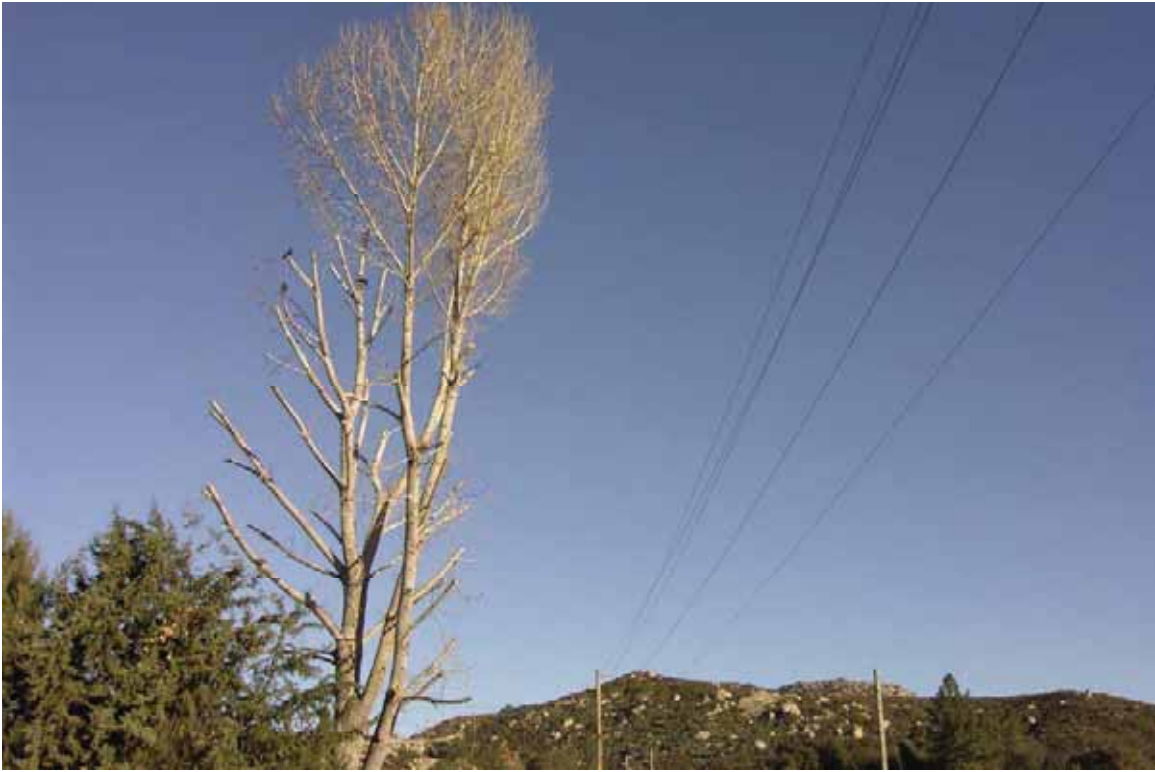
Figure 8: Potential hazard tree showing evidence of poor pruning practices, branch dieback, and overall decline.

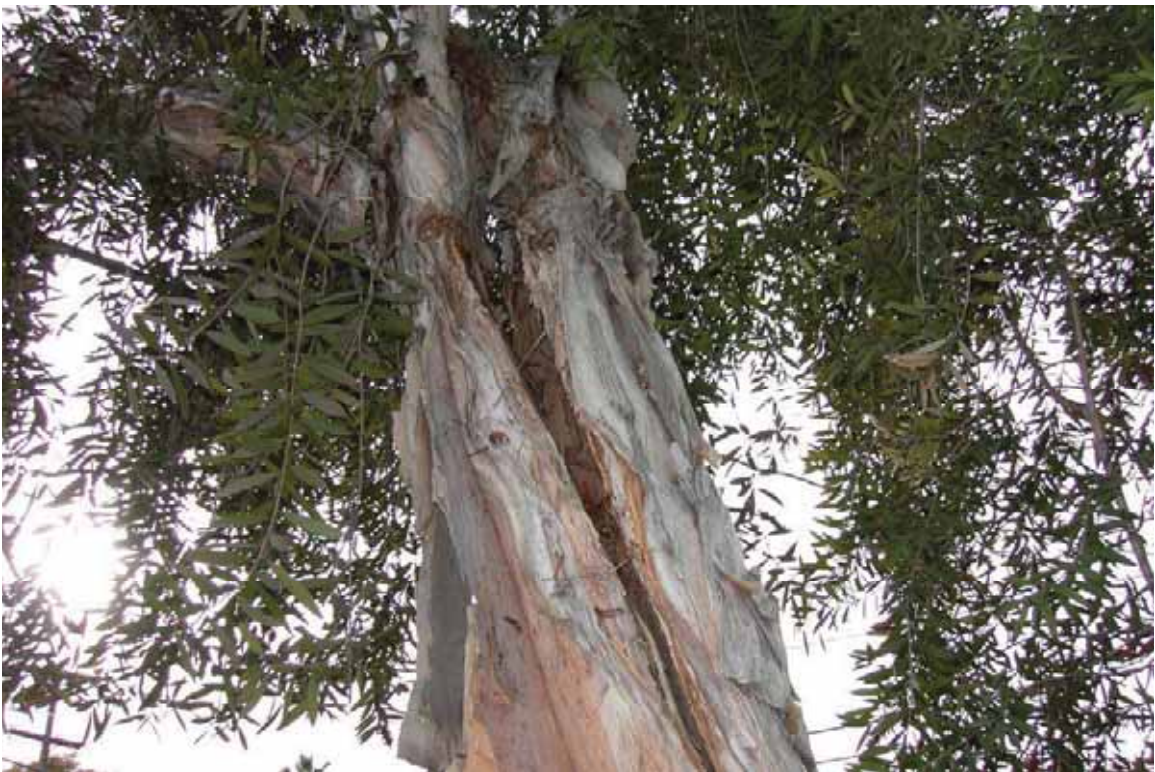
Figure 9: Example of green reliability tree exhibiting extensive trunk cracking.

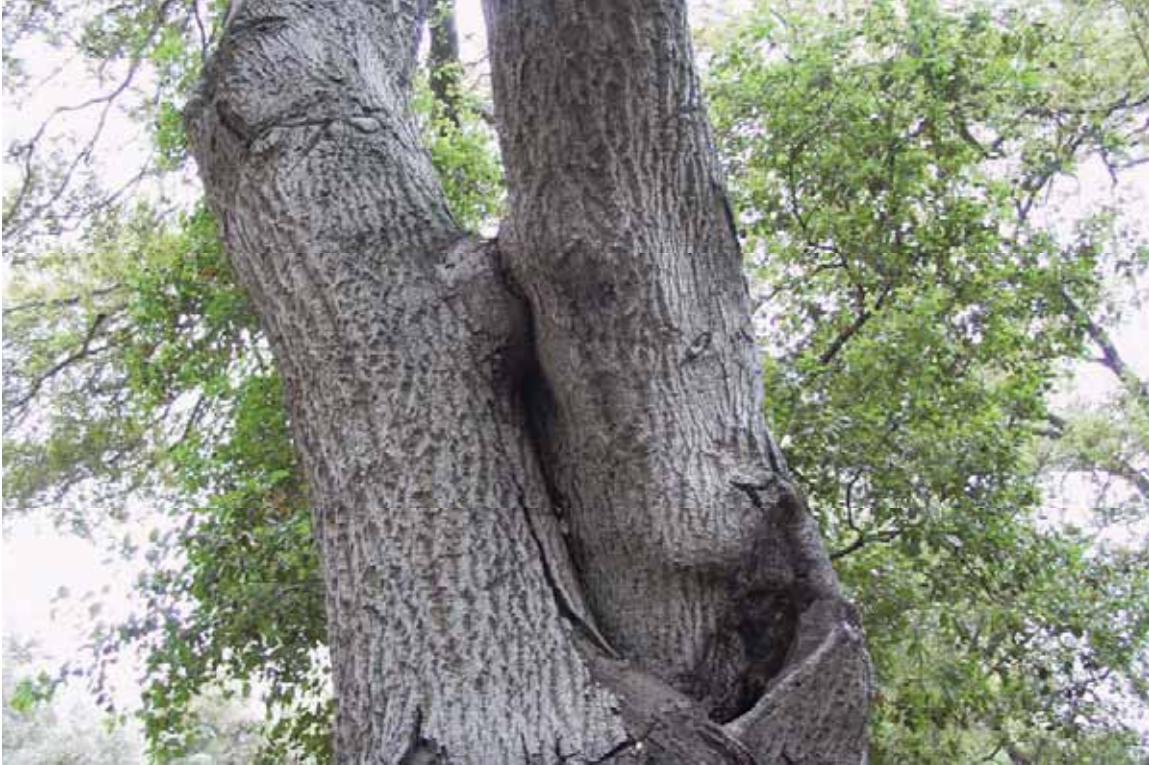
Figure 10: Potential green reliability oak exhibiting evidence of included bark and interior rot.

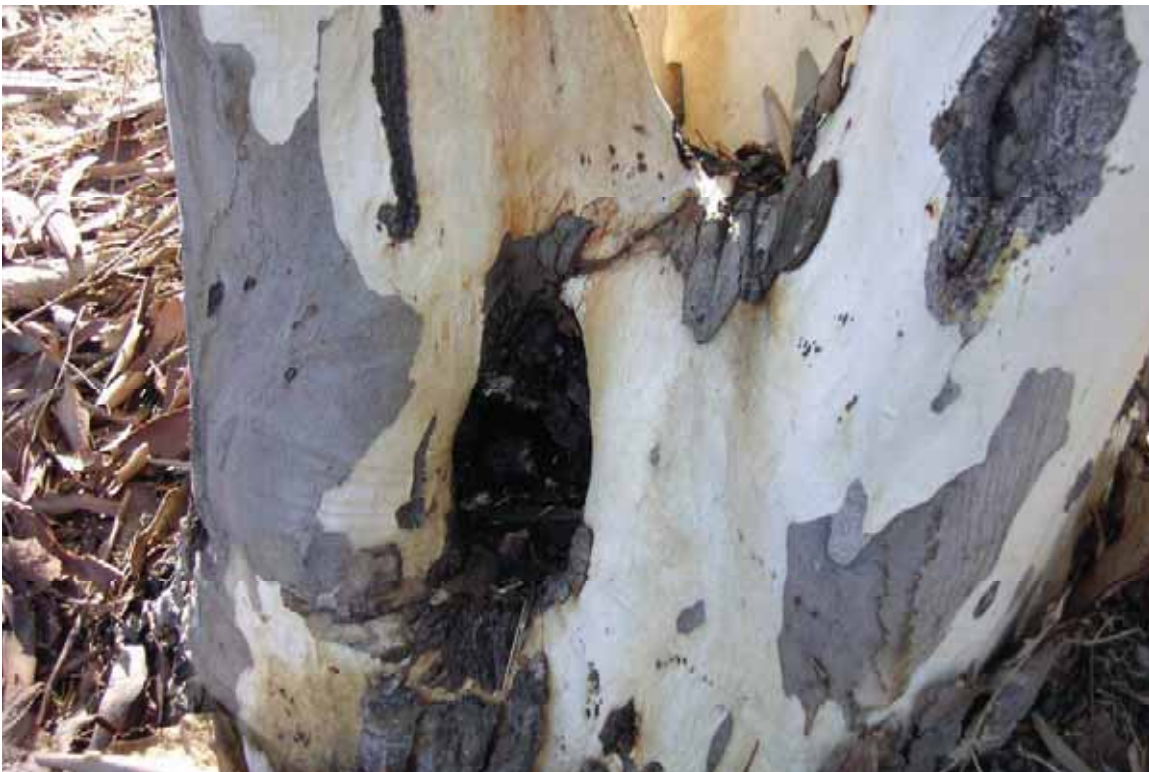
Figure 11: Interior rot at base of eucalyptus that may lead to future failure.

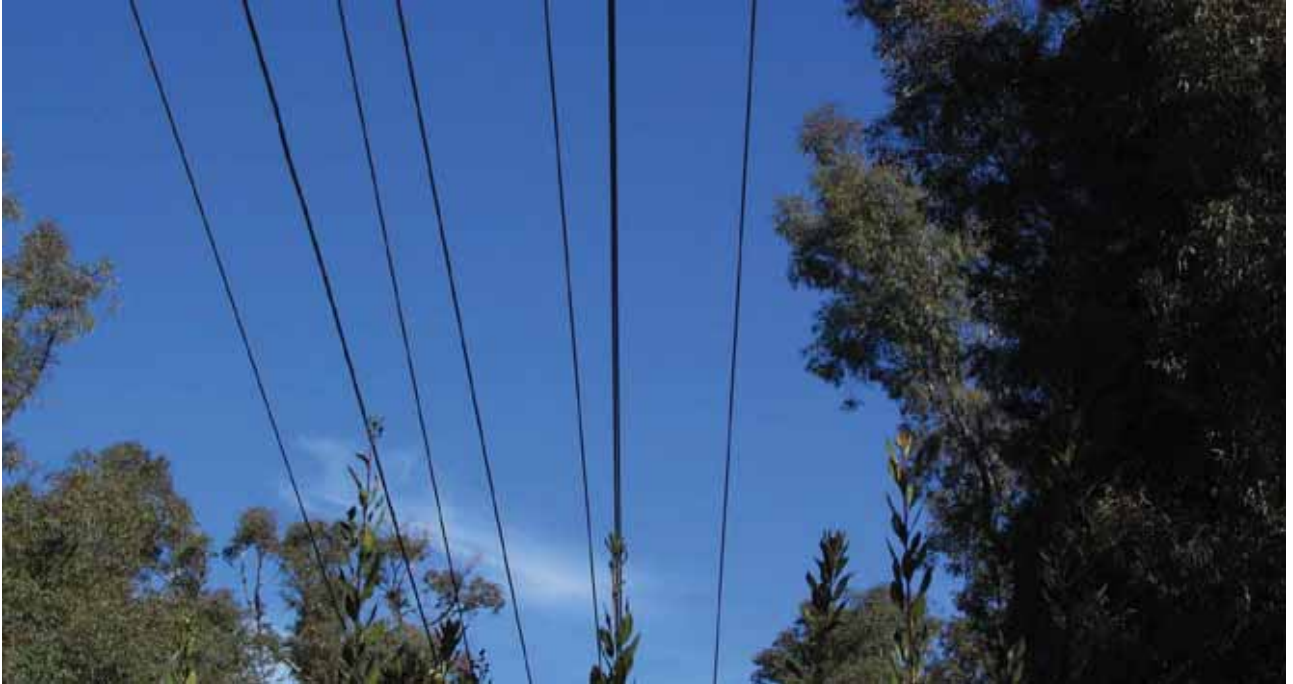
Figure 12: Reliability trees may not always be readily observable. In the example below, the tall, slender eucalyptus tree has a slight lean and may be well clear of the electrical facilities during normal weather conditions.

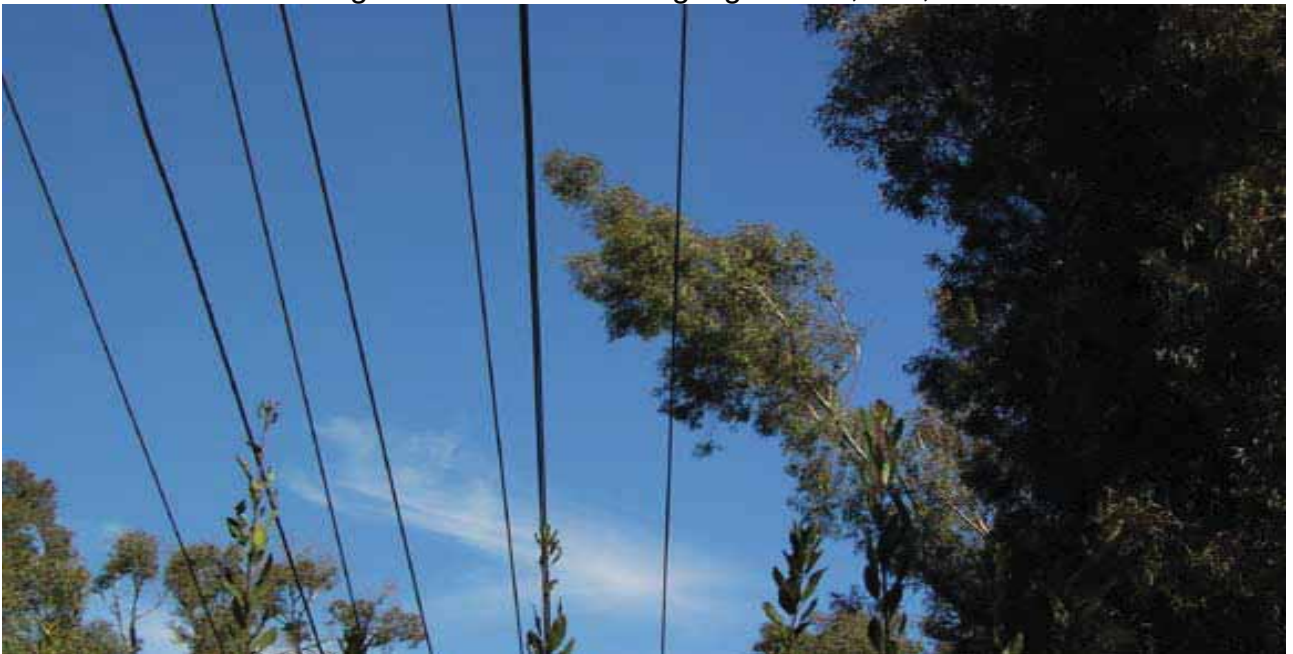
Figure 13: Minutes later the winds pick up and the tree may now pose a potentially hazard. Keep in mind pre-inspection must anticipate tree and weather conditions through all seasons including high winds, rain, and snow.
