Jurisdictional Delineation Report for Tie-Line 649 Wood-to-Steel Pole Replacement Project

Prepared by:
San Diego Gas & Electric (SDG&E)
8315 Century Park Court, CP21E
San Diego, CA 92123
Contact: Ms. Tamara Spear

April 28, 2015

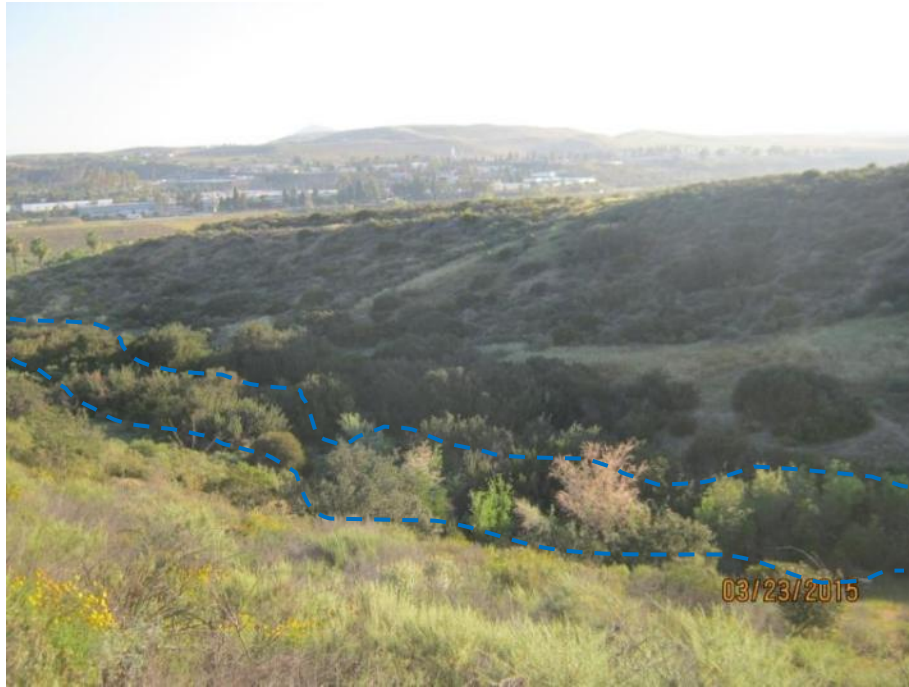
Photograph 1: Feature 1 is a vegetated drainage and emergent wetland located between Location 1 and Location 2. As the project transmission line spans this feature, no impacts are anticipated. Photograph taken facing northeast

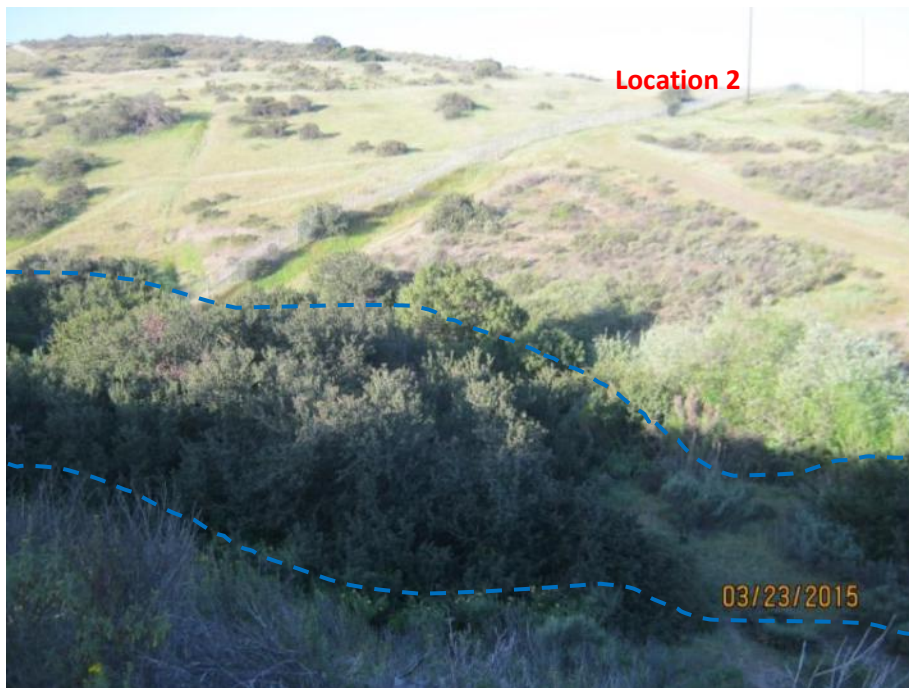
Photograph 2: Feature 2 is an ephemeral drainage located between Location 3 and Location 4. As the project transmission line spans this feature, no impacts are anticipated. Photograph taken facing southwest.

Aquatic Feature Number	Description	Location Description	Jurisdictional Determination Reasoning	Agency Jurisdiction	Sample Point	Map Page Number	Photograph
AF1	Vegetated drainage	Between Location 1 and Location 2	Vegetated drainage with an OHWM and connectivity containing emergent marsh vegetation dominated by southern cattail (<i>Typha domingensis</i> , OBL) and mule fat (<i>Baccharis salicifolia</i> , FAC). This feature is considered an ACOE wetland water of the U.S., CDFW wetland, and RWQCB water of the state. As the project transmission line spans this feature, no impacts are anticipated.	ACOE/CDFW/ RWQCB	NA	2	Photograph 1
AF2	Ephemeral drainage	Between Location 3 and Location 4	Ephemeral drainage with an OHWM and connecting containing fringing riparian scrub vegetation dominated by mule fat. The drainage channel of this feature is likely considered an ACOE non-wetland water of the U.S., CDFW streambed, and RWQCB water of the state, while the riparian scrub fringing the drainage is considered CDFW wetland only. As the project transmission line spans this feature, no impacts are anticipated.	ACOE/CDFW/ RWQCB	NA	2	Photograph 2

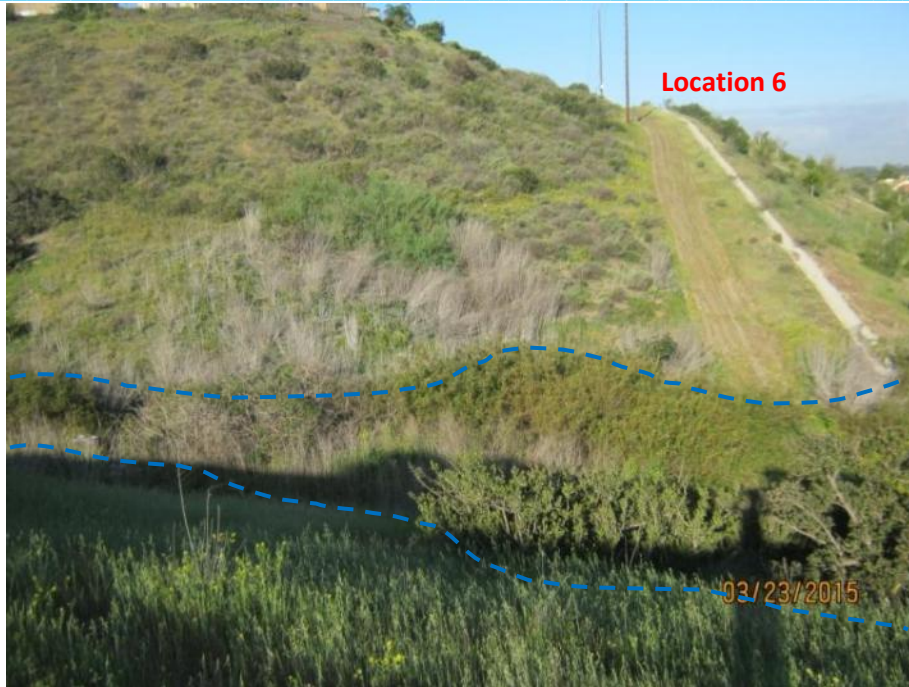
Photograph 3: Feature 3 an ephemeral drainage located between Location 6 and Location 7. Photograph taken facing west. Project activity includes vehicular access through the drainage as it crosses the road.

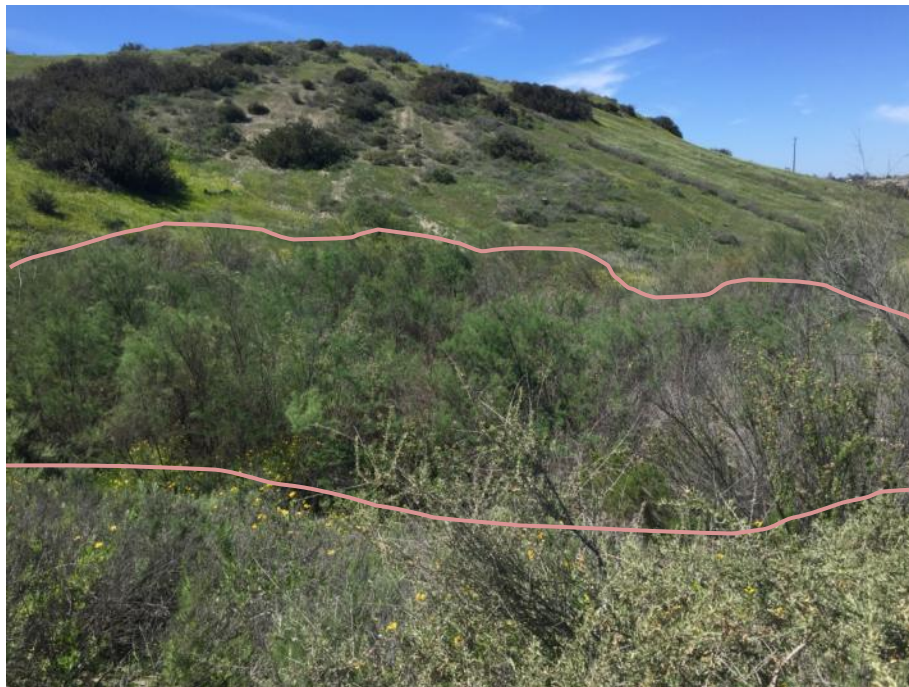
Photograph 4: Feature 4 is a man-made detention basin located southwest of Location 5. As this feature is outside of proposed work areas, no impacts are anticipated. Photograph taken facing northwest.

AF3	Ephemeral drainage	Between Location 6 and Location 7	Ephemeral drainage with an OHWM and connectivity containing fringing riparian scrub vegetation dominated by mule fat and castor bean (<i>Ricinus communis</i> , FACU). The drainage channel of this feature is likely considered an ACOE non-wetland water of the U.S., CDFW streambed, and RWQCB water of the state, while the riparian scrub fringing the drainage is likely CDFW only. The drainage channel of Feature 3 flows across a maintained, unpaved, unculverted, existing project access road. Project activity includes vehicular access through the drainage as it crosses the road.	ACOE/CDFW/ RWQCB	NA	3	Photograph 3
AF4	man-made detention basin	southwest of Location 5	Man-made detention basin vegetated with riparian scrub vegetation dominated by mule fat and salt cedar (<i>Tamarix chinensis</i> , FAC), with occasional herbaceous understory vegetation consisting of dock (<i>Rumex</i> sp.). Feature 4 is not connected to a TNW, and does not exhibit a defined OHWM or streambed. The detention basin is likely considered an ACOE wetland waters and RWQCB water of the state occurring as a result of urban runoff from surrounding development to the west and sheet flow from paved roads to the south. As this feature is outside of proposed work areas, no impacts are anticipated.	ACOE and RWQCB	NA	3	Photograph 4

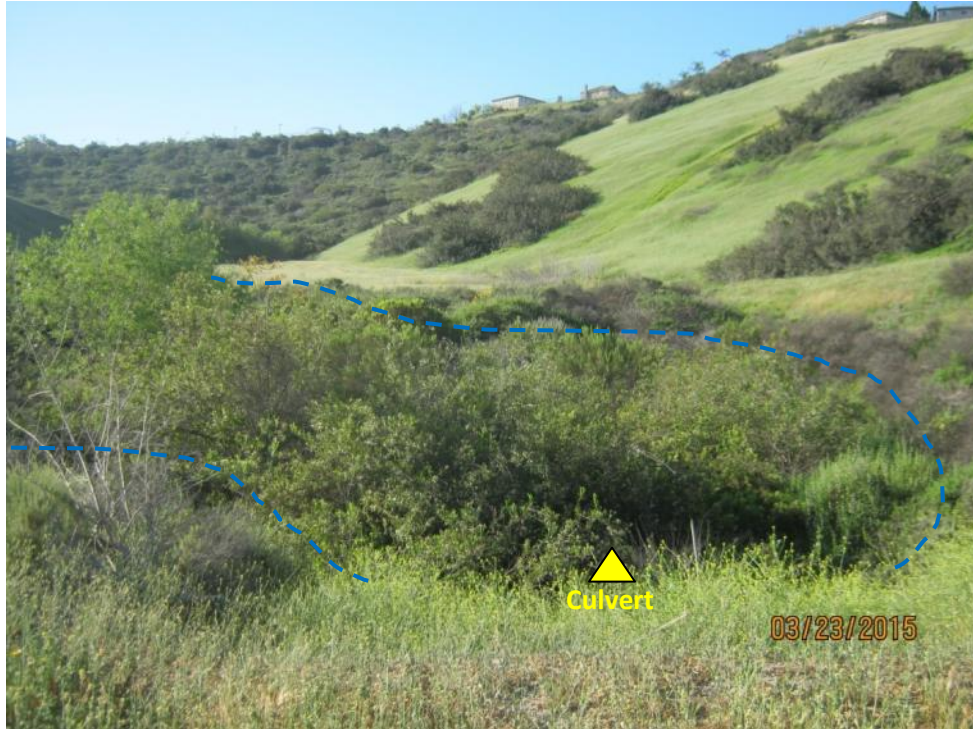
Photograph 5: Feature 5 is a vegetated drainage located southeast of location 14. As this feature is outside of proposed work areas, no impacts are anticipated. Photograph taken facing north.

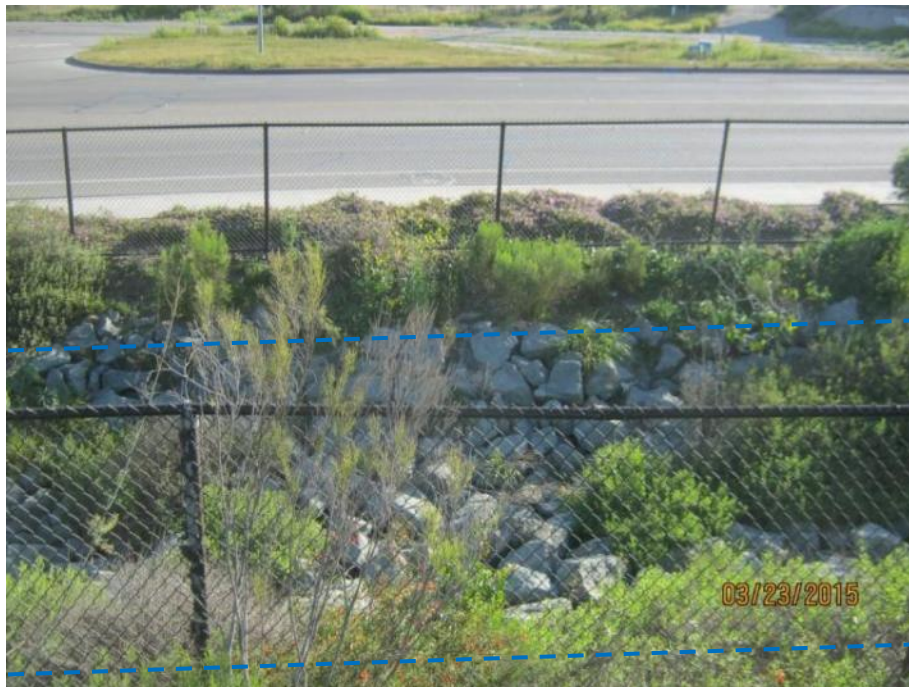
Photograph 6: Feature 6 is an ephemeral drainage located east of pole Location 17 and immediately west of Heritage Road. As the project transmission line spans this feature, no impacts are anticipated. Photograph taken facing east.

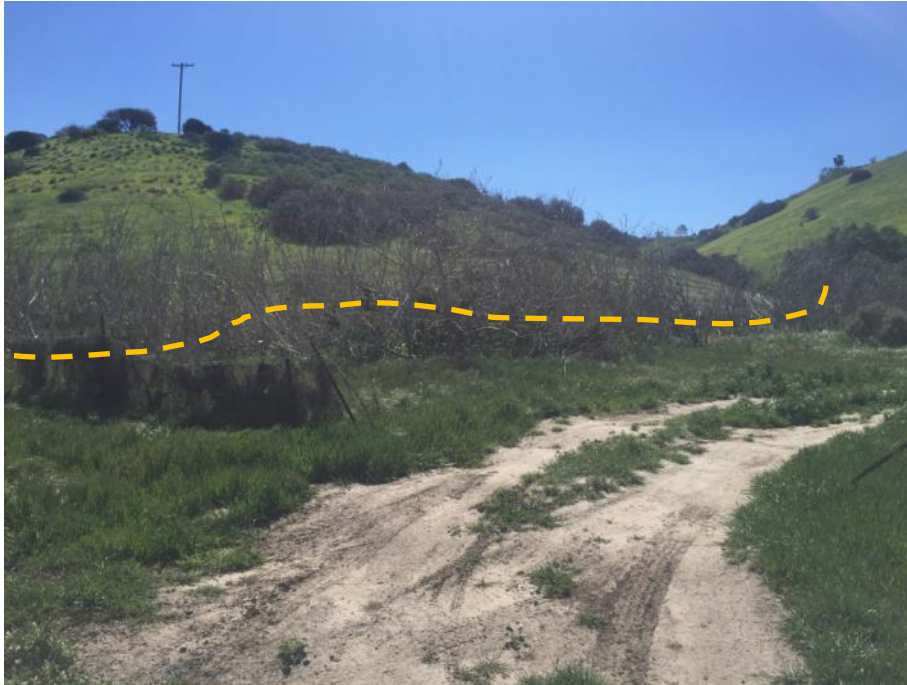
Photograph 7: Feature 7 is a non-jurisdiction swale located between Location 21 and Location 22. Project activity includes vehicular access through the drainage as it crosses the road. Photograph taken facing southeast.

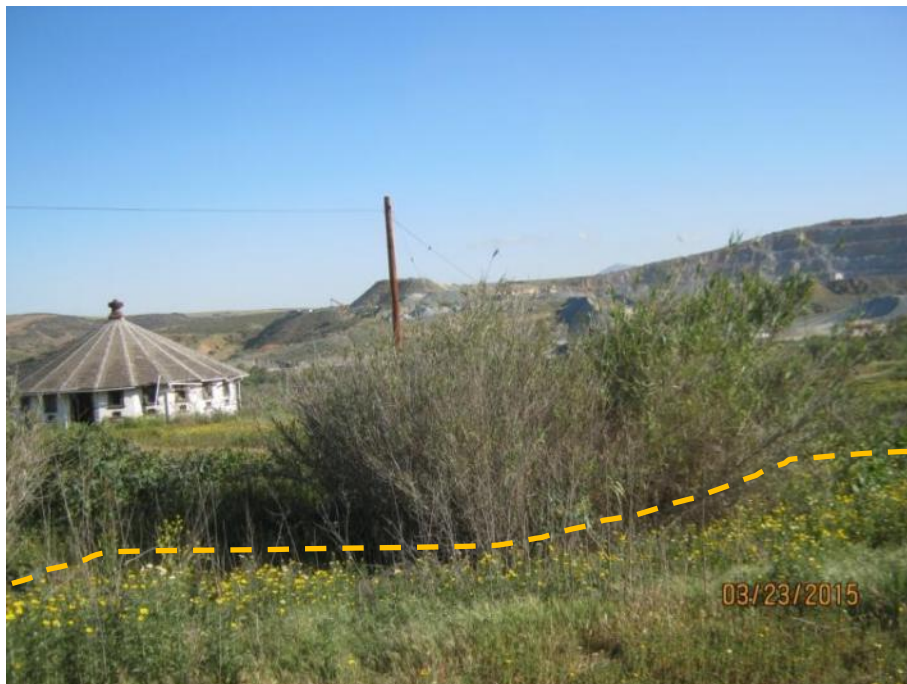
Photograph 8: Feature 8 is a non-jurisdiction swale located between Location 26 and Location 27. Feature 8 sheet flows across a maintained, unpaved, unculverted, existing project access road and dissipates into upland. Photograph taken facing northwest.

AF7	Swale	Between Location 21 and Location 22	Non-jurisdiction swale dominated by disturbed vegetation, including castor bean and non-native upland grasses. This feature is not considered an ACOE non-wetland water of the U.S., CDFW streambed, and RWQCB water of the state due to lack of OHWM, defined streambed, and dissipation of flow to upland vegetation south of the project access road.	Non-jurisdictional	NA	6	Photograph 7
AF8	Swale	Between poles Location 26 and Location 27	Non-jurisdiction swale dominated by disturbed vegetation, including castor bean and non-native upland vegetation. Incidental patches of giant reed (<i>Arundo donax</i> , FACW) occur north of the project access road. The swale is not considered an ACOE non-wetland water of the U.S., CDFW streambed, and RWQCB water of the state due to lack of OHWM or defined streambed. Feature 8 sheet flows across a maintained, unpaved, unculverted, existing project access road.	Non-jurisdictional	NA	6	Photograph 8

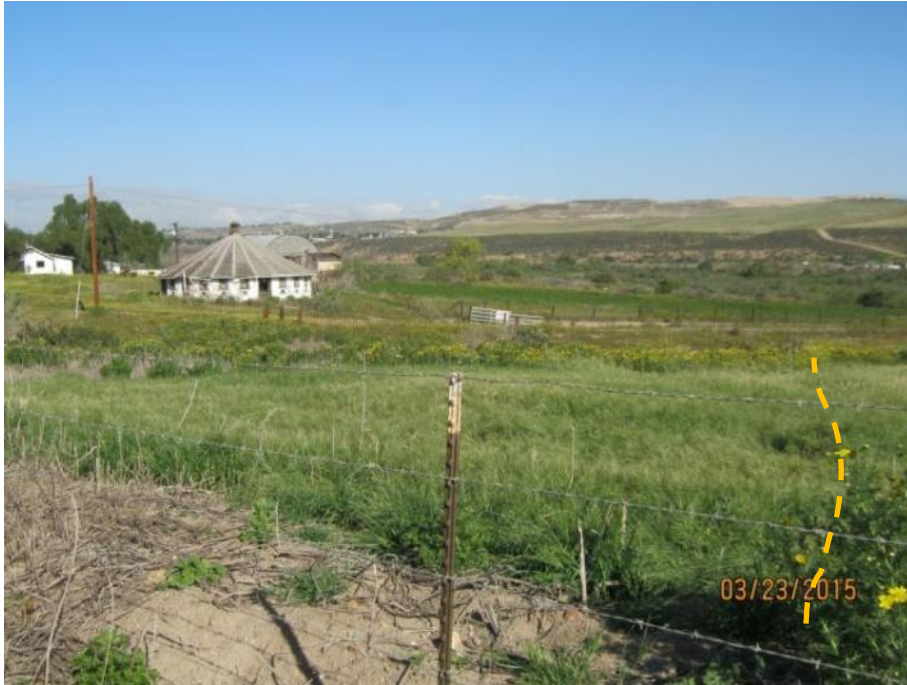
Photograph 9: Feature 9 is a non-jurisdictional swale directly east of Location 27. Feature 9 sheet flows across a maintained, unpaved, unculverted, existing project access road and dissipates into upland. Photograph taken facing northwest.

AF9	Swale	Directly east of Location 27	Non-jurisdictional swale dominated by upland non-native grasses. The swale is not considered an ACOE non-wetland water of the U.S., CDFW streambed, and RWQCB water of the state due to lack of OHWM or defined streambed. Feature 9 sheet flows across a maintained, unpaved, unculverted, existing project access road.	Non-jurisdictional	NA	6	Photograph 9

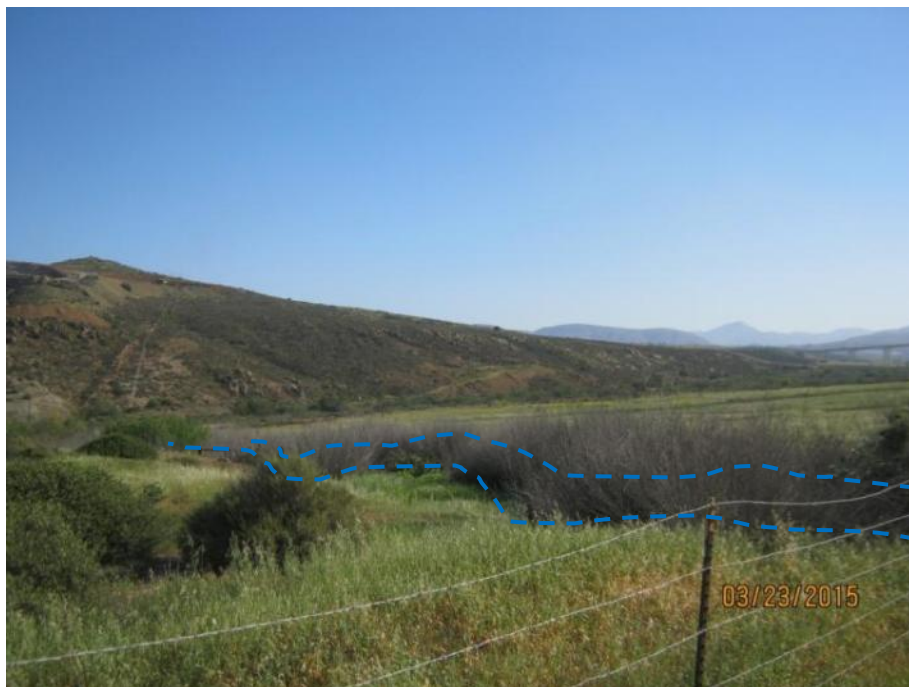
Photograph 10: Feature 10 is an ephemeral drainage located between Location 32 and Location 33. Project activity includes vehicular access through the drainage as it crosses the road. Photograph taken facing northeast.

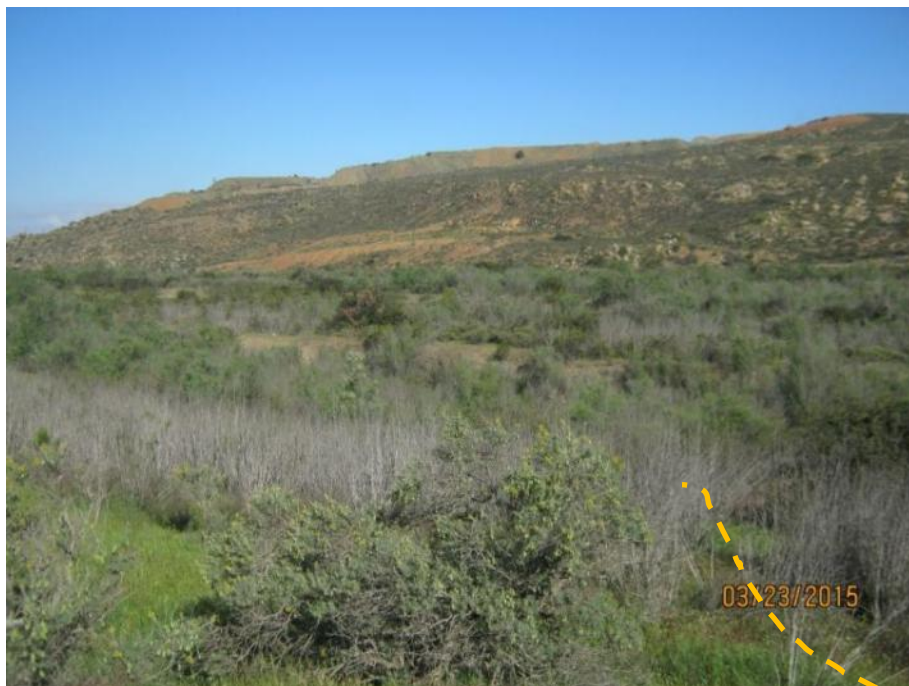
Photograph 12: Feature 12 is a non-jurisdictional swale located between Location 38 and Location 39. Water conveyed by Feature 12 sheet flows across a maintained, unpaved, unculverted, existing project access road and dissipates into upland. Photograph taken facing north.

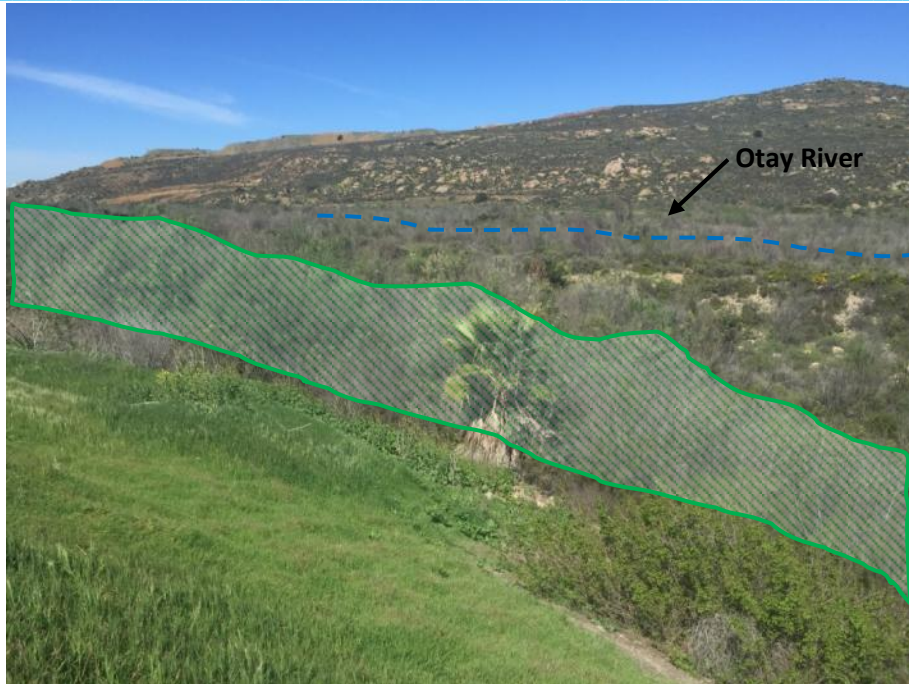
Photograph 13: Feature 13 is an adjacent wetland within the floodplain of the Otay River. The feature occurs north of the project from Location 38 east to Location 42.

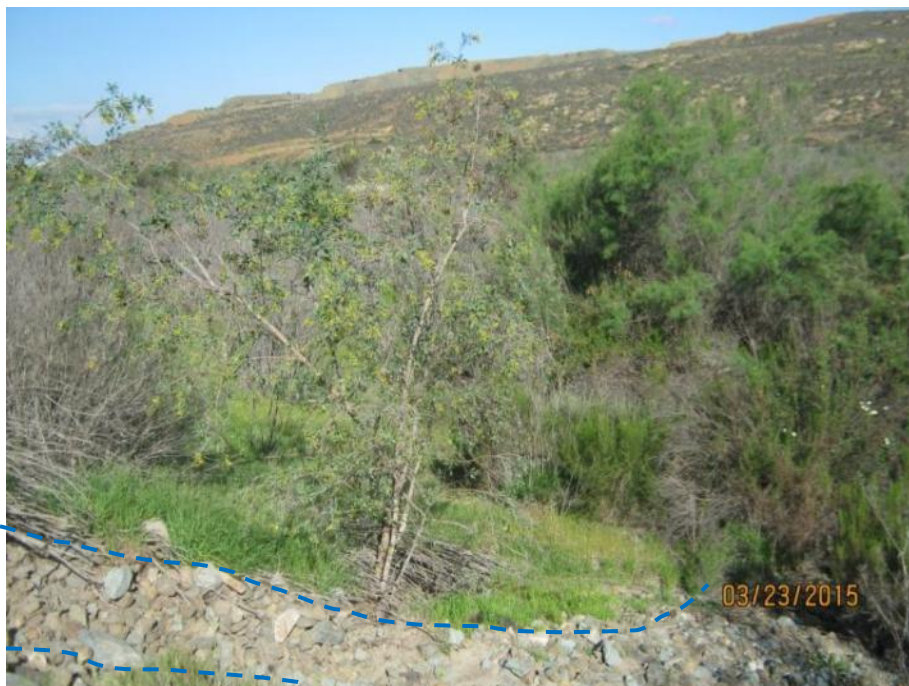
Photograph 14: Feature 14 is an ephemeral drainage and un-named tributary of the Otay River. Project activity includes vehicular access through the drainage as it crosses the road. Photograph taken facing northwest, where feature exits road into floodplain.

Aquatic Feature Number	Description	Location Description	Jurisdictional Determination Reasoning	Agency Jurisdiction	Sample Point	Map Page Number	Photograph
AF14	Ephemeral drainage	South of project access road and west of Location 41 extending to the north and west	Ephemeral drainage and un-named tributary to the Otay River dominated by upland lemonade berry (<i>Rhus integrifolia</i> , UPL). Feature 14 is characterized by an approximately 1 to 1.5 foot OHWM and streambed, and intersects an existing project access road approximately 100 feet west of Location 41, where is redirected to the west by an existing road berm. The feature continues along the cobbled north shoulder of the access road for approximately 100 feet to the west, before turning north through an installed energy dissipater and entering the Otay River floodplain. The ephemeral drainage is likely considered an ACOE non-wetland water of the U.S., CDFW streambed, and RWQCB water of the state. Project activity includes vehicular access through the drainage as it crosses the road.	ACOE/CDFW/ RWQCB	NA	9	Photograph 14

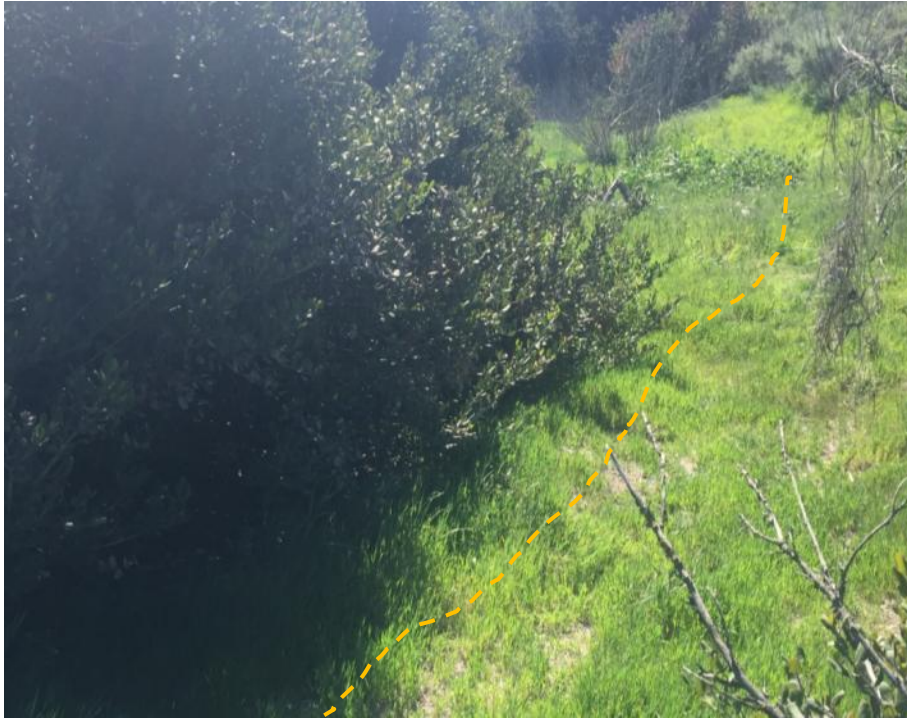
Photograph 15: Feature 15 is a non-jurisdictional swale. Feature 15 sheet flows across a maintained, unpaved, unculverted, existing project access road near location 43. Photograph taken facing south.

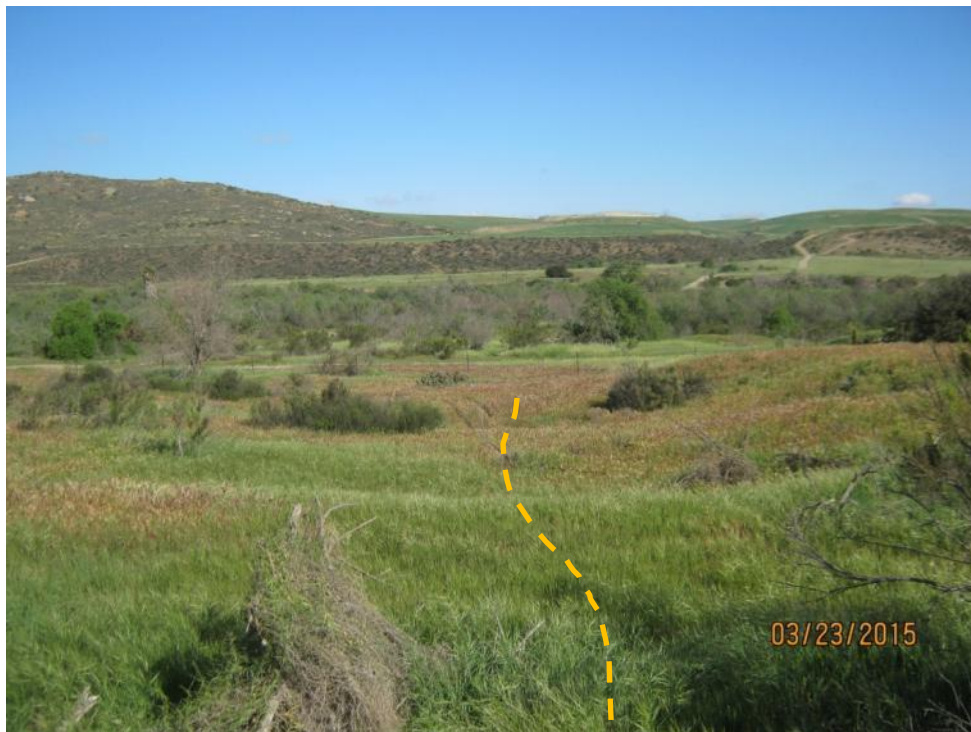
Photograph 16: Feature 16 is non-jurisdictional swale located in between Location 46 and Location 47. Feature 16 sheet flows across a maintained, unpaved, unculverted, existing project access road and dissipates into upland. Photograph taken facing north.

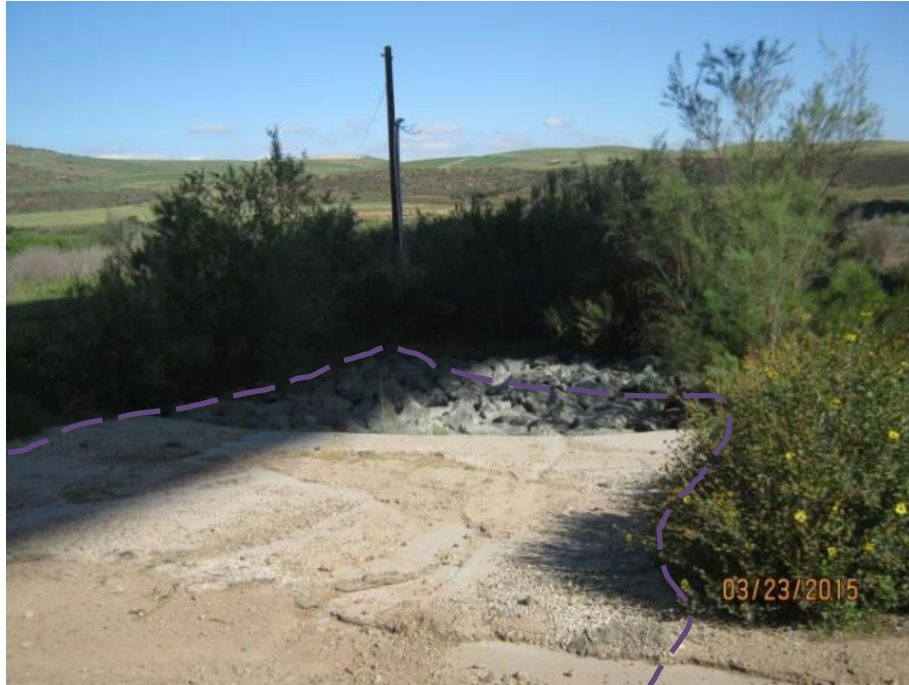
Photograph 17: Feature 17 is a non-jurisdictional concrete brow ditch and energy dissipater east of Locations 50.1 and 50.2. Feature 17 sheet flows across a maintained, concrete Arizona crossing on an existing project access road. Photograph taken facing north.

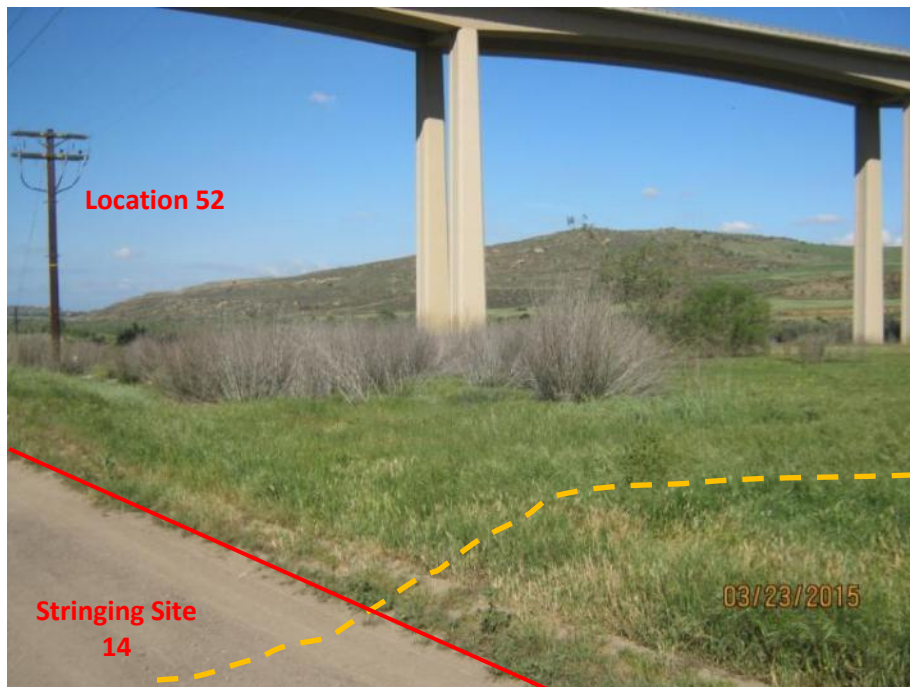
Photograph 18: Feature 18 is non-jurisdictional swale located in between Location 52 and Location 53, and crosses Stringing Site 14. Photograph taken facing northwest.

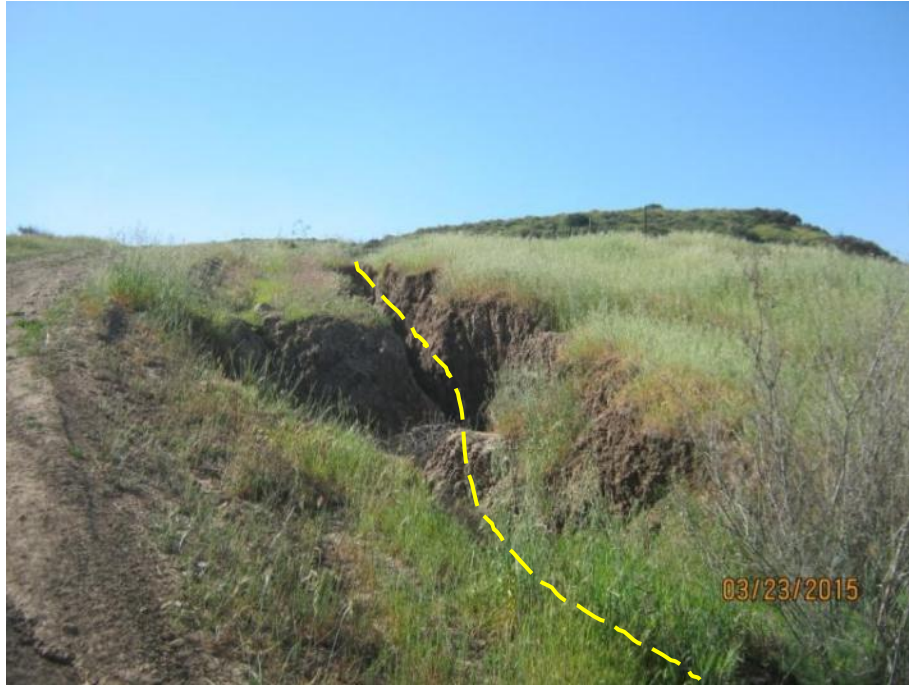
Photograph 19: Feature 19 is a non-jurisdictional erosional feature immediately to the east of Location 55 occurring along the shoulder of an unmaintained dirt access road extending to the south of Location 55. Photograph taken facing south.

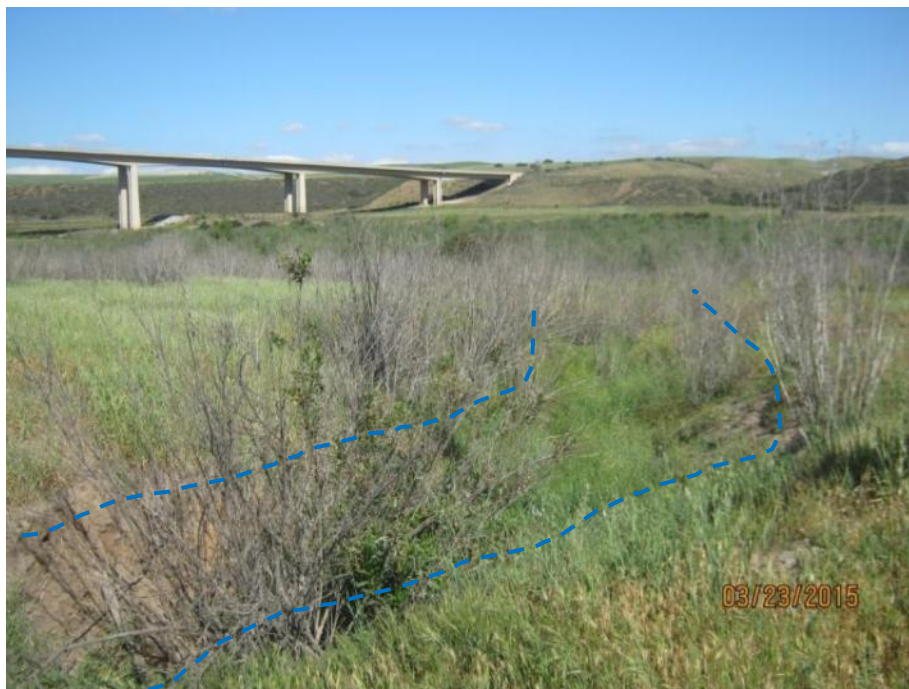
Photograph 20: Feature 20 is an ephemeral drainage located approximately 25 feet west of Location 56. Project activity includes vehicular access through the drainage as it crosses the road. Photograph taken facing north.

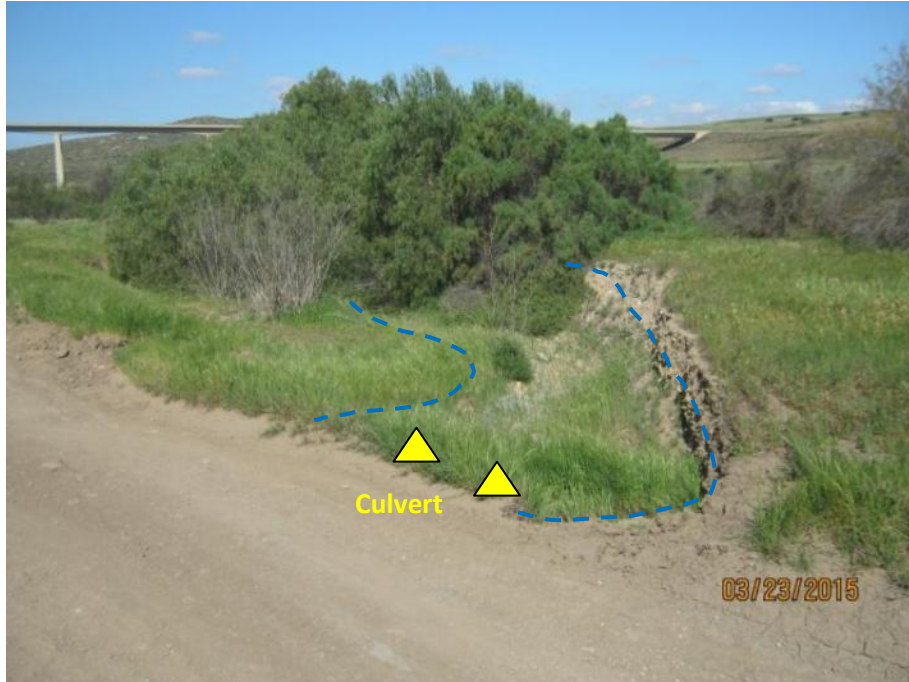
Photograph 21: Feature 21 is an un-vegetated ephemeral drainage located in between Location 57 and Location 58. Project activity includes vehicular access through the drainage as it crosses the road. Photograph taken facing north.

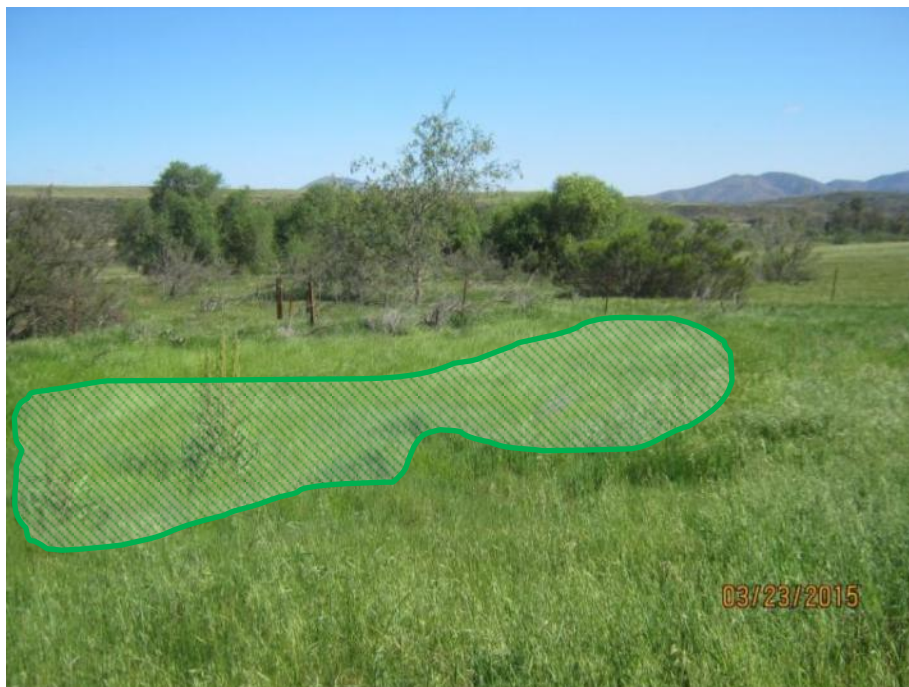
Photograph 22: Feature 22 is an isolated emergent wetland located approximately 7 feet east of Location 59. The replacement pole will be installed west of the existing pole, and will not impact this feature. Photograph taken facing north.

AF22	Emergent wetland	Approximately 7 feet east of Location 59	Emergent wetland dominated by beardless wild-rye (<i>Elymus triticoides</i> , FAC). The wetland is not associated with a streambed, but rather is a closed-depressional feature and; therefore, is not considered jurisdictional by CDFW. The wetland is likely considered an ACOE wetland water of the U.S. and RWQCB water of the state. The replacement pole will be installed west of the existing pole, and will not impact this feature.	ACOE and RWQCB	SP3	12	Photograph 22

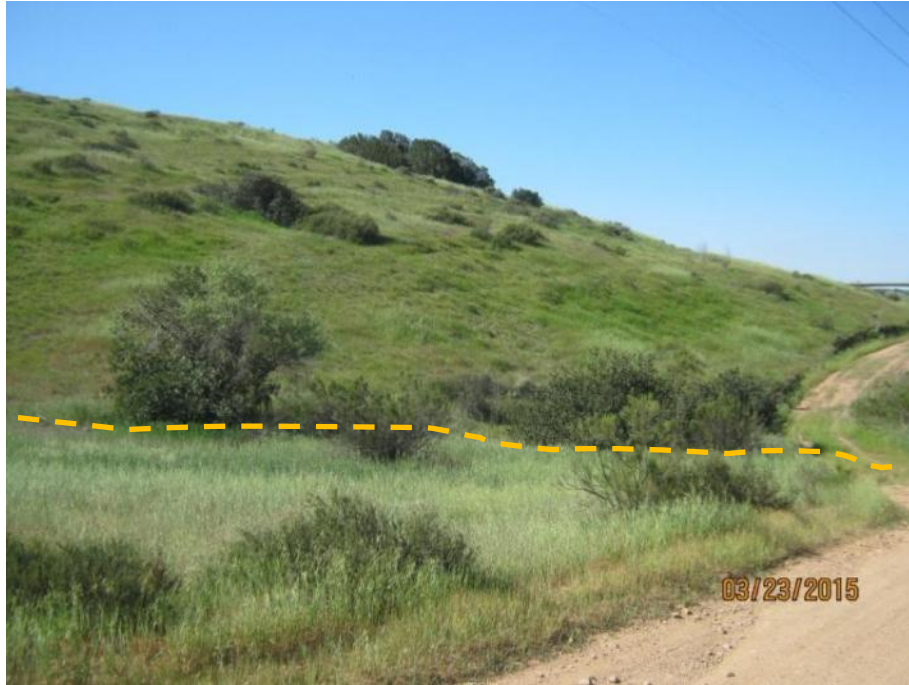
Photograph 23: Feature 23 is non-jurisdictional swale located in between Locations 60 and Locations 61, and intersects the existing project spur road to Location 60. Photograph taken facing west.

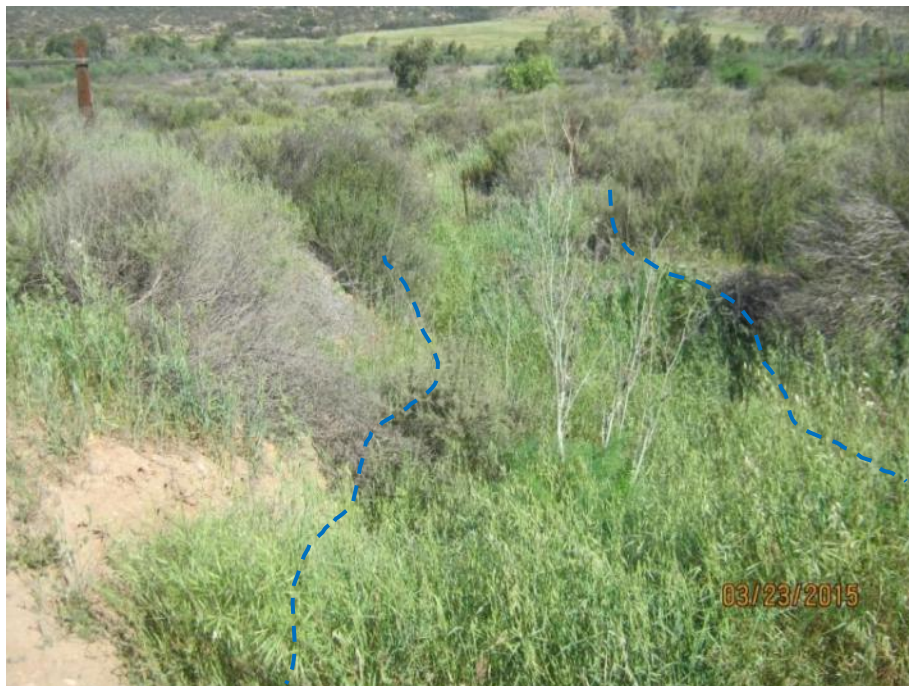
Photograph 24: Feature 24 is an ephemeral drainage located approximately 40 feet northeast of Location 62. Project activity includes vehicular access through the drainage as it crosses the road. Photograph taken facing north.

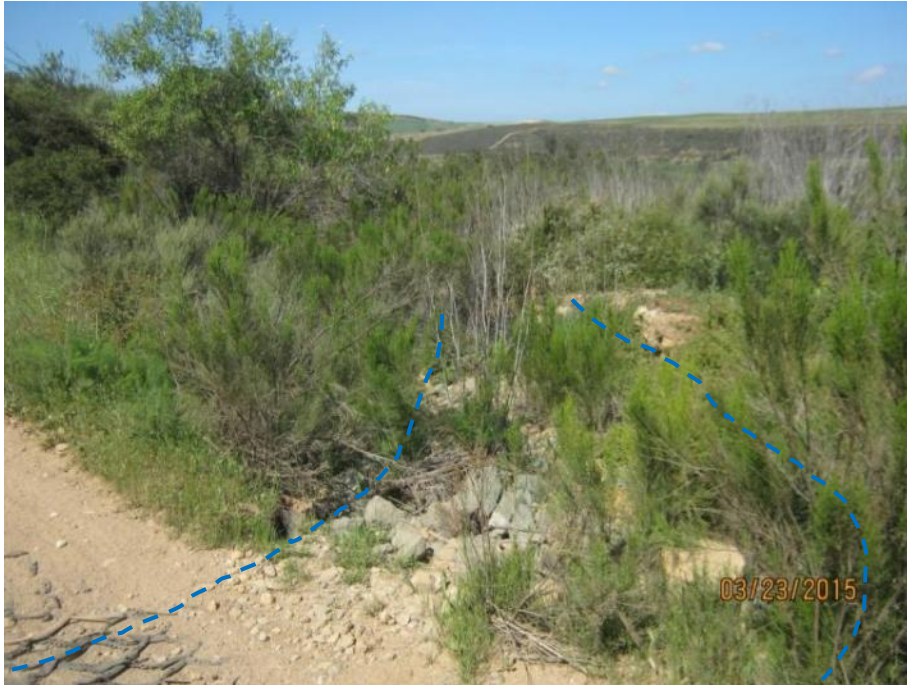
Photograph 25: Feature 25 is an ephemeral drainage located in between Location 65 and Location 66. Project activity includes vehicular access through the drainage as it crosses the road. Photograph taken facing northwest.

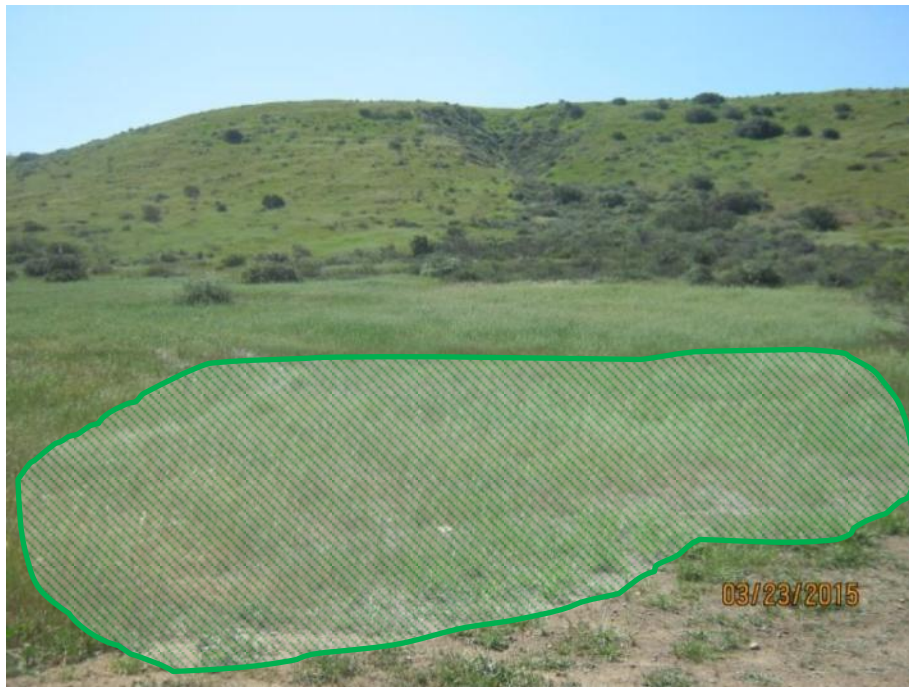
Photograph 26: Feature 26 is a jurisdictional emergent marsh located east-northeast of Location 69. This feature is located immediately south of the existing project access road, and are not expected to be impacted by vehicular use. Photograph taken facing south.

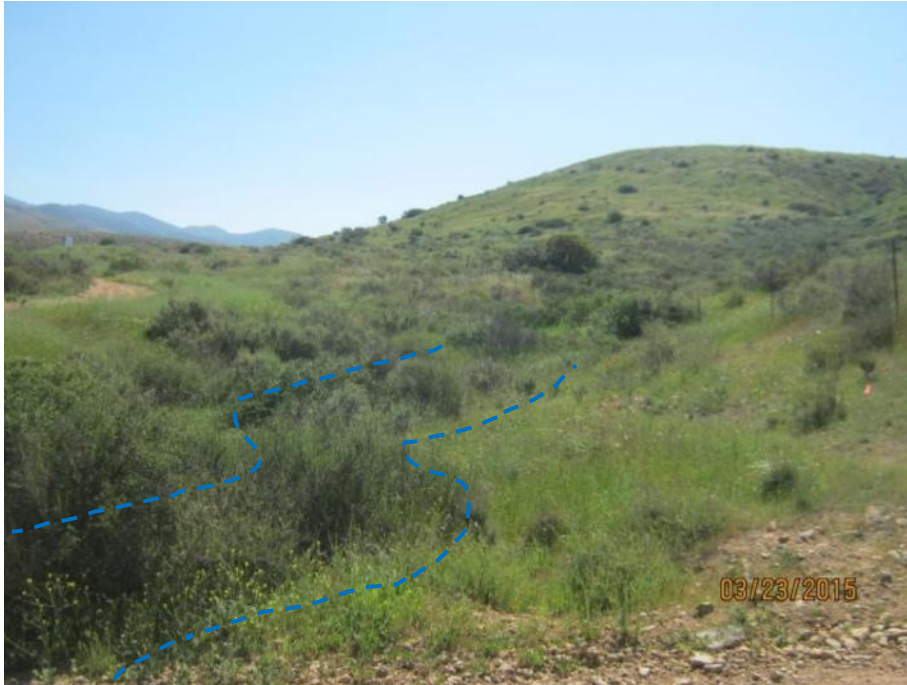
Photograph 27: Feature 27 is an ephemeral drainage located southwest of Location 70. Project activity includes vehicular access through the drainage as it crosses the road. Photograph taken facing south.

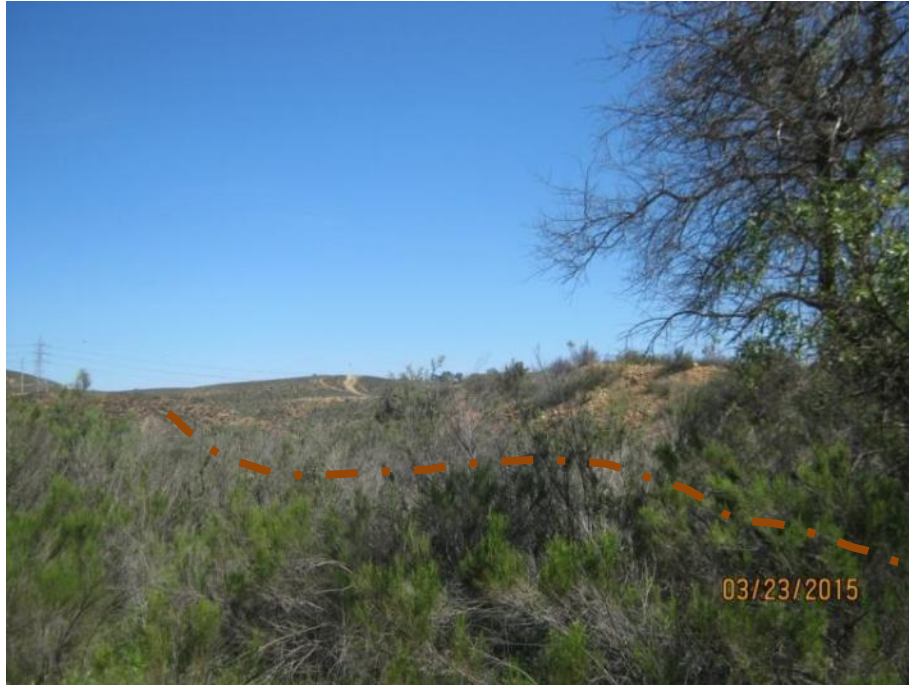
Photograph 29: Feature 29 is characterized as fringing riparian scrub vegetation located immediately north of the existing project access road near location 75, and is not expected to be impacted by vehicular use. Photograph taken facing north.

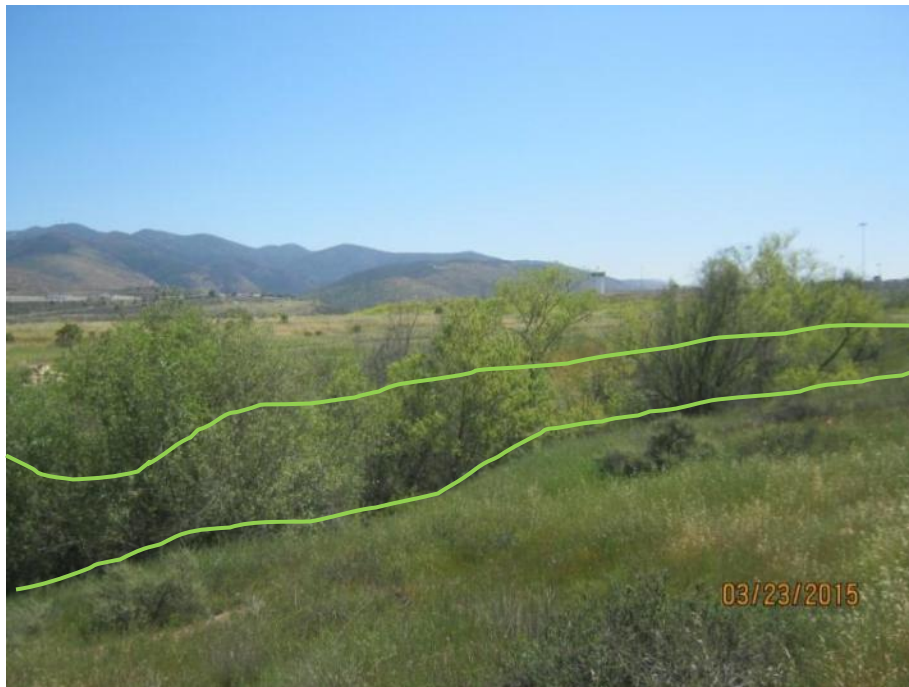
Photograph 30: Feature 30 is a drainage and un-named tributary of the Otay River occurring along an access road between Location 86 and Location 87. Project activity includes vehicular access through the drainage as it crosses the road. Photograph taken facing northeast.

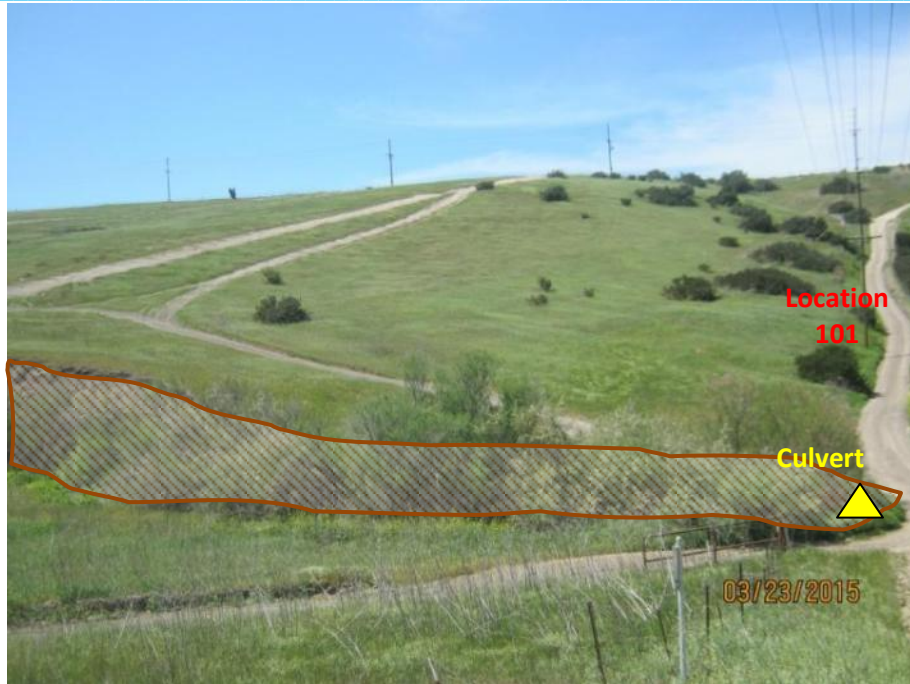
Photograph 31: Feature 31 is an ephemeral drainage with CDFW riparian scrub habitat located west of Location 100. Project activity includes vehicular access through the drainage as it crosses the road. Photograph taken facing southwest.

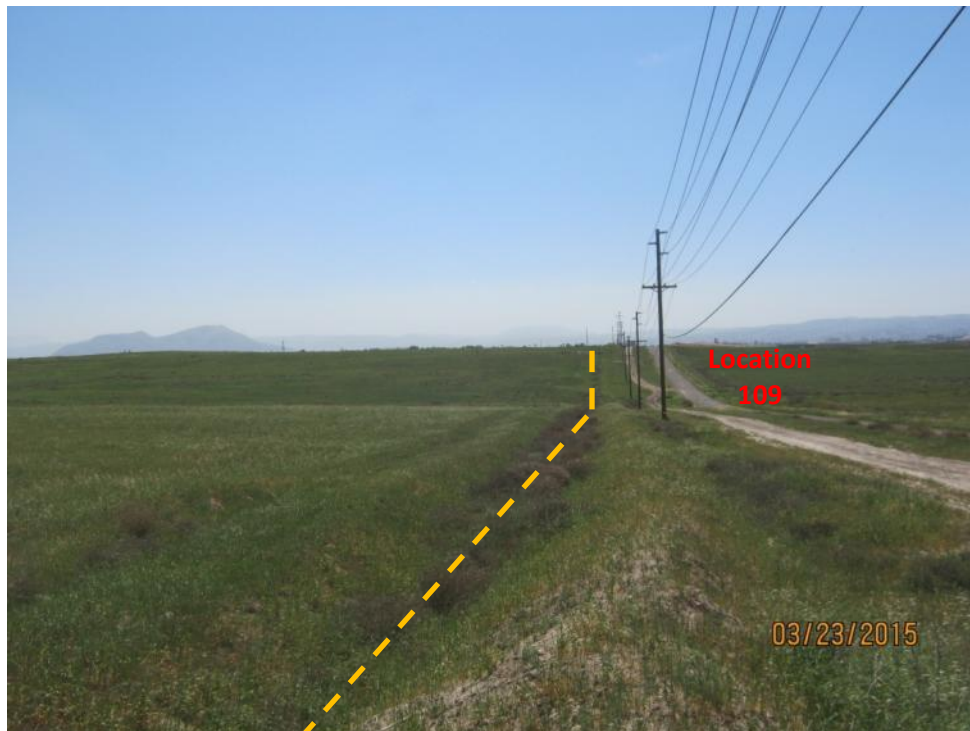
Photograph 32: Feature 32 is a non-jurisdictional erosional feature east of Stringing Site 27 and Location 109, extending south to Location 116. The feature is expected to carry surface water runoff, and does not connect to a TNW. Photograph taken facing south.
