Jurisdictional Delineation Report for Tie-Line 649 Wood-to-Steel Pole Replacement Project

Prepared by:
San Diego Gas & Electric (SDG&E)
8315 Century Park Court, CP21E
San Diego, CA 92123
Contact: Ms. Tamara Spear

April 28, 2015

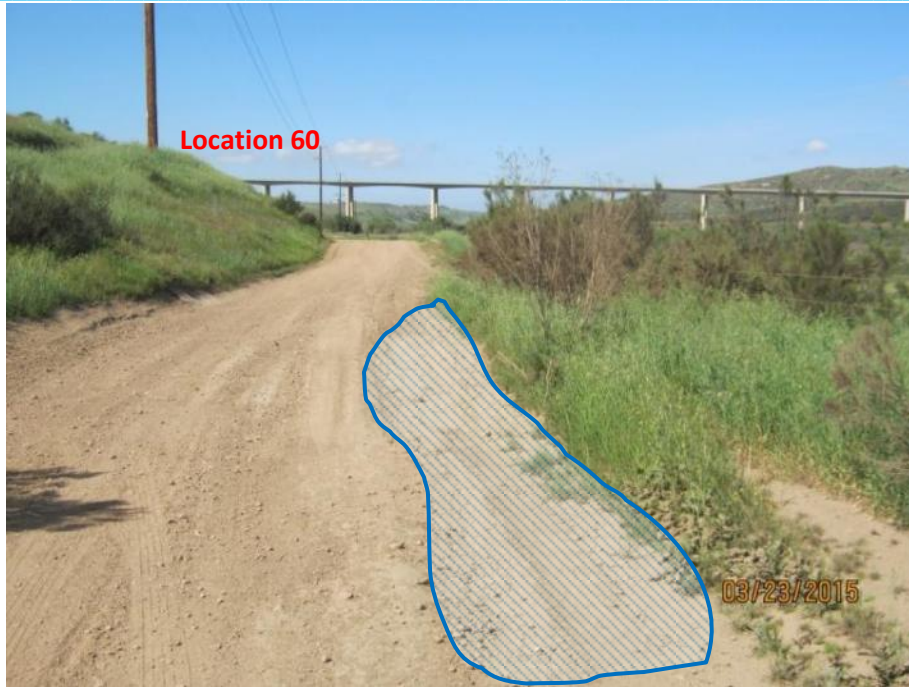
Photograph 33: Vernal pool 1 is located on a utility access road approximately 40 feet northeast of Location 60. Photograph taken facing west.

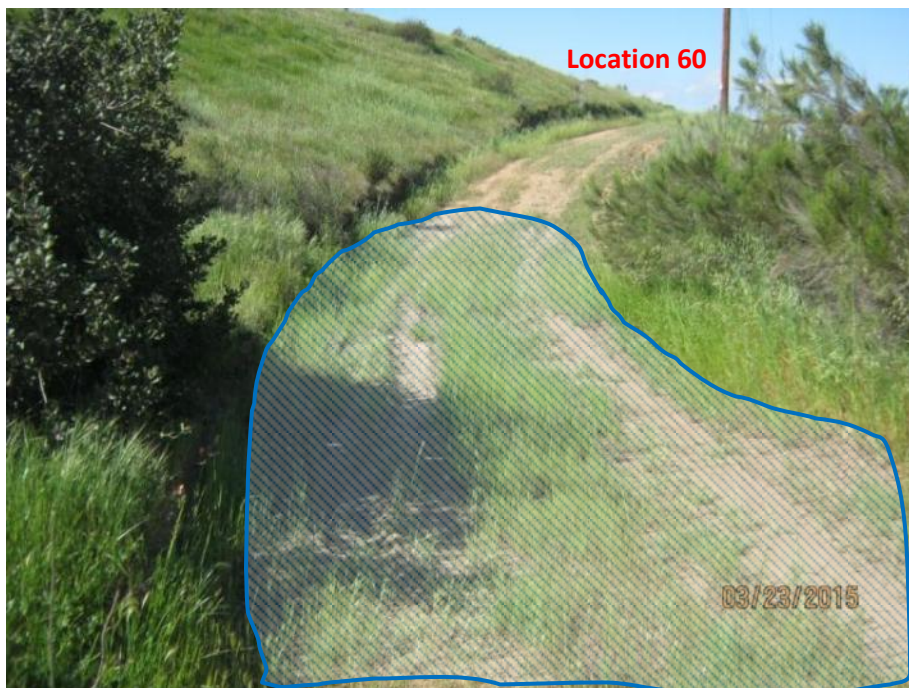
Photograph 34: Vernal pool 2 (vernal pool 2011-VP-12) is located on the spur road to Location 60. Photograph taken facing west.

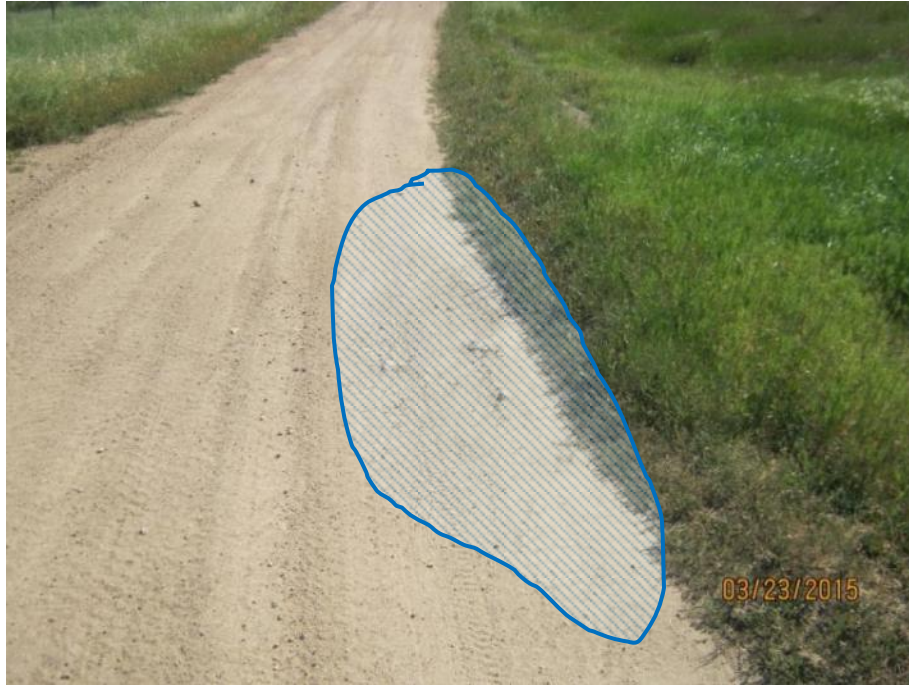
Photograph 35: Vernal pool 3 (vernal pool 2010-VP-14) is located on a utility access road approximately 150 feet west of Location 63. Photograph taken facing east.

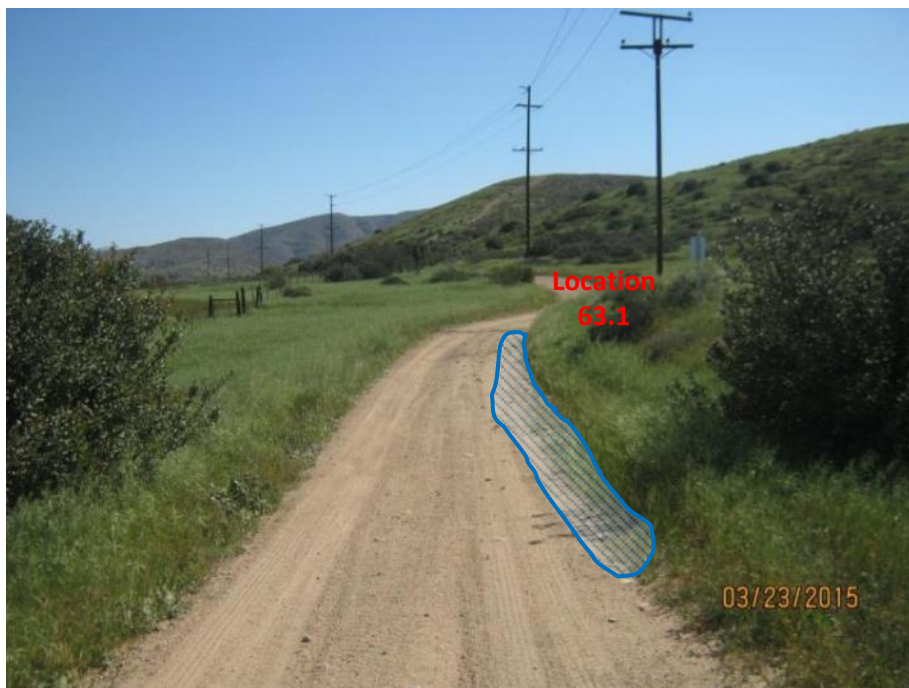
Photograph 36: Vernal pool 4 (vernal pool 2011-VP-11) is located on a utility access road approximately 55 feet east of Location 63, and 75 feet west of Location 63.1. Photograph taken facing east.

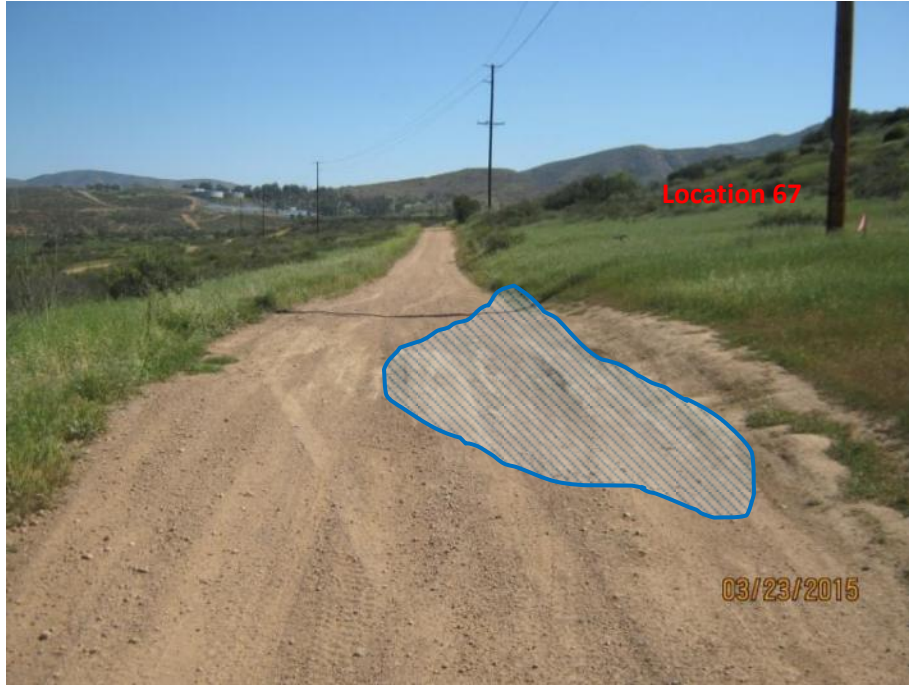
Photograph 37: Vernal pool 5 (vernal pool 2009-VP-36) located on a utility access road approximately 35 feet northwest of Location 67. Photograph taken facing east.

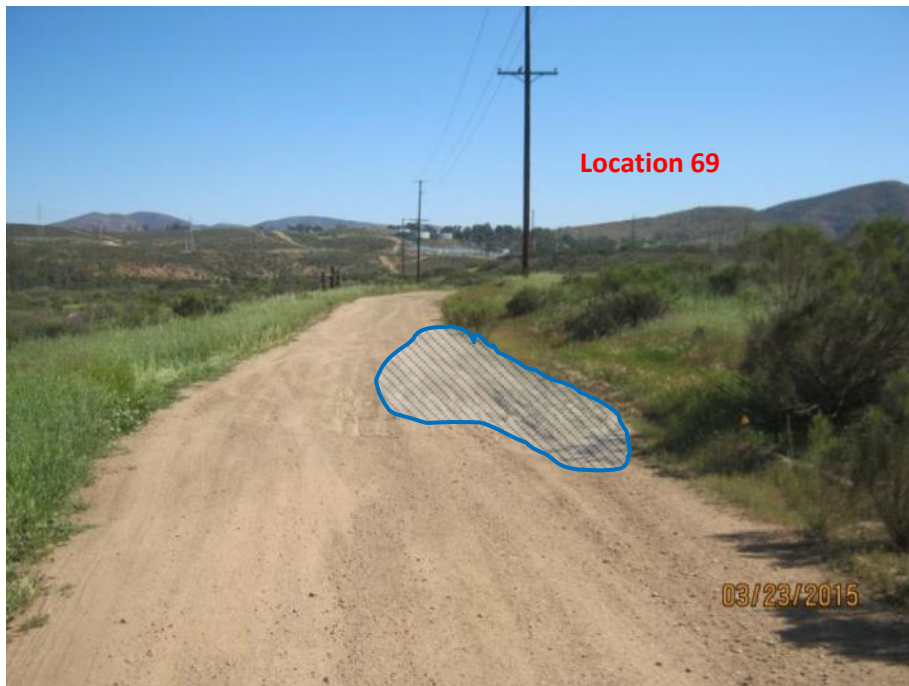
Photograph 38: Vernal pool 6 (vernal pool 2009-VP-37) is located on a utility access road approximately 120 feet southwest of Location 69. Photograph taken facing east.

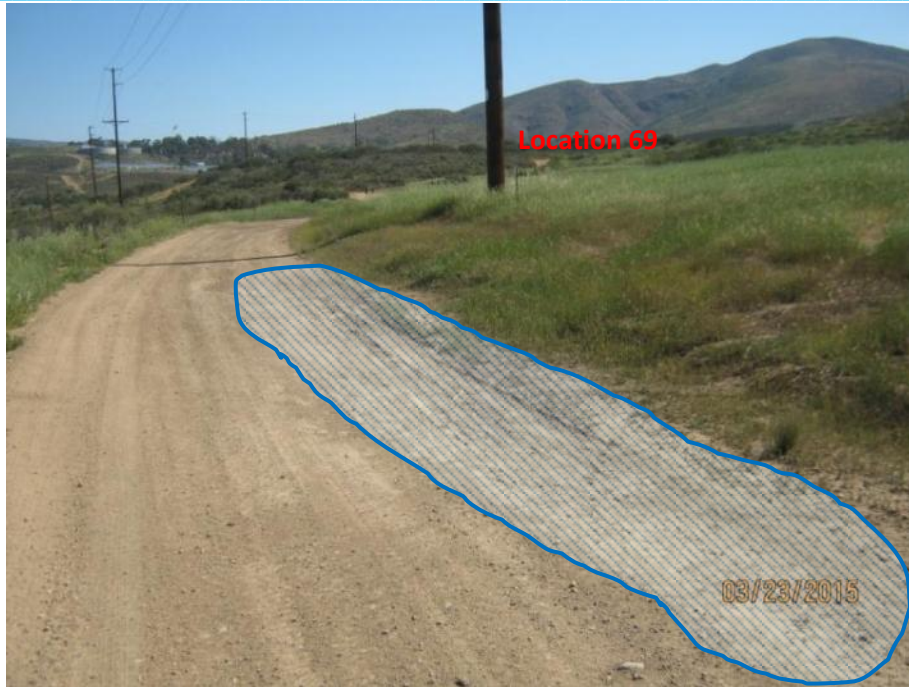
Photograph 39: Vernal pool 7 (vernal pool 2011-VP-10) is located on a utility access road immediately southwest of Location 69. Photograph taken facing east.

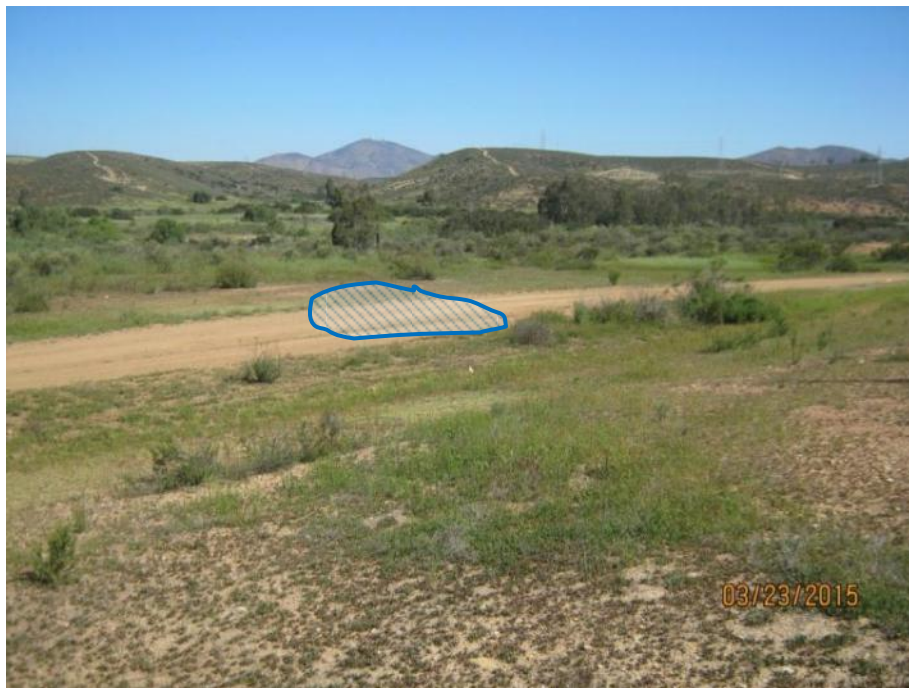
Photograph 40: Vernal pool 8 is located on an alternate utility access road approximately 120 feet north of Location 69. Photograph taken facing north.

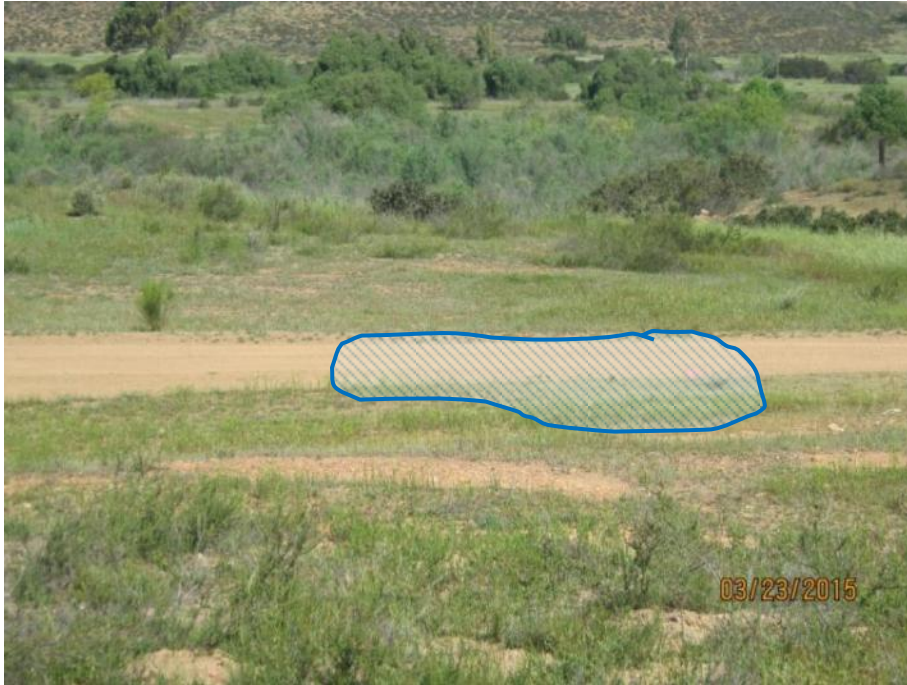
Photograph 41: Vernal pool 9 is located on an alternate utility access road approximately 145 feet northeast of Location 69. Photograph taken facing north.

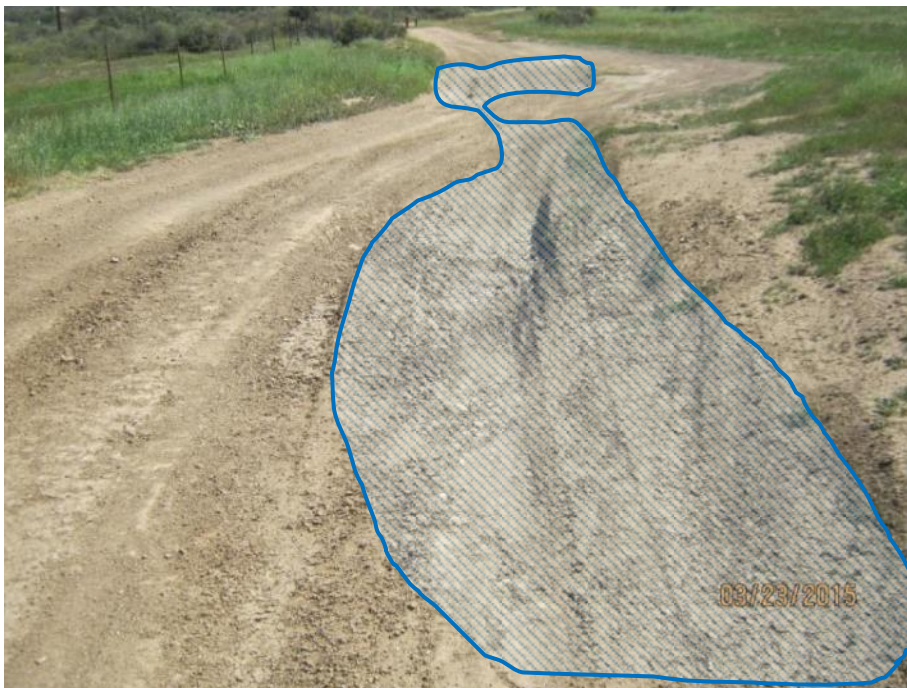
Photograph 42: Vernal pool 10 (vernal pool 2009-VP-38) is located on a utility access road immediately southwest of Location 69. Photograph taken facing northeast.

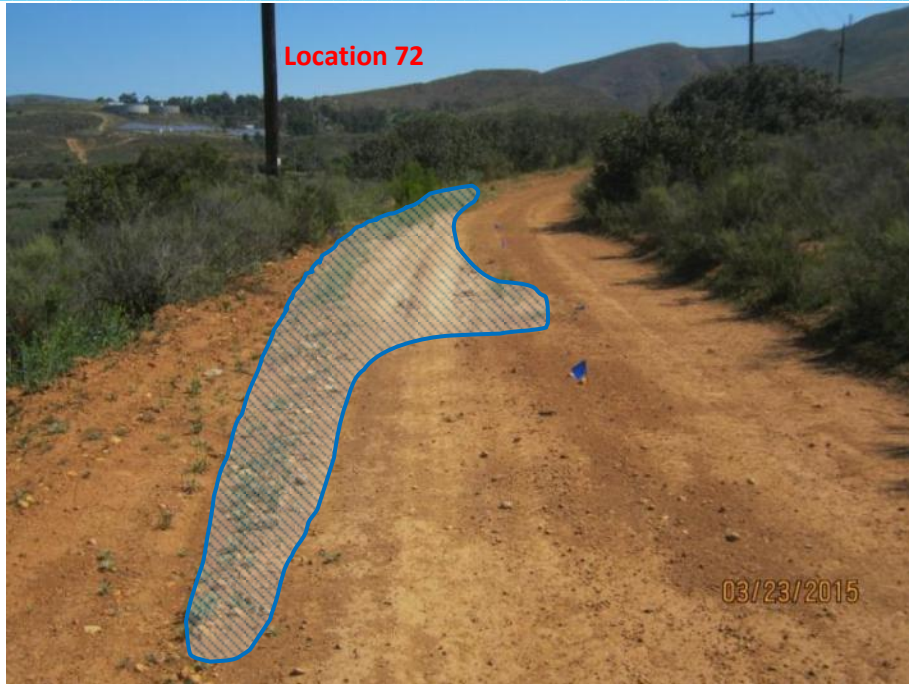
Photograph 43: Vernal pool 11 (vernal pool 2011-VP-09) is located on a utility access road immediately south of Location 72. Photograph taken facing east.

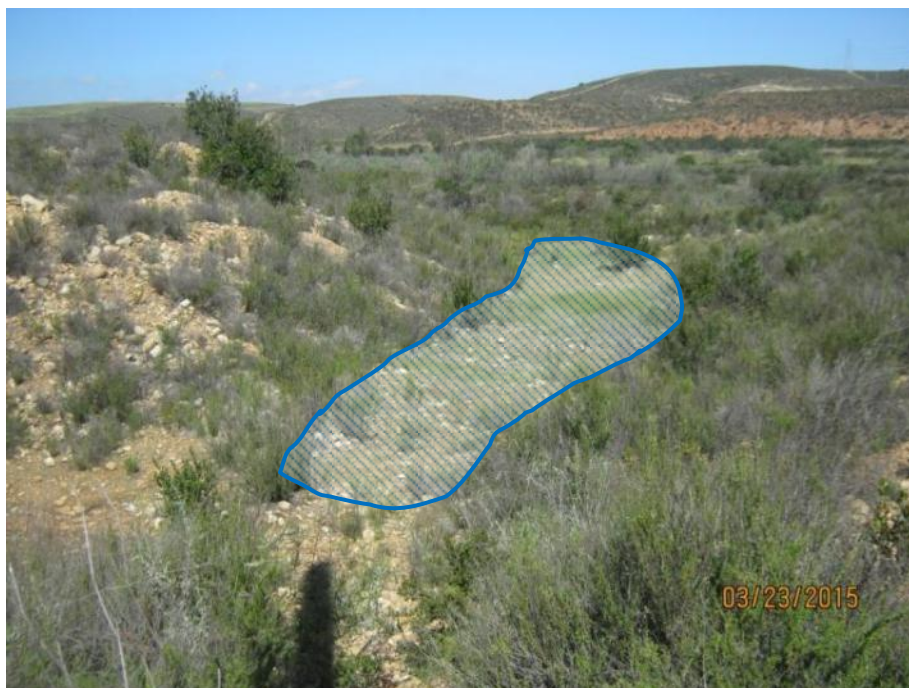
Photograph 44: Vernal pool 12 (vernal pool 2010-VP-15) is a naturally occurring vernal pool (within a vernal pool complex) located north of Location 75 and Location 0 within the Otay River floodplain. Photograph taken facing north.

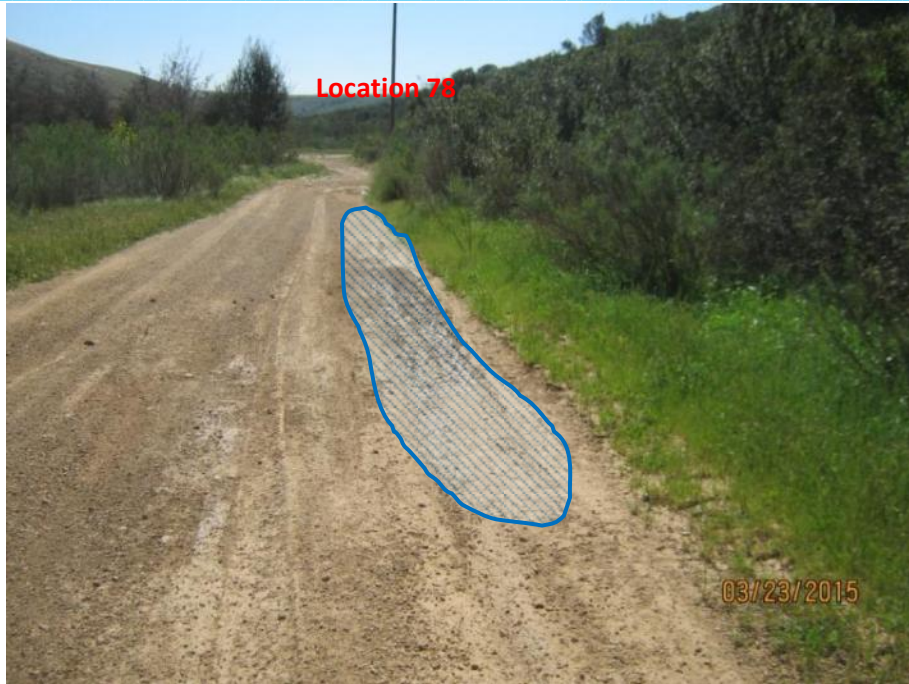
Photograph 45: Vernal pool 13 (vernal pool 2011-VP-08) is located on a utility access road approximately 200 feet west of Location 77. Photograph taken facing north.

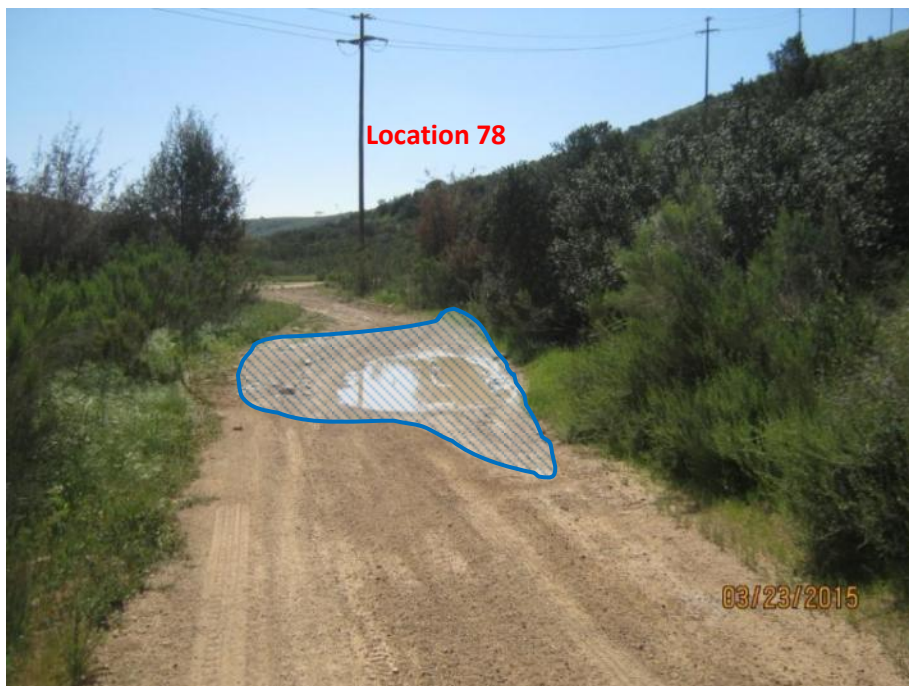
Photograph 46: Vernal pool 14 (vernal pool 2011-VP-07) is located on a utility access road approximately 210 feet southwest of Location 77. Photograph taken facing east.

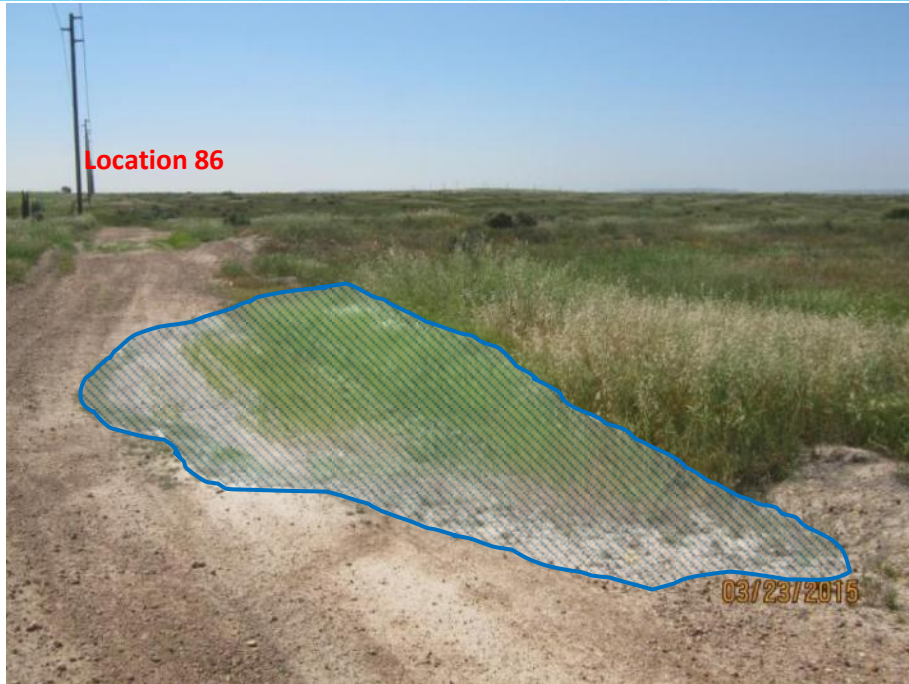
Photograph 47: Vernal pool 18 (vernal pool 2009-VP-47) is located on a utility access road approximately 15 feet south of Location 85. Photograph taken facing south.

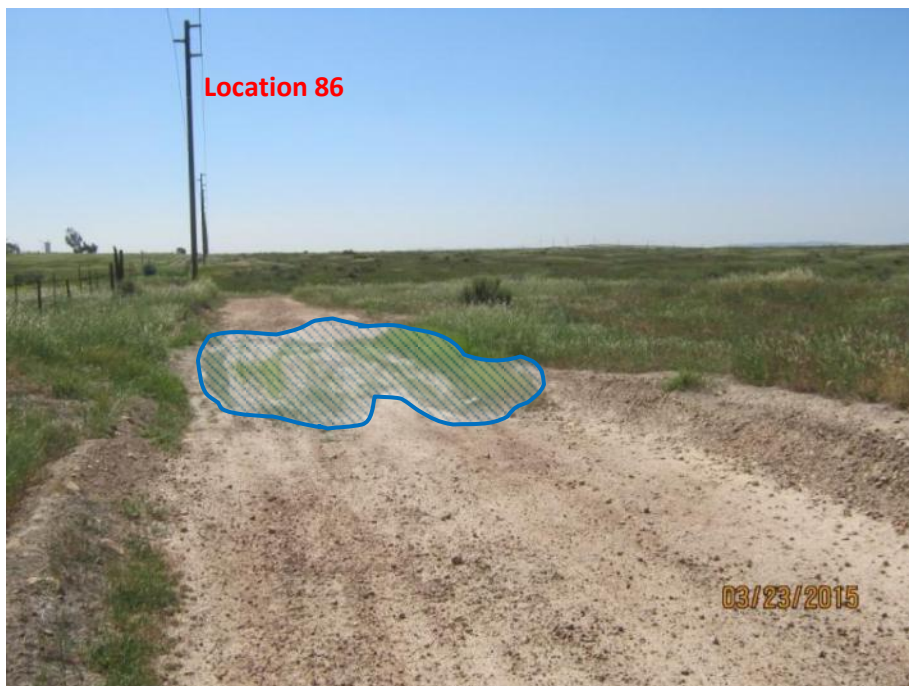
Photograph 48: Vernal pool 19 (vernal pool 2009-VP-47) is located on a utility access road approximately 100 feet south of Location 85. Photograph taken facing south.

Vernal Pool Number	Included in Baseline	AECOM Pool Number	Vegetated or Unvegetated during time of survey	Location Description	Jurisdictional Determination Reasoning	Sample Point	Map Page Number	Photograph
VP19	Yes	2009-VP-47	Vegetated	Approximately 100 feet south of Location 85	Located within an access road, previously delineated during the 2009 Vernal Pool Data Accuracy Assessment Report, located on a utility access road. This vernal pool is likely considered jurisdictional by ACOE and RWQCB. At the time of the survey, vegetation within the pool was included wooly marbles, beard grass, and Italian rye grass.	NA	19	Photograph 48
VP20	No	NA	Vegetated	Approximately 85 feet north of Location 86	Located on a utility access road. This vernal pool is likely considered jurisdictional by ACOE and RWQCB. At the time of the survey, vegetation within the pool was included wooly marbles and beardless wild rye.	SP48	19	Photograph 49

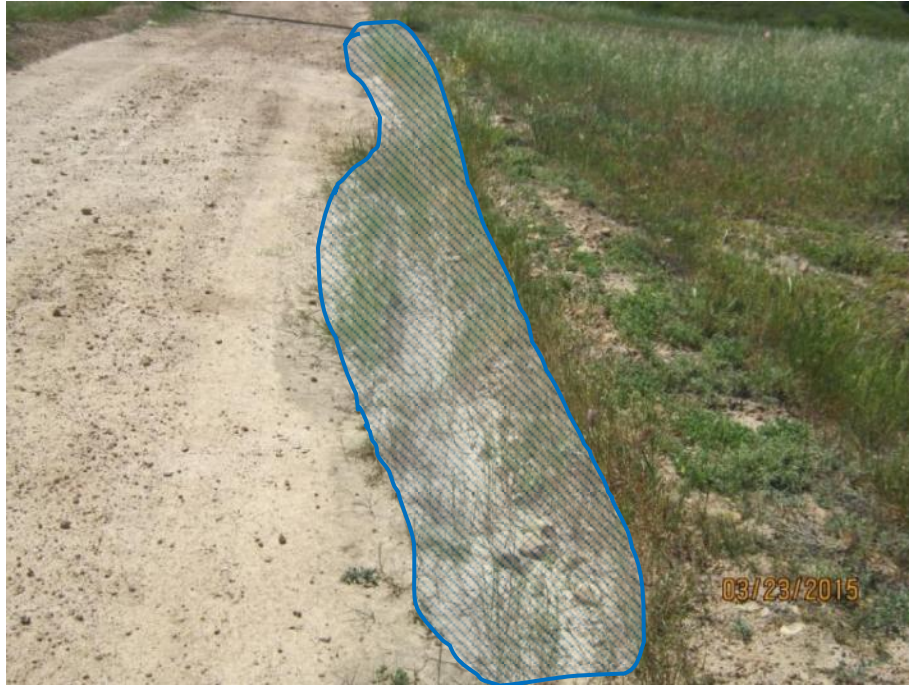
Photograph 49: Vernal pool 20 is located on a utility access road approximately 85 feet north of Location 86. Photograph taken facing south.

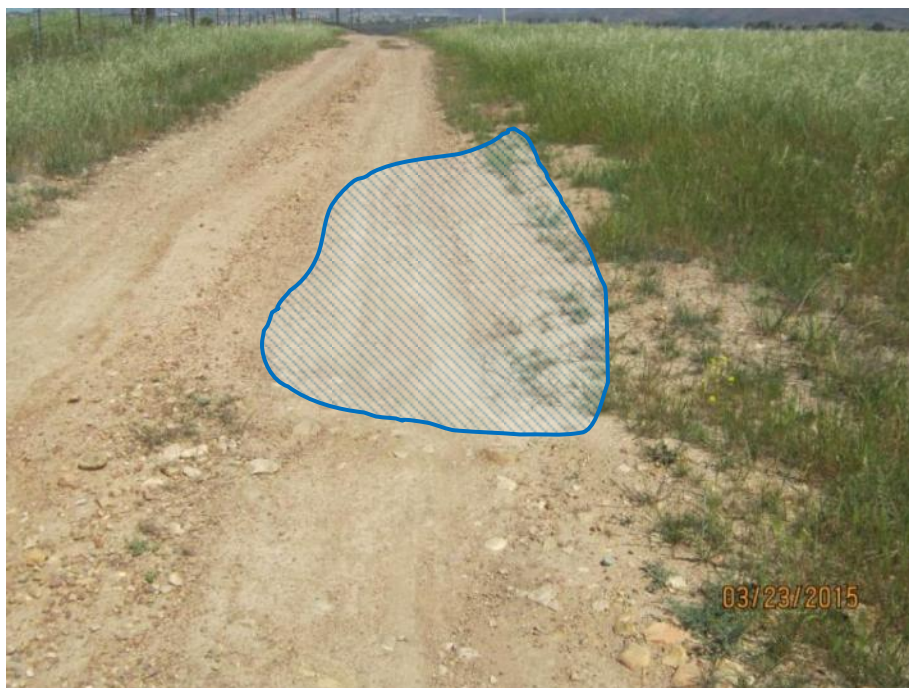
Photograph 50: Vernal pool 21 is located on the Donovan State Prison access road approximately 30 feet northeast of Location 86. Photograph taken facing south.

VP21	No	NA	Unvegetated	Approximately 30 feet northeast of Location 86	Located on a utility access road. Although vernal pool indicator species were not observed at the time of the survey, during periods of sufficient rainfall and inundation, this road rut may support the vernal pool indicator species due to proximity to adjacent vernal pools. If vernal pool indicator species are observed, this pool is may be considered jurisdictional by ACOE and RWQCB due to hydrology and connectivity with the surrounding, natural, vernal pool areas.	SP19	19	Photograph 50
VP22	Yes	2011-VP-05	Vegetated	Approximately 50 feet west of Location 87	Naturally occurring vernal pool located within the San Diego mesa claypan vernal pool complex west of location 87 and was previously delineated during the 2009 Vernal Pool Data Accuracy Assessment Report. San Diego button celery (<i>Eryngium aristulatum ssp. parishii</i> ; OBL) was observed to occur within this pool during the 2014 and 2015 survey efforts. This vernal pool is likely considered jurisdictional by ACOE and RWQCB. Note: CDFW has jurisdiction over San Diego button celery through CESA.	NA	20	Photograph 67

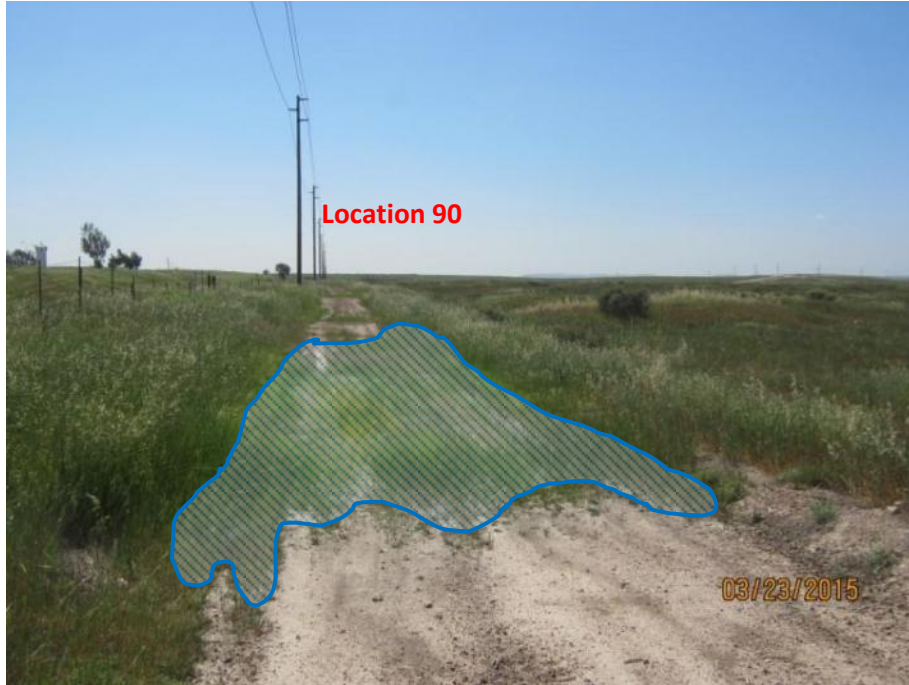
Photograph 51: Vernal pool 25 (vernal pool 2010-VP-01) is located on a utility access road approximately 10 feet south of Location 89. Photograph taken facing south.

Vernal Pool Number	Included in Baseline	AECOM Pool Number	Vegetated or Unvegetated during time of survey	Location Description	Jurisdictional Determination Reasoning	Sample Point	Map Page Number	Photograph
VP24	Yes	2009-VP-41	Vegetated	Approximately 45 feet west of Location 89	Naturally occurring vernal pool located within the San Diego mesa claypan vernal pool complex west of location 89 and was previously delineated during the 2009 Vernal Pool Data Accuracy Assessment Report. This vernal pool is likely considered jurisdictional by ACOE and RWQCB.	NA	20	Photograph 67
VP25	Yes	2010-VP-01	Vegetated	Approximately 10 feet south of Location 89	Located within an access road, previously delineated during the 2009 Vernal Pool Data Accuracy Assessment Report, located on a utility access road. This vernal pool is likely considered jurisdictional by ACOE and RWQCB. At the time of the survey, vegetation within the pool was included toad rush (<i>Juncus bufonius</i> , FACW), wooly marbles, beard grass, and Italian rye grass.	SP21	20	Photograph 51

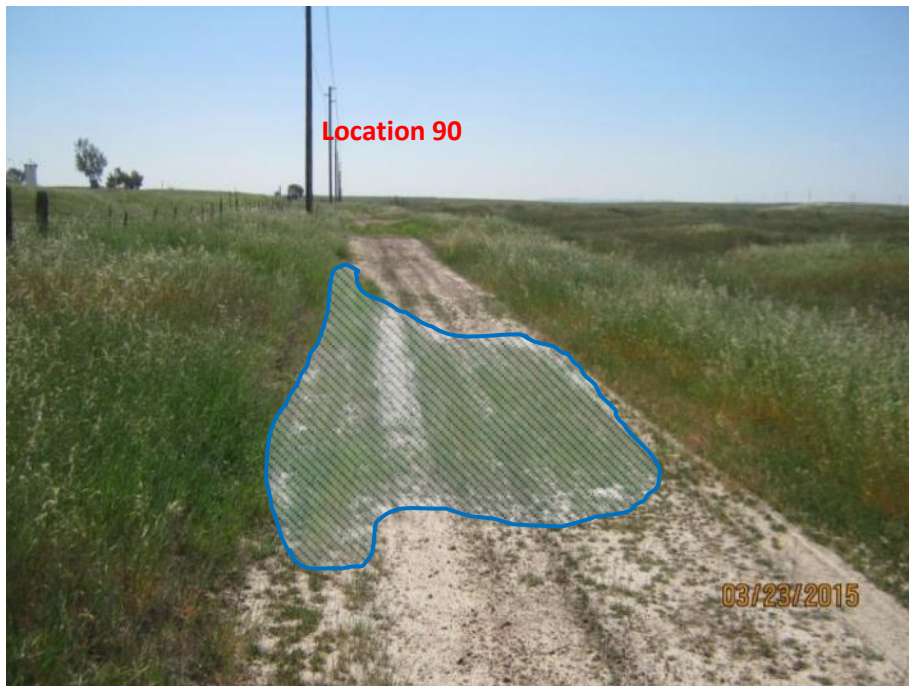
Photograph 52: Vernal pool 26 is located on a utility access road approximately 120 feet north of Location 90. Photograph taken facing south.

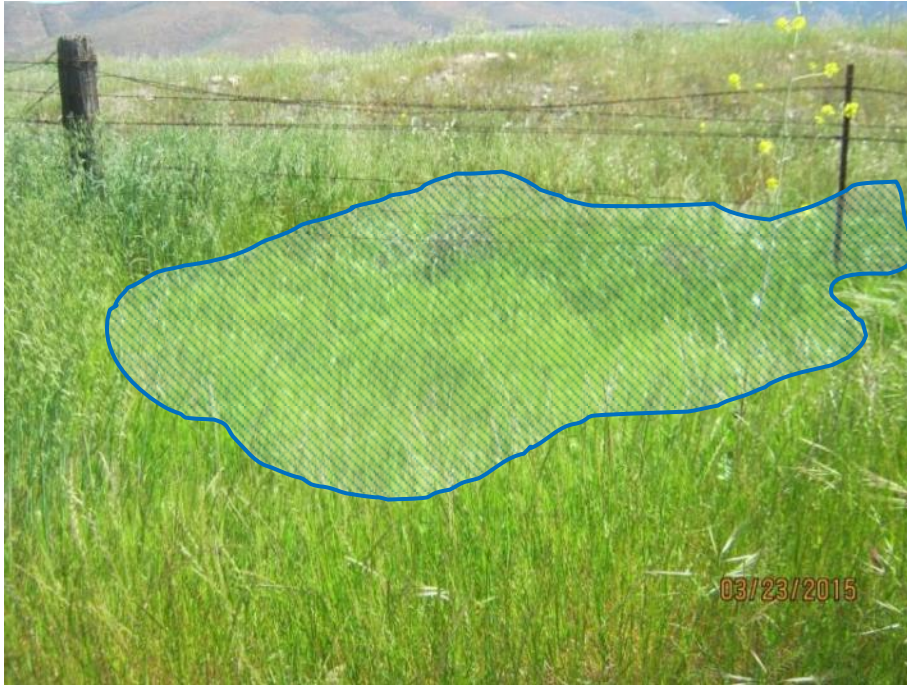
Photograph 53: Vernal pool 27 (vernal pool 2011-VP-06) is a vegetated depression located 110 feet north of Location 90.

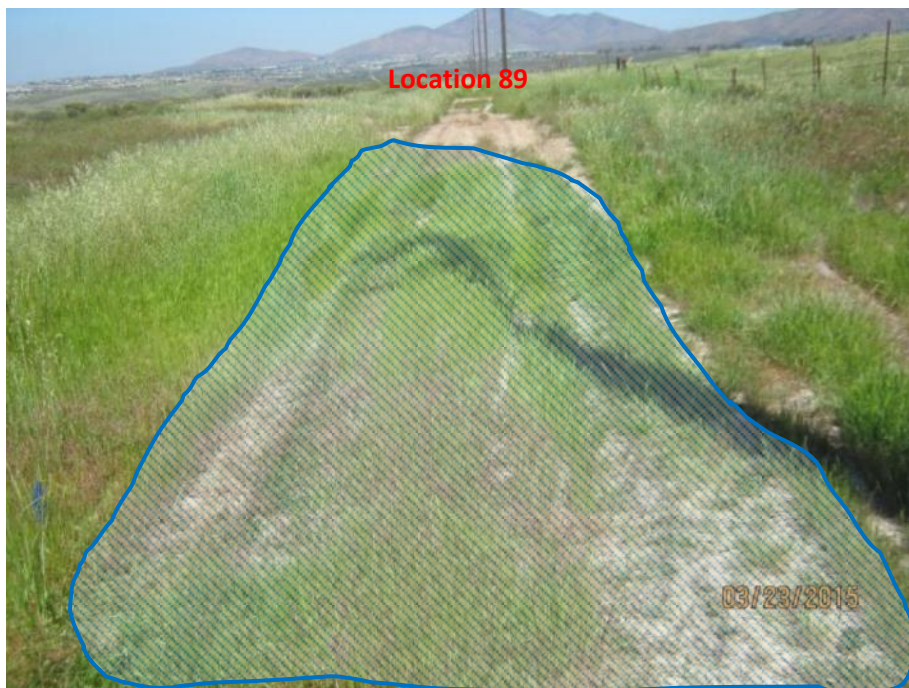
Photograph 54: Vernal pool 28 (vernal pool 2010-VP-19 and 2011-VP-01) is located on a utility access road approximately 115 feet north of Location 90. Photograph taken facing north.

VP26	No	NA	Vegetated	Approximately 120 feet north of Location 90	Located on a utility access road. This vernal pool is likely considered jurisdictional by ACOE and RWQCB. At the time of the survey, vegetation within the pool included, Mediterranean barley (<i>Hordeum marinum</i> , FAC), wooly marbles, beard grass, Italian rye grass, Australian saltbush (<i>Atriplex semibaccata</i> , FAC).	SP22	20	Photograph 52
VP27	Yes	2011-VP-06	Vegetated	Approximately 110 feet north of Location 90	Disturbed vernal pool located immediately west of the existing utility road shoulder and east of the Donovan State Prison road within a depression. This pool was previously delineated during the 2009 Vernal Pool Data Accuracy Assessment Report. This vernal pool is likely considered jurisdictional by ACOE and RWQCB.	NA	20	Photograph 53
VP28	Yes	2011-VP-06	Vegetated	Approximately 115 feet north of Location 90	Located within an access road, previously delineated during the 2009 Vernal Pool Data Accuracy Assessment Report, located on a utility access road. This vernal pool is likely considered jurisdictional by ACOE and RWQCB. At the time of the survey, vegetation within the pool was included toad rush, Mediterranean barley, wooly marbles, beard grass, and Italian rye grass.	SP23	20	Photograph 54

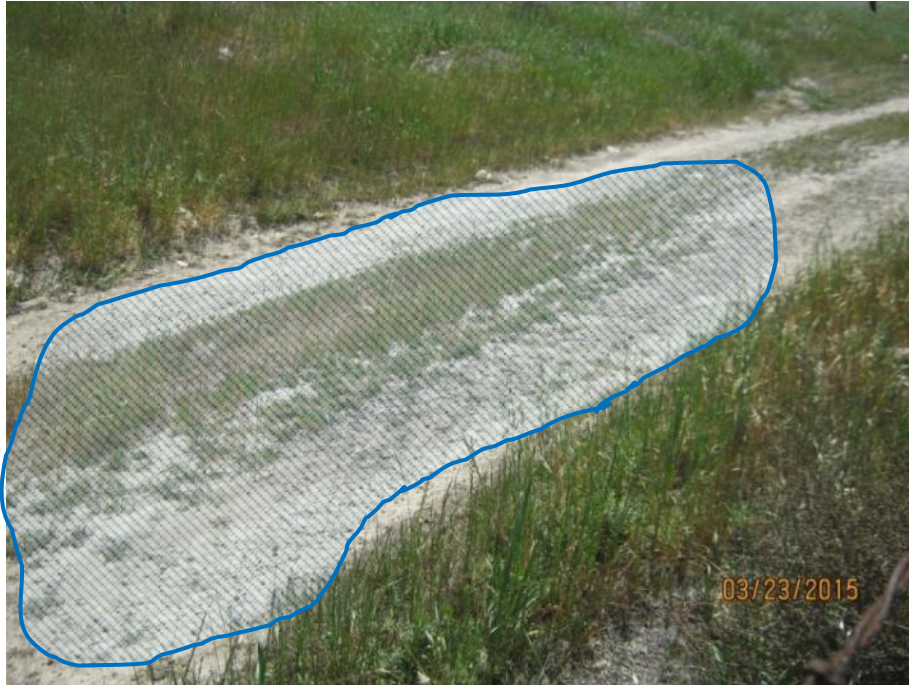
Photograph 55: Vernal pool 29 is located on Donovan State Prison access road approximately 20 feet southeast of Location 90. Photograph taken facing southeast.

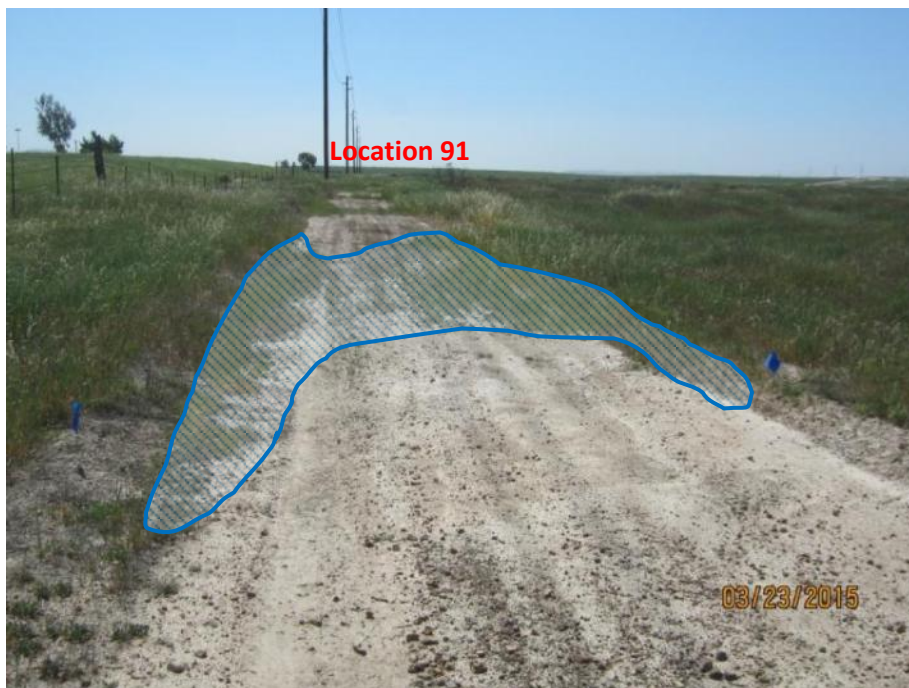
Photograph 56: Vernal pool 30 is located on a utility access road approximately 25 feet southwest of Location 90. Photograph taken facing south.

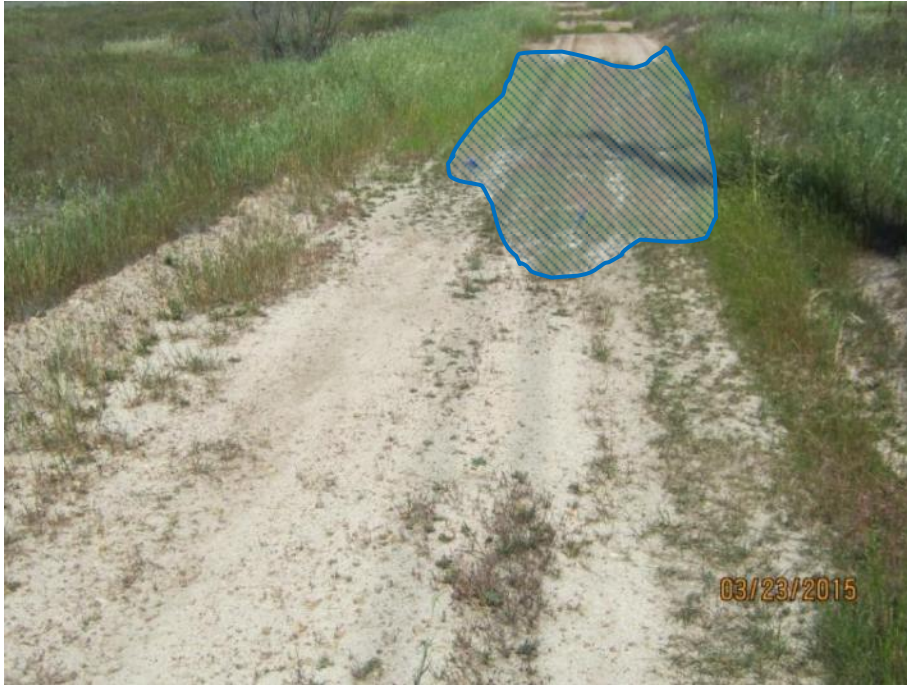
Photograph 57: Vernal pool 31 is located within an access road approximately 10 feet north of Location 91. Photograph taken facing south.

Vernal Pool Number	Included in Baseline	AECOM Pool Number	Vegetated or Unvegetated during time of survey	Location Description	Jurisdictional Determination Reasoning	Sample Point	Map Page Number	Photograph
VP29	No	NA	Vegetated	Approximately 20 feet southeast of Location 90	R Located on Donovan State Prison access road. This vernal pool is likely considered jurisdictional by ACOE and RWQCB. At the time of the survey, vegetation within the pool included, Mediterranean barley, wooly marbles, Italian rye grass, and wild oat.	SP24	20	Photograph 55
VP30	No	NA	Vegetated	Approximately 25 feet southwest of Location 90	Located on a utility access road. This vernal pool is likely considered jurisdictional by ACOE and RWQCB. At the time of the survey, vegetation within the pool included wooly marbles.	NA	20	Photograph 56
VP31	No	NA	Vegetated	Approximately 10 feet north of Location 91	Located within an access road, dominated by Italian ryegrass, woolly marbles, Mediterranean barley, and Australian saltbush in a dirt access road. This vernal pool is likely considered jurisdictional by ACOE and RWQCB.	SP25	21	Photograph 57

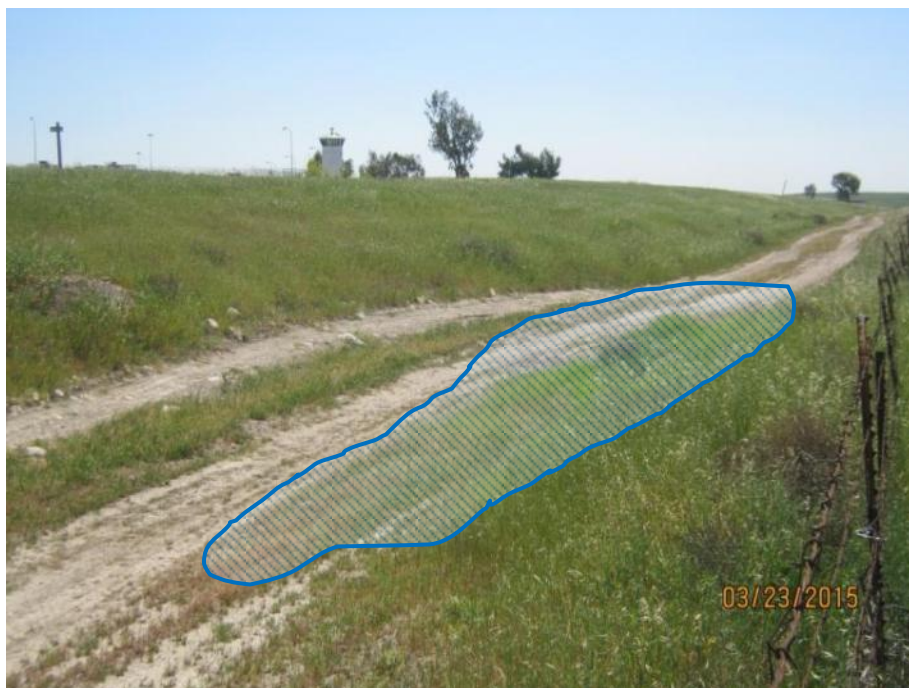
Photograph 58: Vernal pool 32 is located on Donovan State Prison access road approximately 15 feet southeast of Location 91. Photograph taken facing south.

VP32	No	NA	Vegetated	Approximately 15 feet southeast of Location 90	Located on Donovan State Prison access road. This vernal pool is likely considered jurisdictional by ACOE and RWQCB. At the time of the survey, vegetation within the pool included beard grass and Italian rye grass.	SP26	21	Photograph 58
VP33	No	NA	Vegetated	Approximately 40 feet south of Location 91	Located on access road, previously delineated during the 2009 Vernal Pool Data Accuracy Assessment Report, located on a utility access road. This vernal pool is likely considered jurisdictional by ACOE and RWQCB. At the time of the survey, vegetation within the pool was included toad rush Mediterranean barley, wooly marbles, and Italian rye grass.	SP27	21	Photograph 59
VP34	Yes	2011-VP-04 and 2009-VP-43	Vegetated	Approximately 65 feet north of Location 92	Located on access road, previously delineated during the 2009 Vernal Pool Data Accuracy Assessment Report, located on a utility access road. The 2011 mapped limits of the pool extend beyond the east road shoulder to a low lying depression located between the existing utility access road and the Donovan State Prison Access road. This vernal pool is likely considered jurisdictional by ACOE and RWQCB. At the time of the survey, vegetation within the pool was included toad rush Mediterranean barley, grass poly, toad rush, and Italian rye grass.	SP28	21	Photograph 60

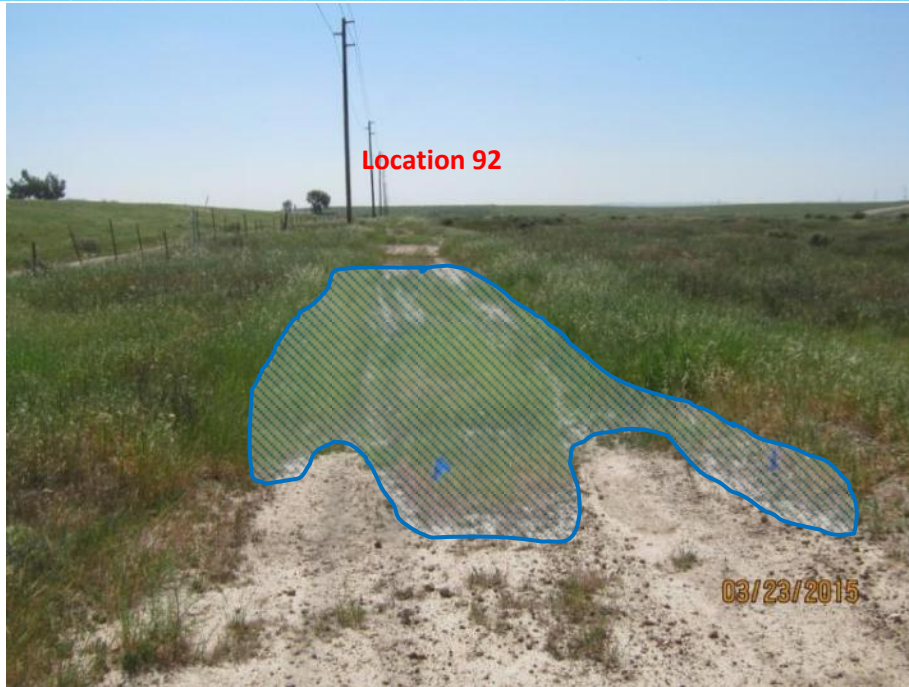
Photograph 59: Vernal pool 33 (vernal pool 2009-VP-42) is located on a utility access road approximately 40 feet south of Location 91. Photograph taken facing south.

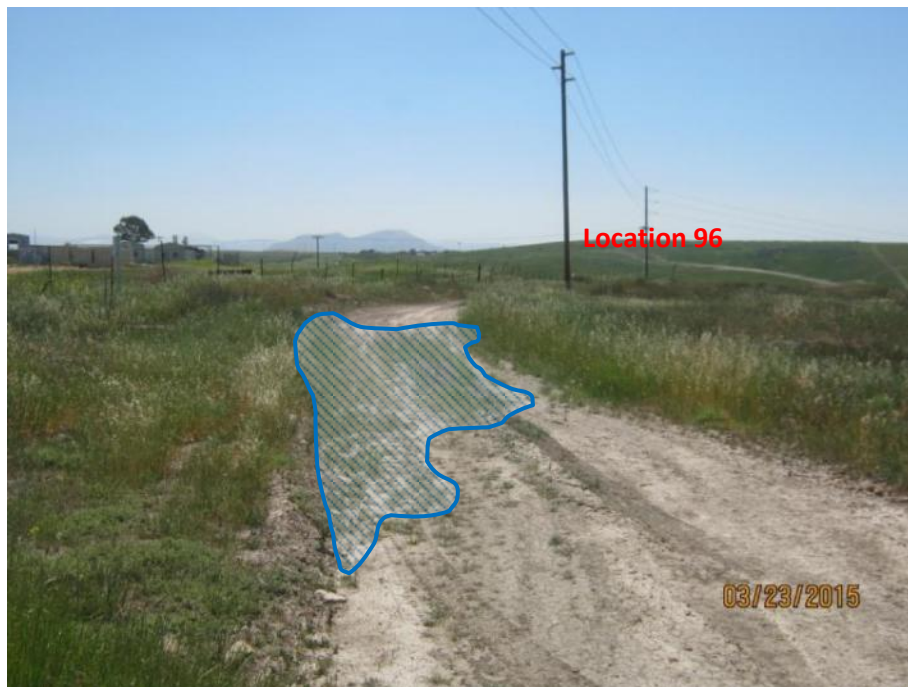
Photograph 66: Vernal pool 51 is located on a utility access road approximately 75 feet south of Location 95. Photograph taken facing south.

VP50	No	NA	Vegetated	Approximately 40 feet east of Location 95	Located on Donovan State Prison access road. At the time of the survey, vegetation within the pool included sea spurreys and cow thistle (<i>Sonchus oleraceous</i> , UPL); however, this pool exhibits hydrological connectivity to adjacent vernal pools 48 and 50, as well as the natural San Diego mesa claypan vernal pool habitat to the west. Vernal pool indicator species were not observed to occur at the time of the survey. During periods of sufficient rainfall and inundation, this road rut may support the vernal pool indicator species due to proximity to adjacent vernal pools. If vernal pool indicator species are observed, this pool may be considered jurisdictional by ACOE and RWQCB due to hydrology and connectivity with the surrounding, natural, vernal pool areas.	SP39	22	Photograph 65
VP51	No	NA	Vegetated	Approximately 75 feet south of Location 95	Located on a utility access road. This vernal pool is likely considered jurisdictional by ACOE and RWQCB. At the time of the survey, vegetation within the pool included wooly marbles and beard grass.	SP40	22	Photograph 66
