Jurisdictional Delineation Report for Tie-Line 649 Wood-to-Steel Pole Replacement Project

Prepared by:
San Diego Gas & Electric (SDG&E)
8315 Century Park Court, CP21E
San Diego, CA 92123
Contact: Ms. Tamara Spear

April 28, 2015

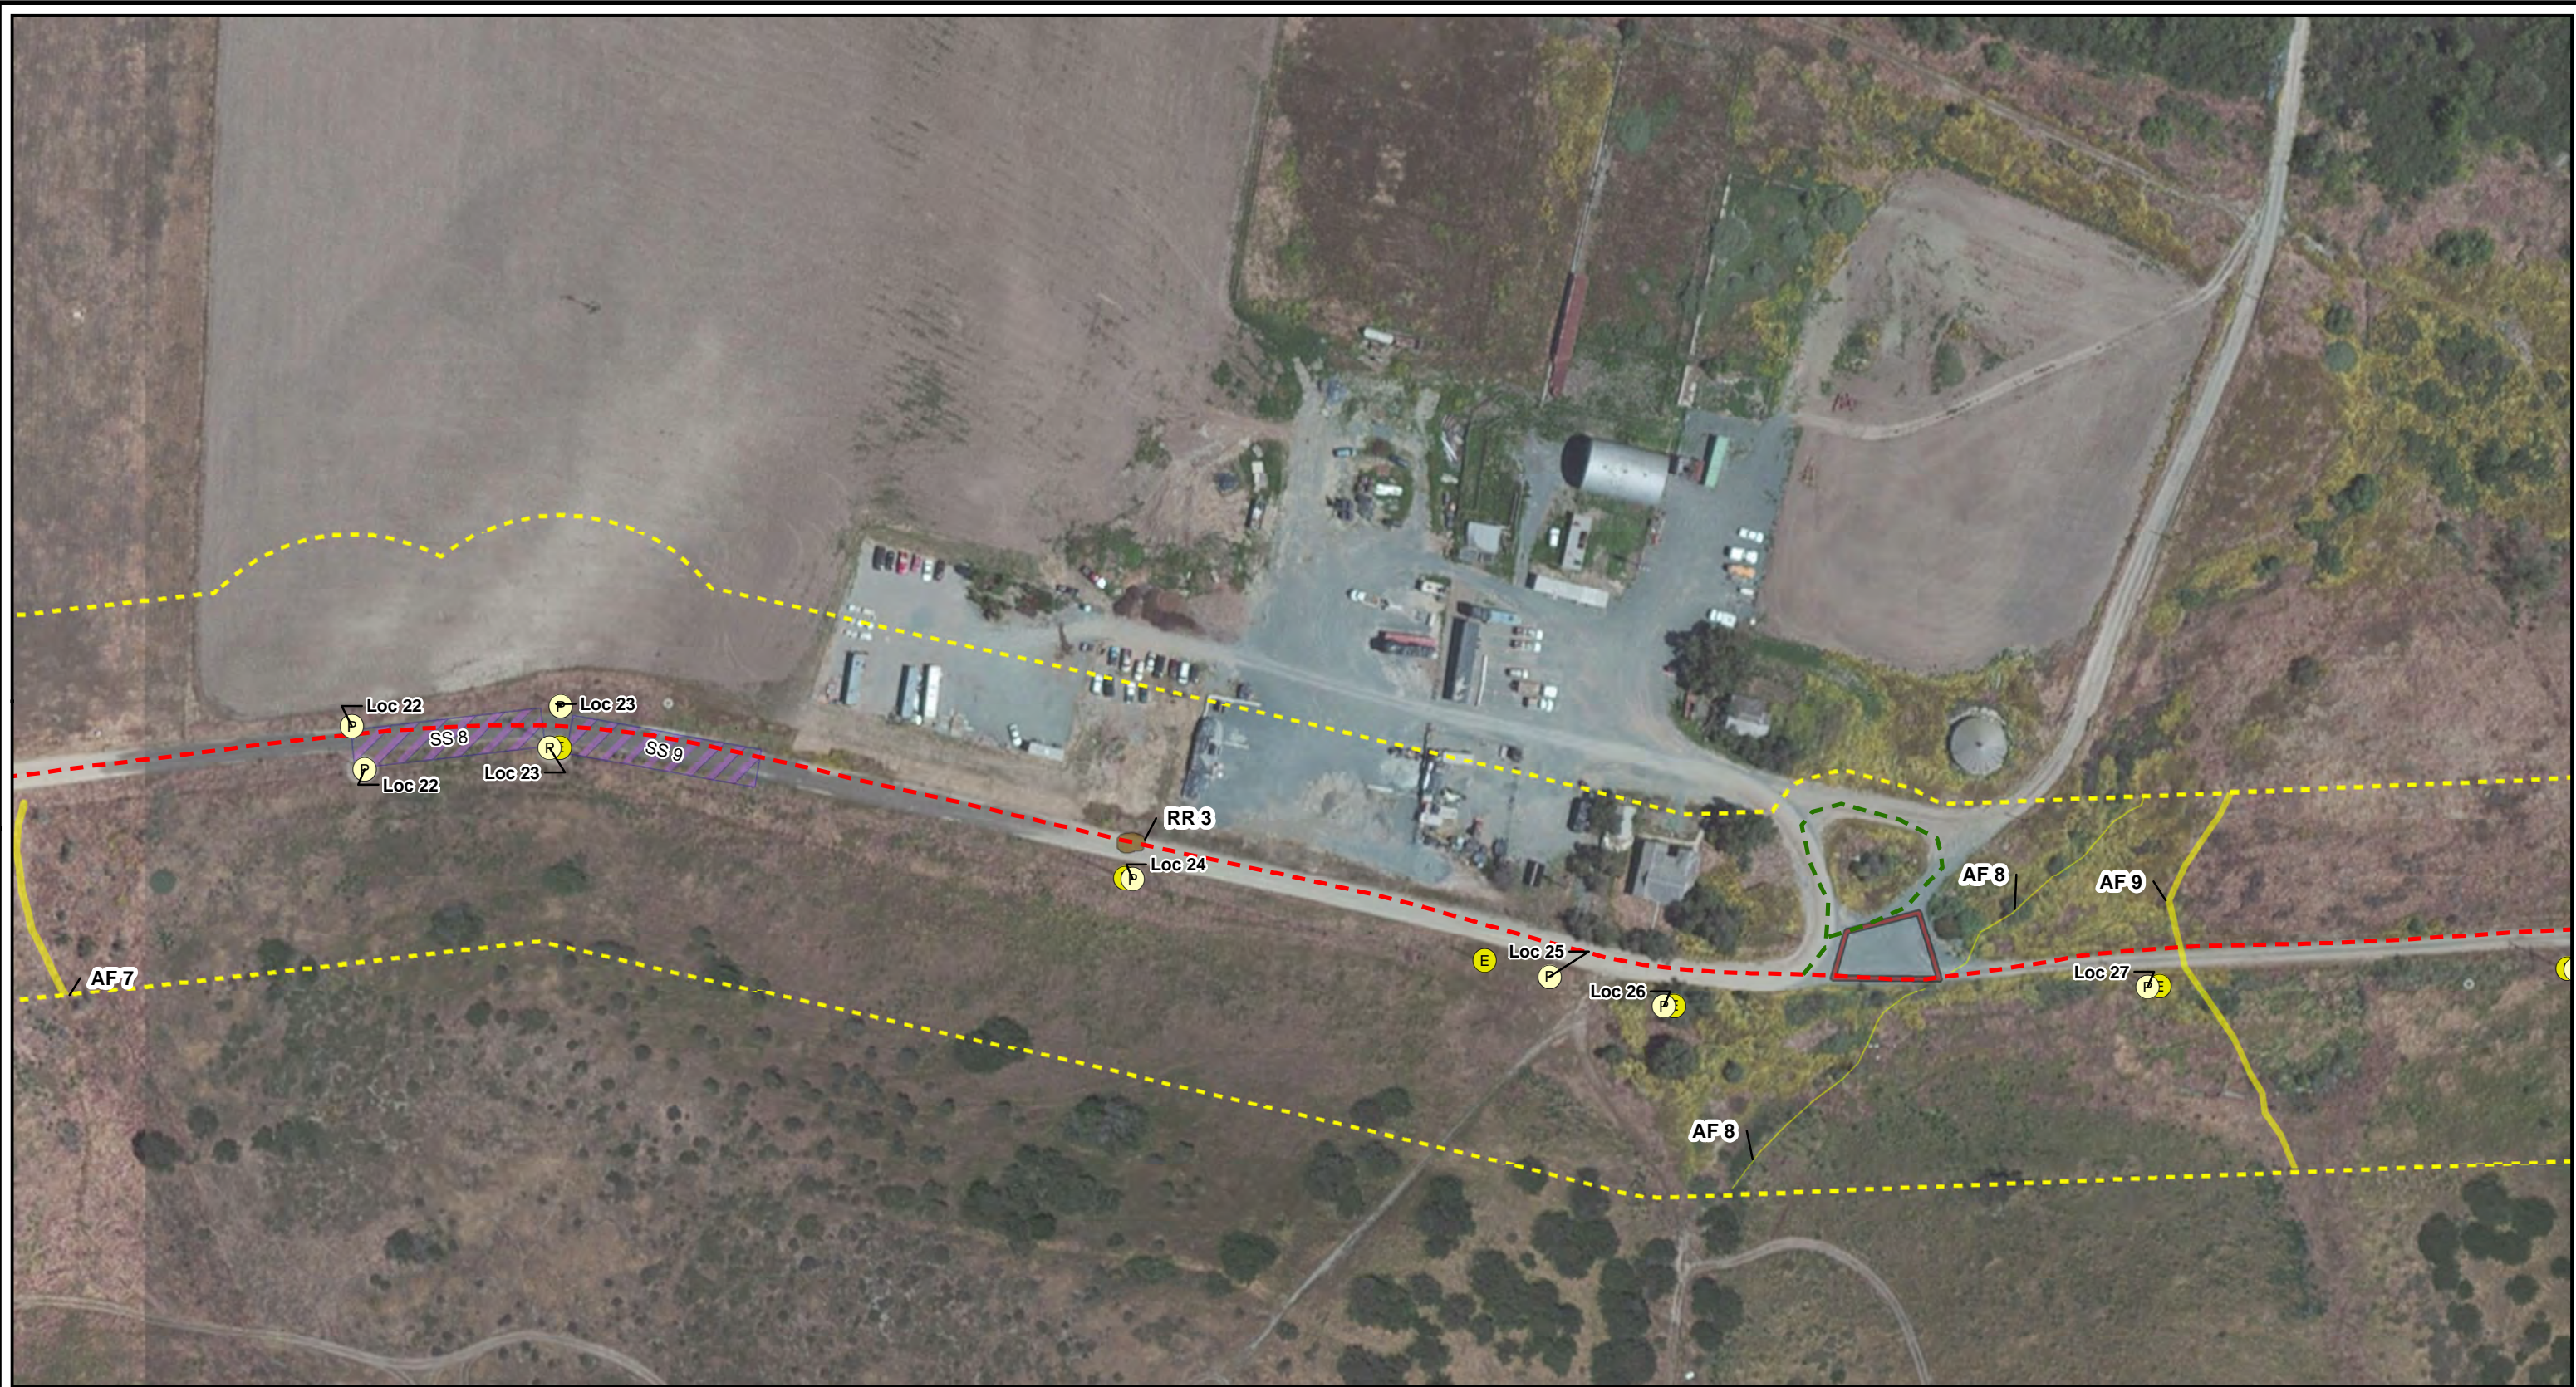
Figure 5
Jurisdictional Resources
TL-649 Wood-to-Steel Project

- Legend**
- Project Pole
 - Existing Pole
 - Existing Non-TCM Access Road
 - Access Road
 - String Site
 - Turnaround Area
 - Survey Corridor
 - Non-jurisdictional Road Rut [Bare Ground]
 - Non-jurisdictional Swale

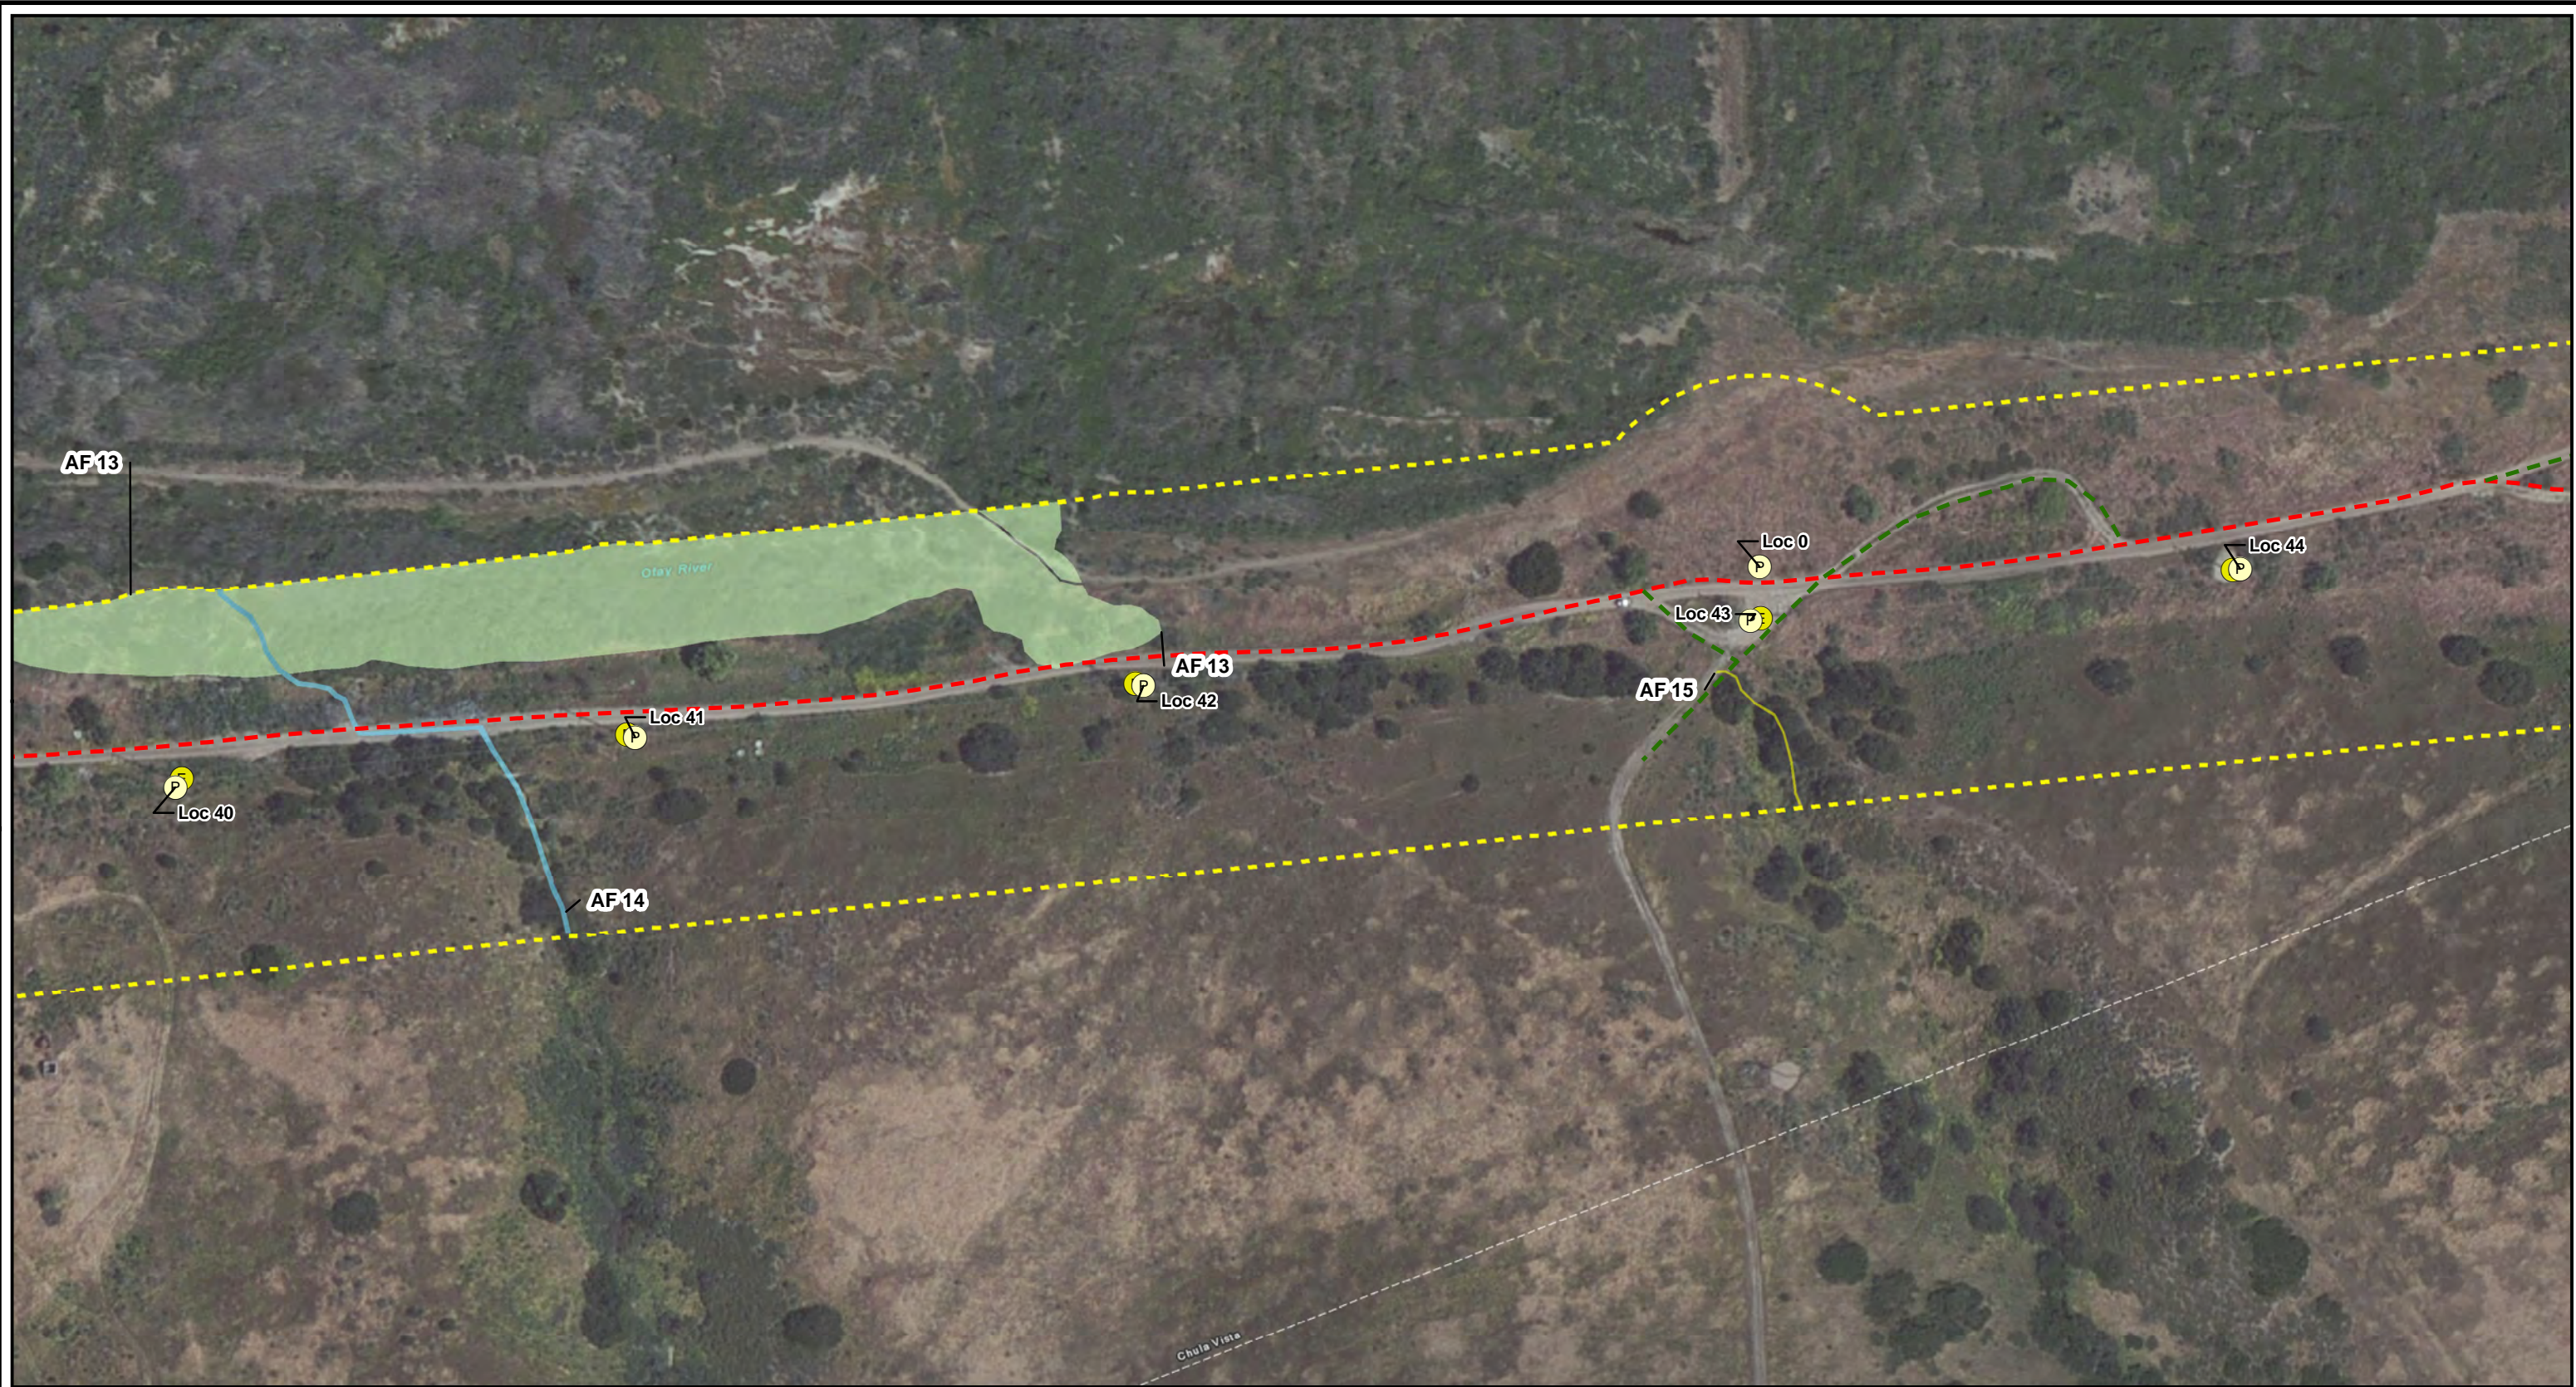
Figure 5
Jurisdictional Resources
TL-649 Wood-to-Steel Project

- Legend**
- (P) Project Pole
 - (E) Existing Pole
 - Existing Non-TCM Access Road
 - - - Access Road
 - - - Survey Corridor
 - ACOE Wetland Waters, CDFW Riparian, RWQCB Waters of the State [Riparian Scrub]
 - Non-jurisdictional Swale
 - ACOE Non-wetland Waters, CDFW Streambed, RWQCB Waters of the State

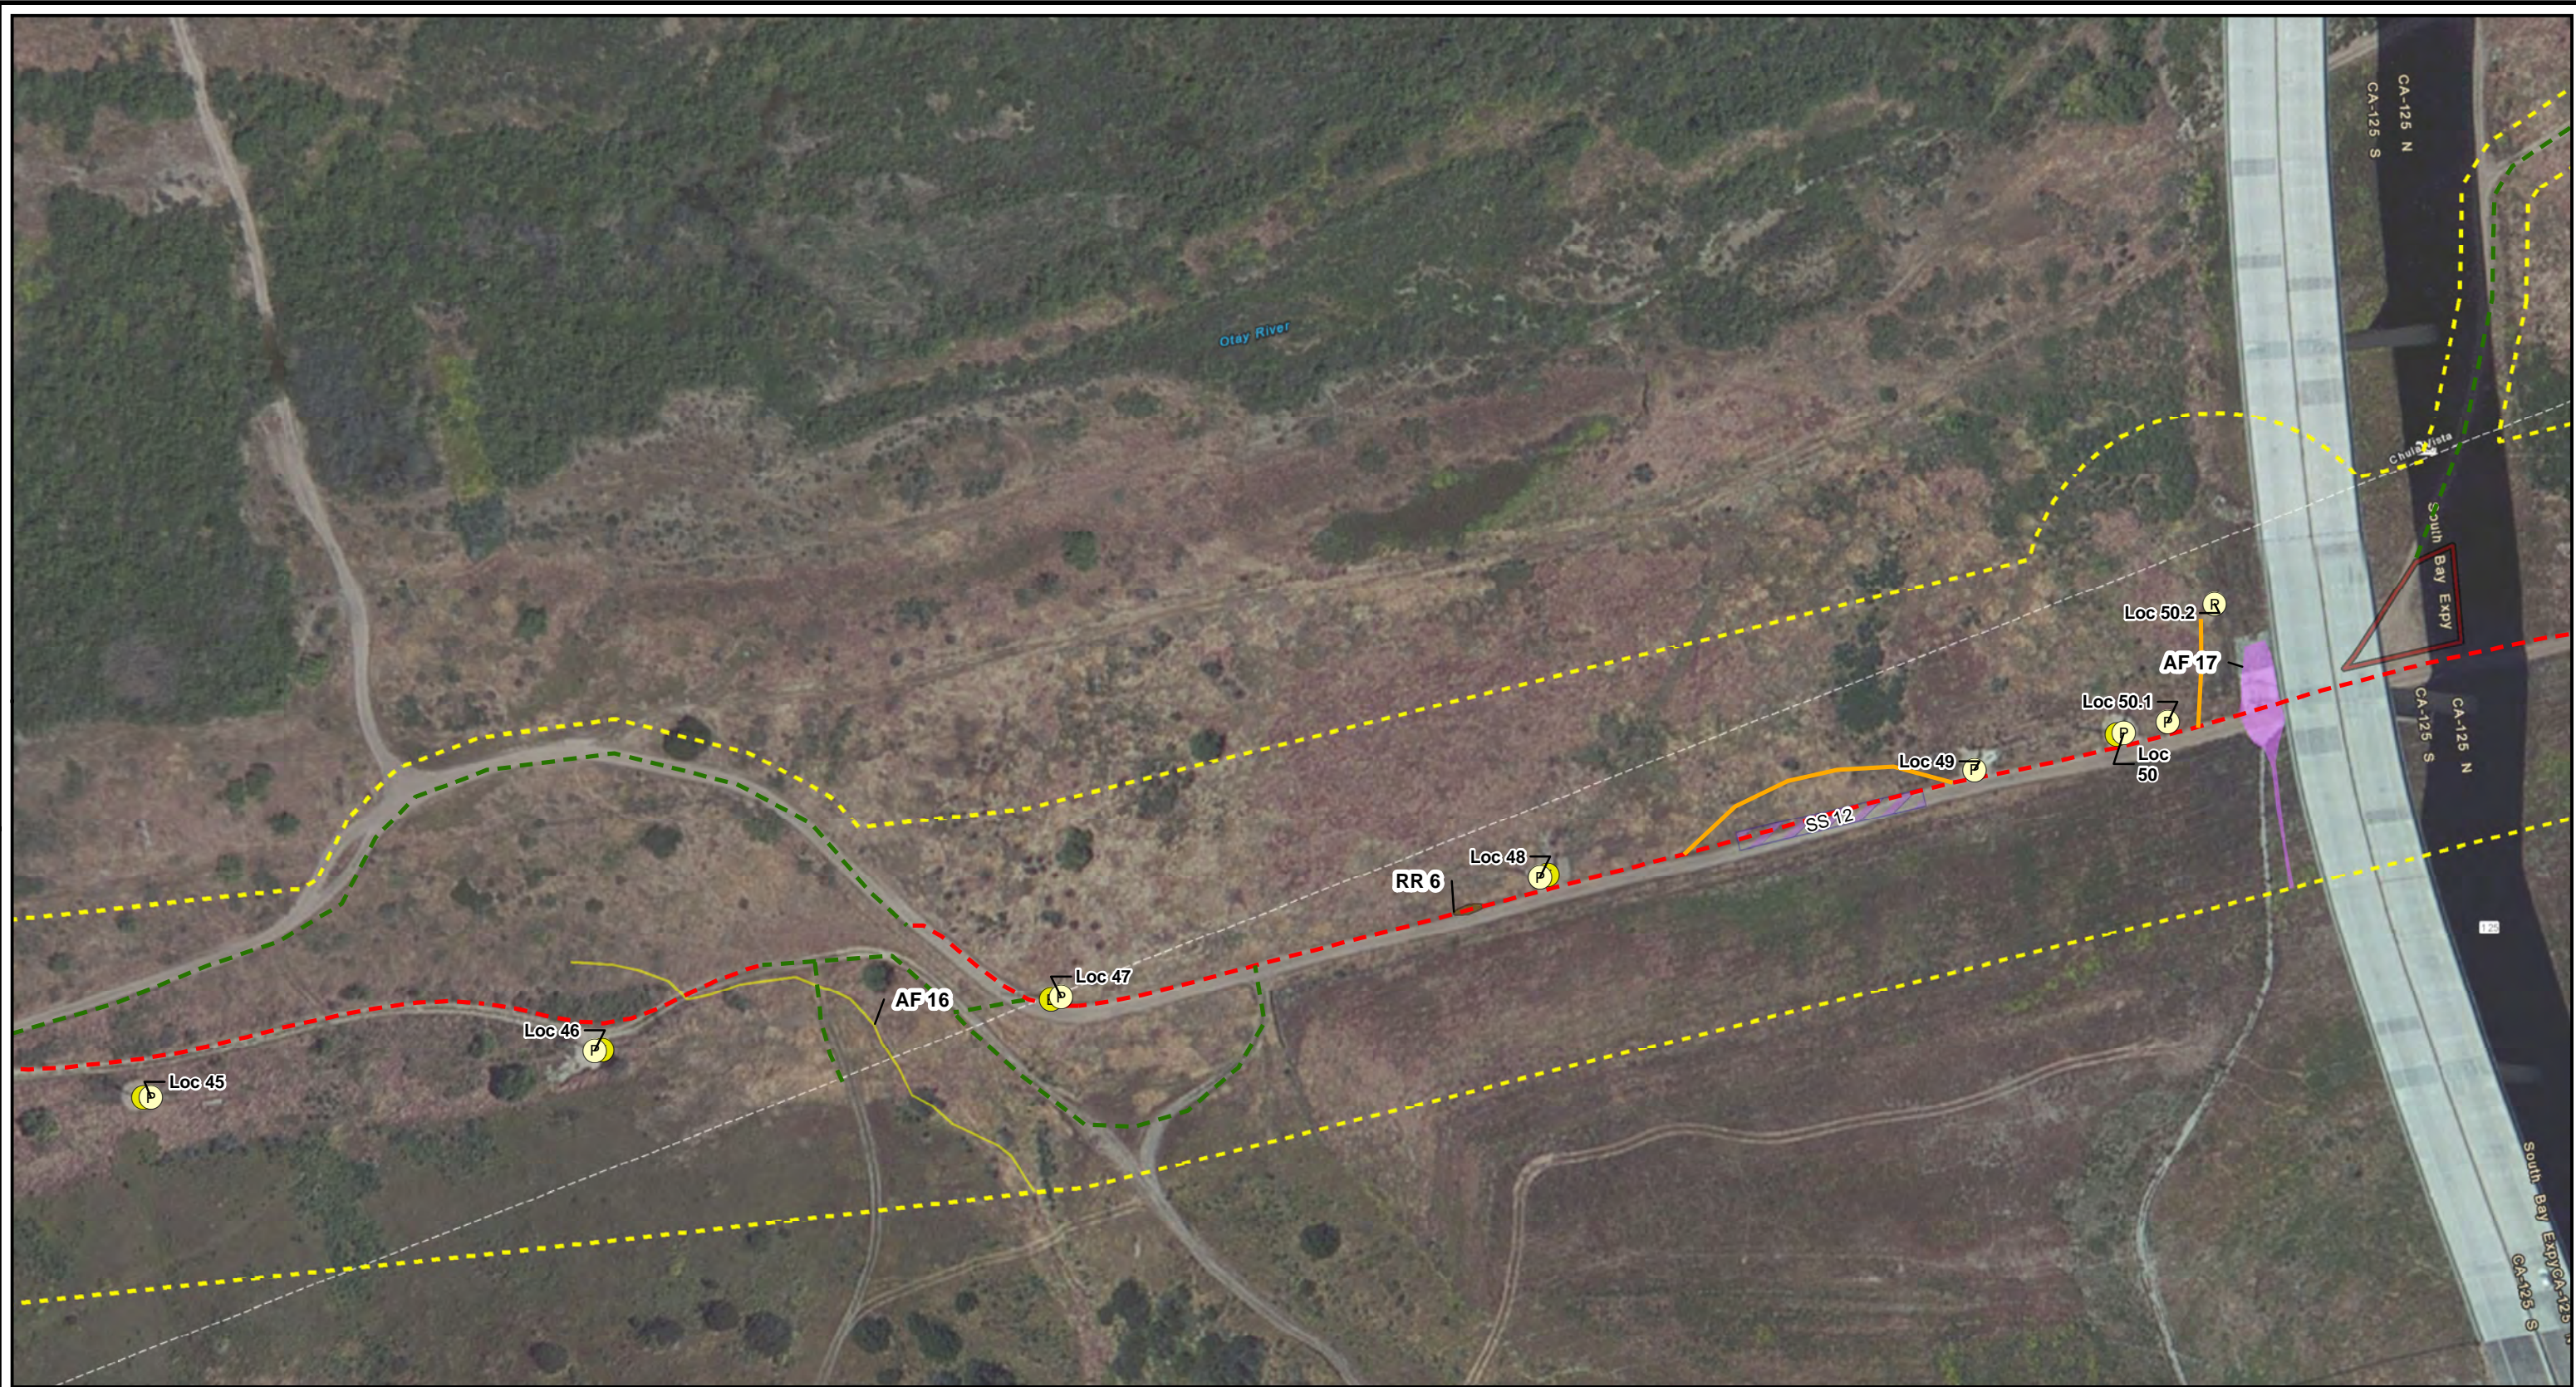
Figure 5
Jurisdictional Resources
TL-649 Wood-to-Steel Project

- Legend**
- Project Pole
 - Existing Pole
 - Existing Non-TCM Access Road
 - Access Road
 - Overland Travel
 - ▨ String Site
 - ▨ Turnaround Area
 - Survey Corridor
 - ▨ Non-jurisdictional Brow Ditch and Dissapator [Bare Ground]
 - ▨ Non-jurisdictional Road Rut [Bare Ground]
 - Non-jurisdictional Swale

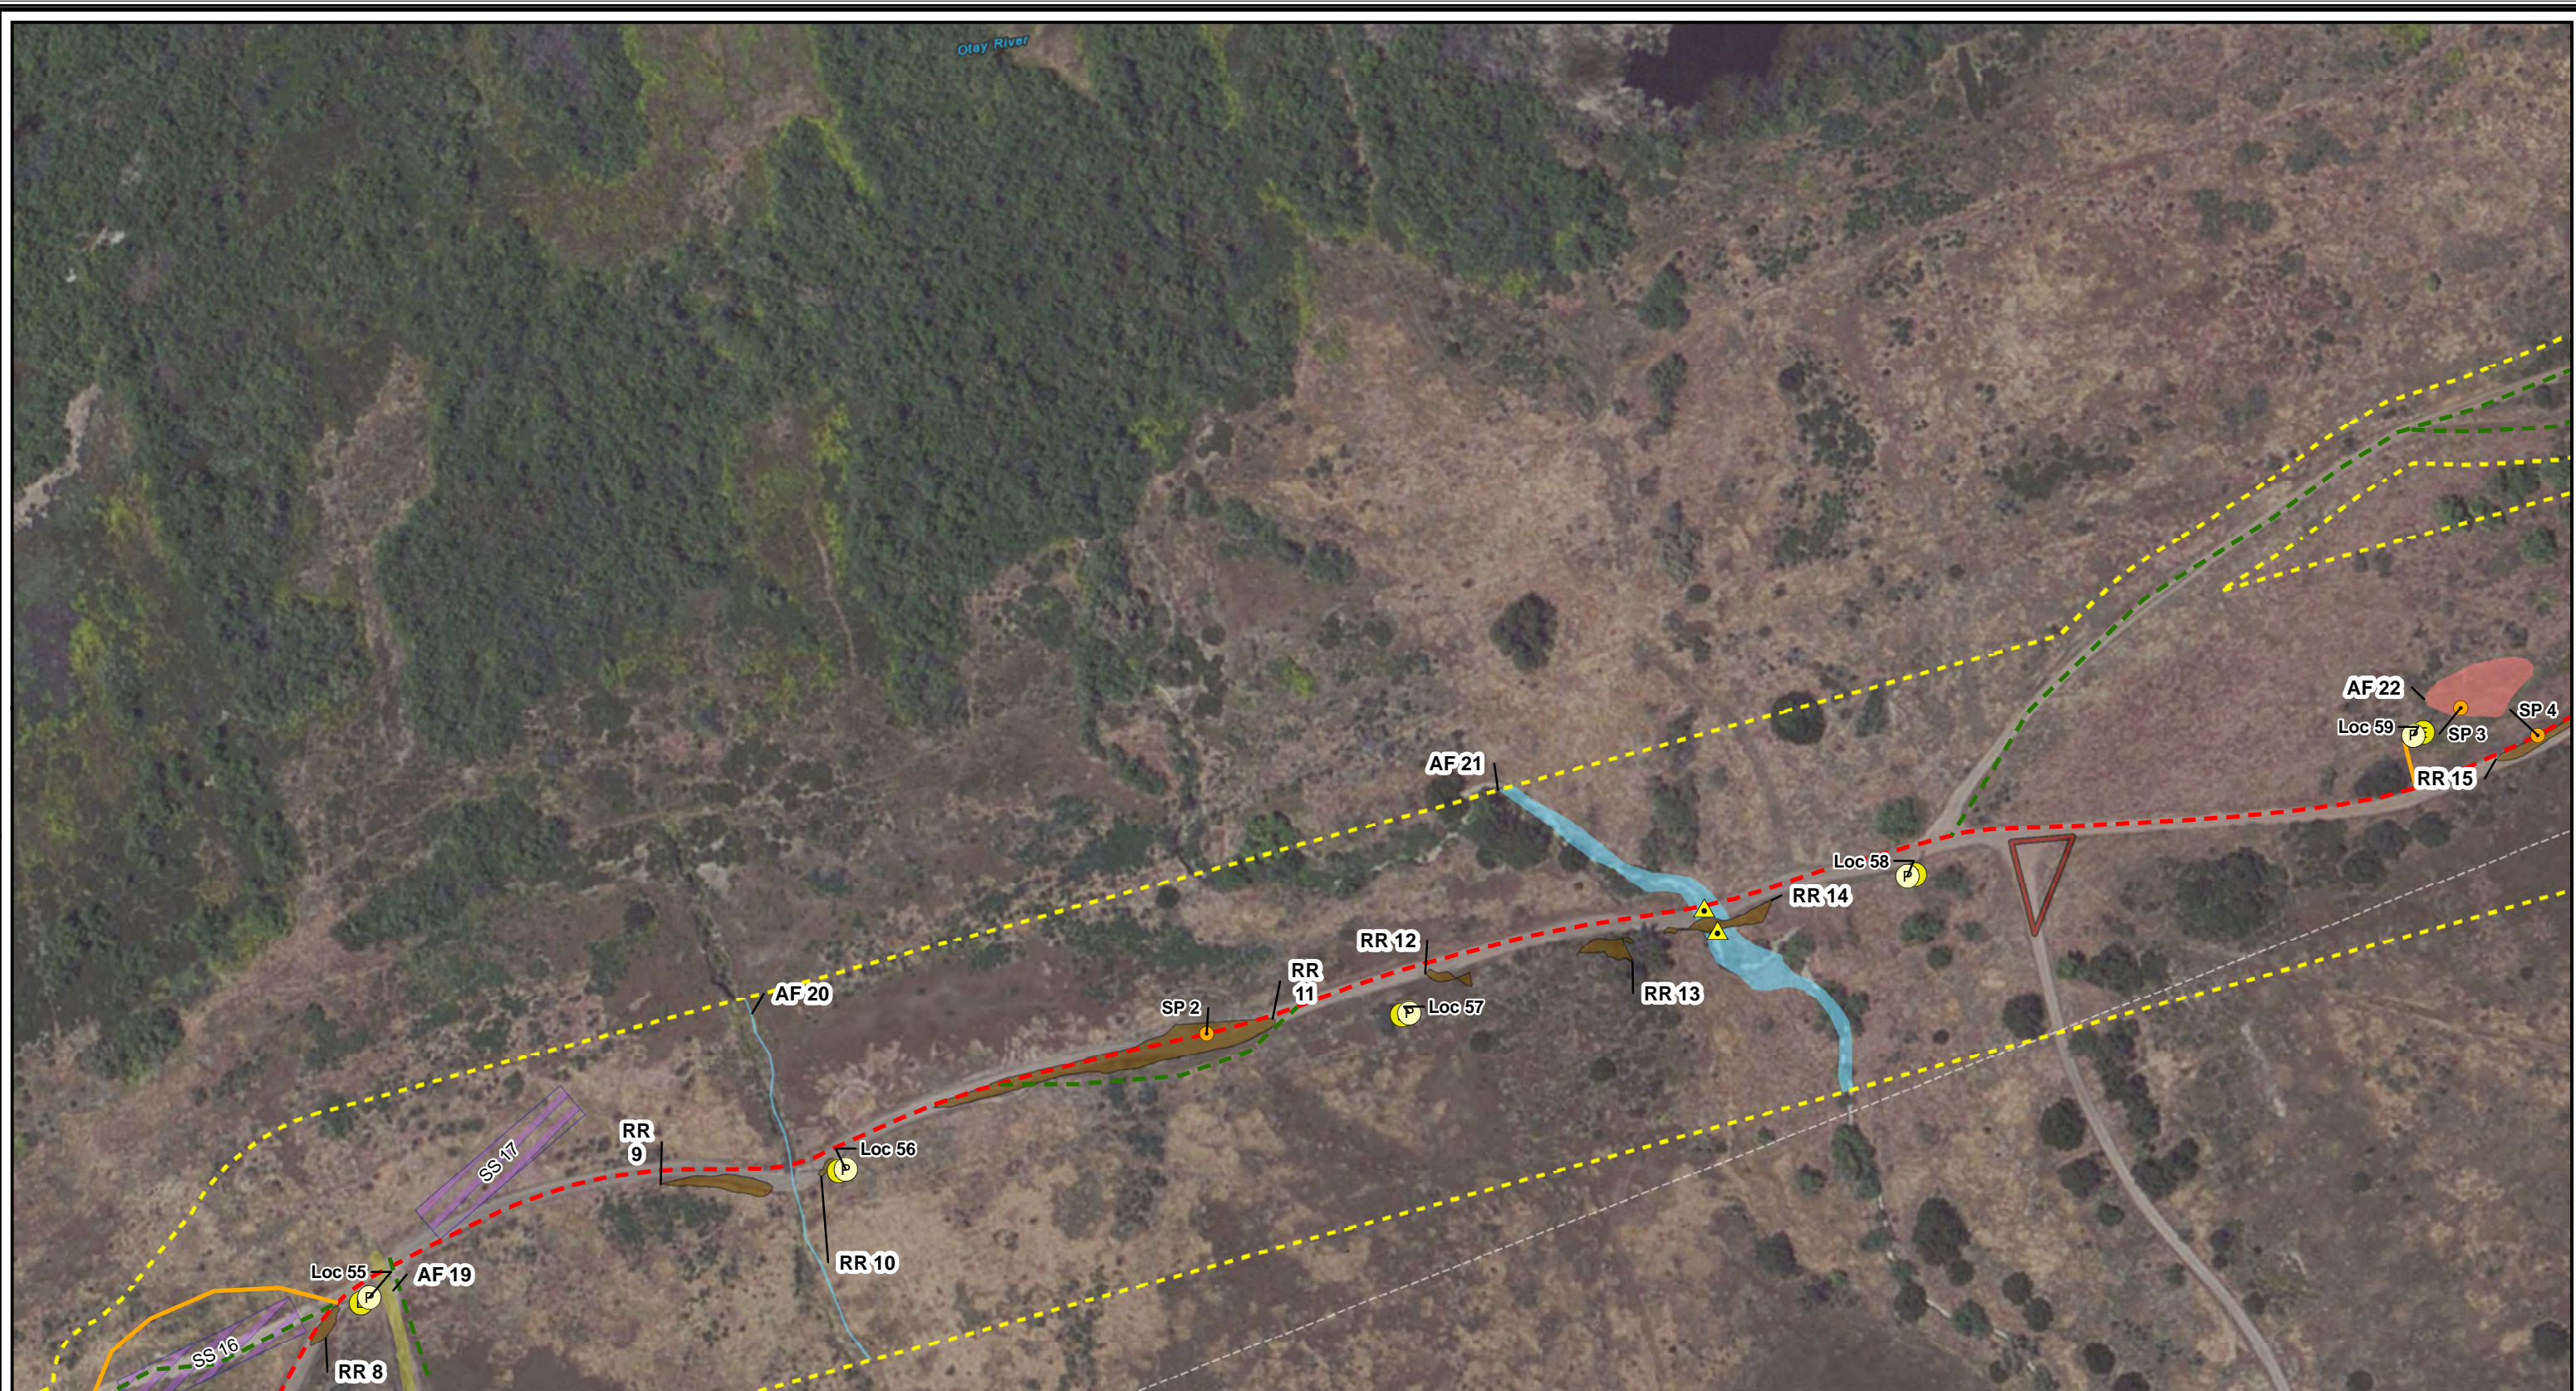
Figure 5
Jurisdictional Resources
TL-649 Wood-to-Steel Project

- Legend**
- P Project Pole
 - E Existing Pole
 - Existing Non-TCM Access Road
 - Access Road
 - Overland Travel
 - ▭ String Site
 - ▭ Turnaround Area
 - Survey Corridor
 - ▲ Culvert
 - Soil Pit
 - ▭ ACOE Non-wetland Waters, CDFW Streambed, RWQCB Waters of the State
 - ▭ ACOE Wetland Waters, RWQCB Waters of the State [Emergent Wetland]
 - ▭ Non-jurisdictional Road Rut [Bare Ground]
 - ▭ Non-jurisdictional Erosional Feature

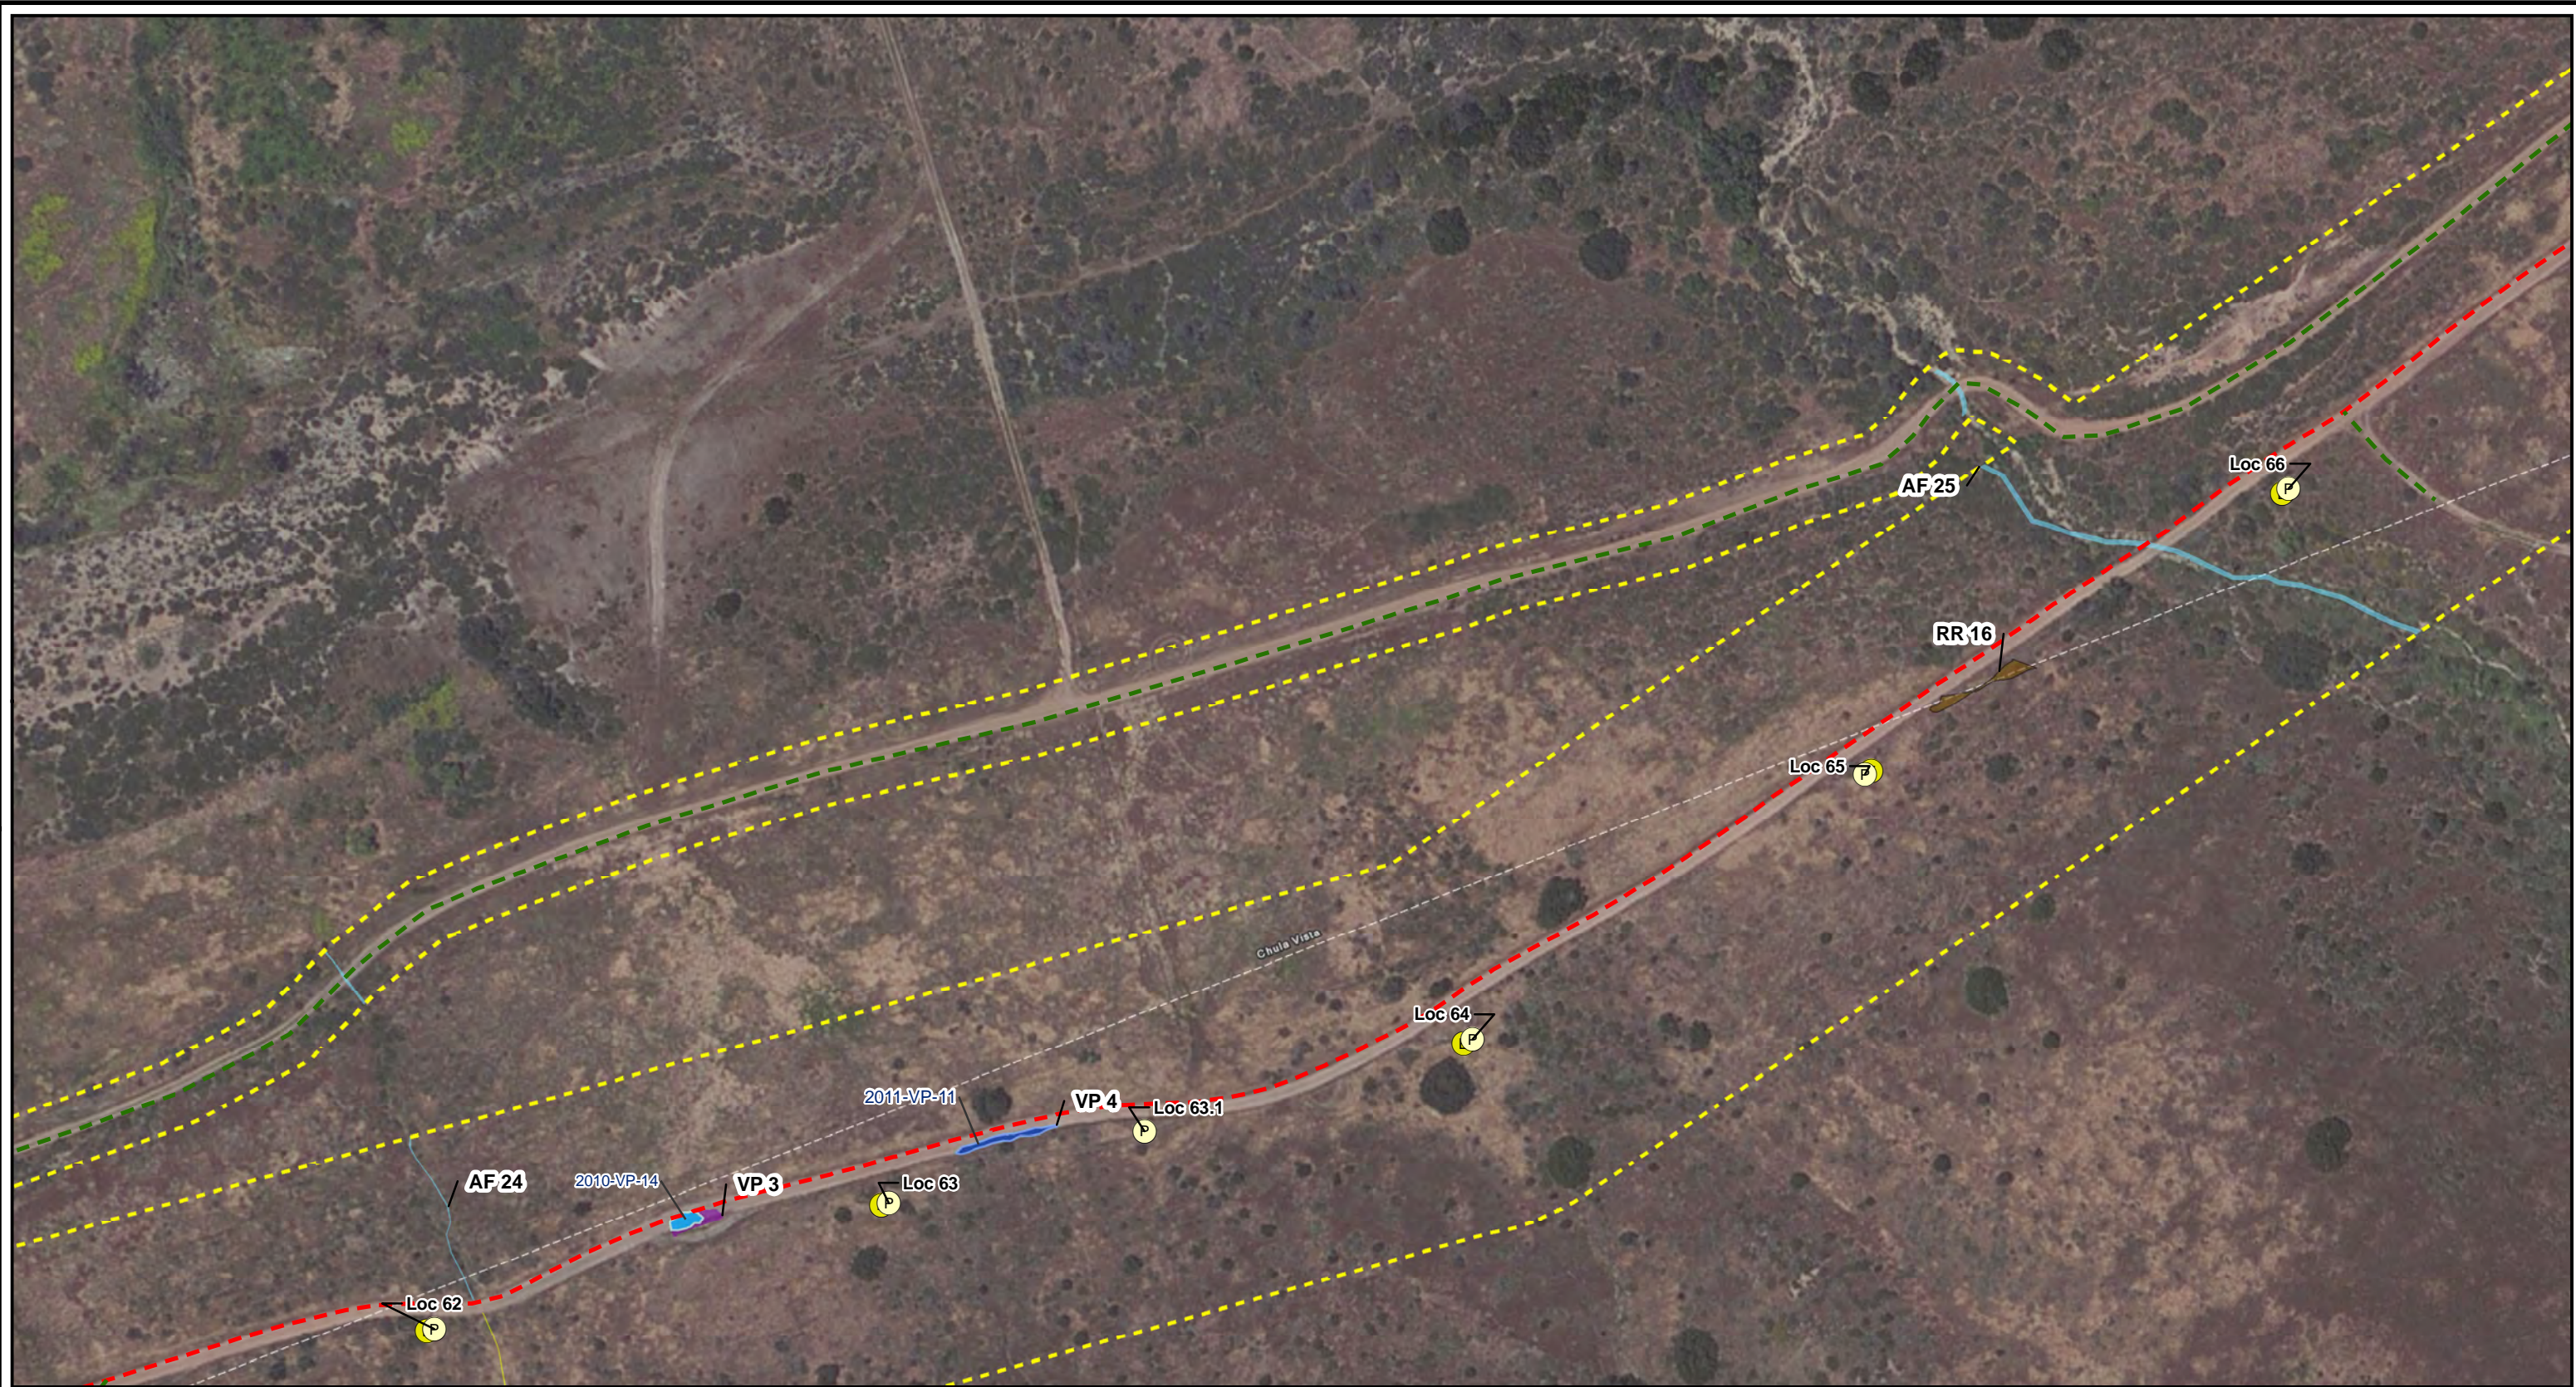
Figure 5
Jurisdictional Resources
TL-649 Wood-to-Steel Project

- Legend**
- Project Pole
 - Existing Pole
 - Existing Non-TCM Access Road
 - Access Road
 - Survey Corridor
 - Vernal Pool-2010, ACOE Wetland Waters, RWQCB Waters of the State
 - Vernal Pool-2011, ACOE Wetland Waters, RWQCB Waters of the State
 - ACOE Non-wetland Waters, CDFW Streambed, RWQCB Waters of the State
 - ACOE Wetland Waters, RWQCB Waters of the State [Vernal Pool]
 - Non-jurisdictional Road Rut [Bare Ground]
 - Non-jurisdictional Swale

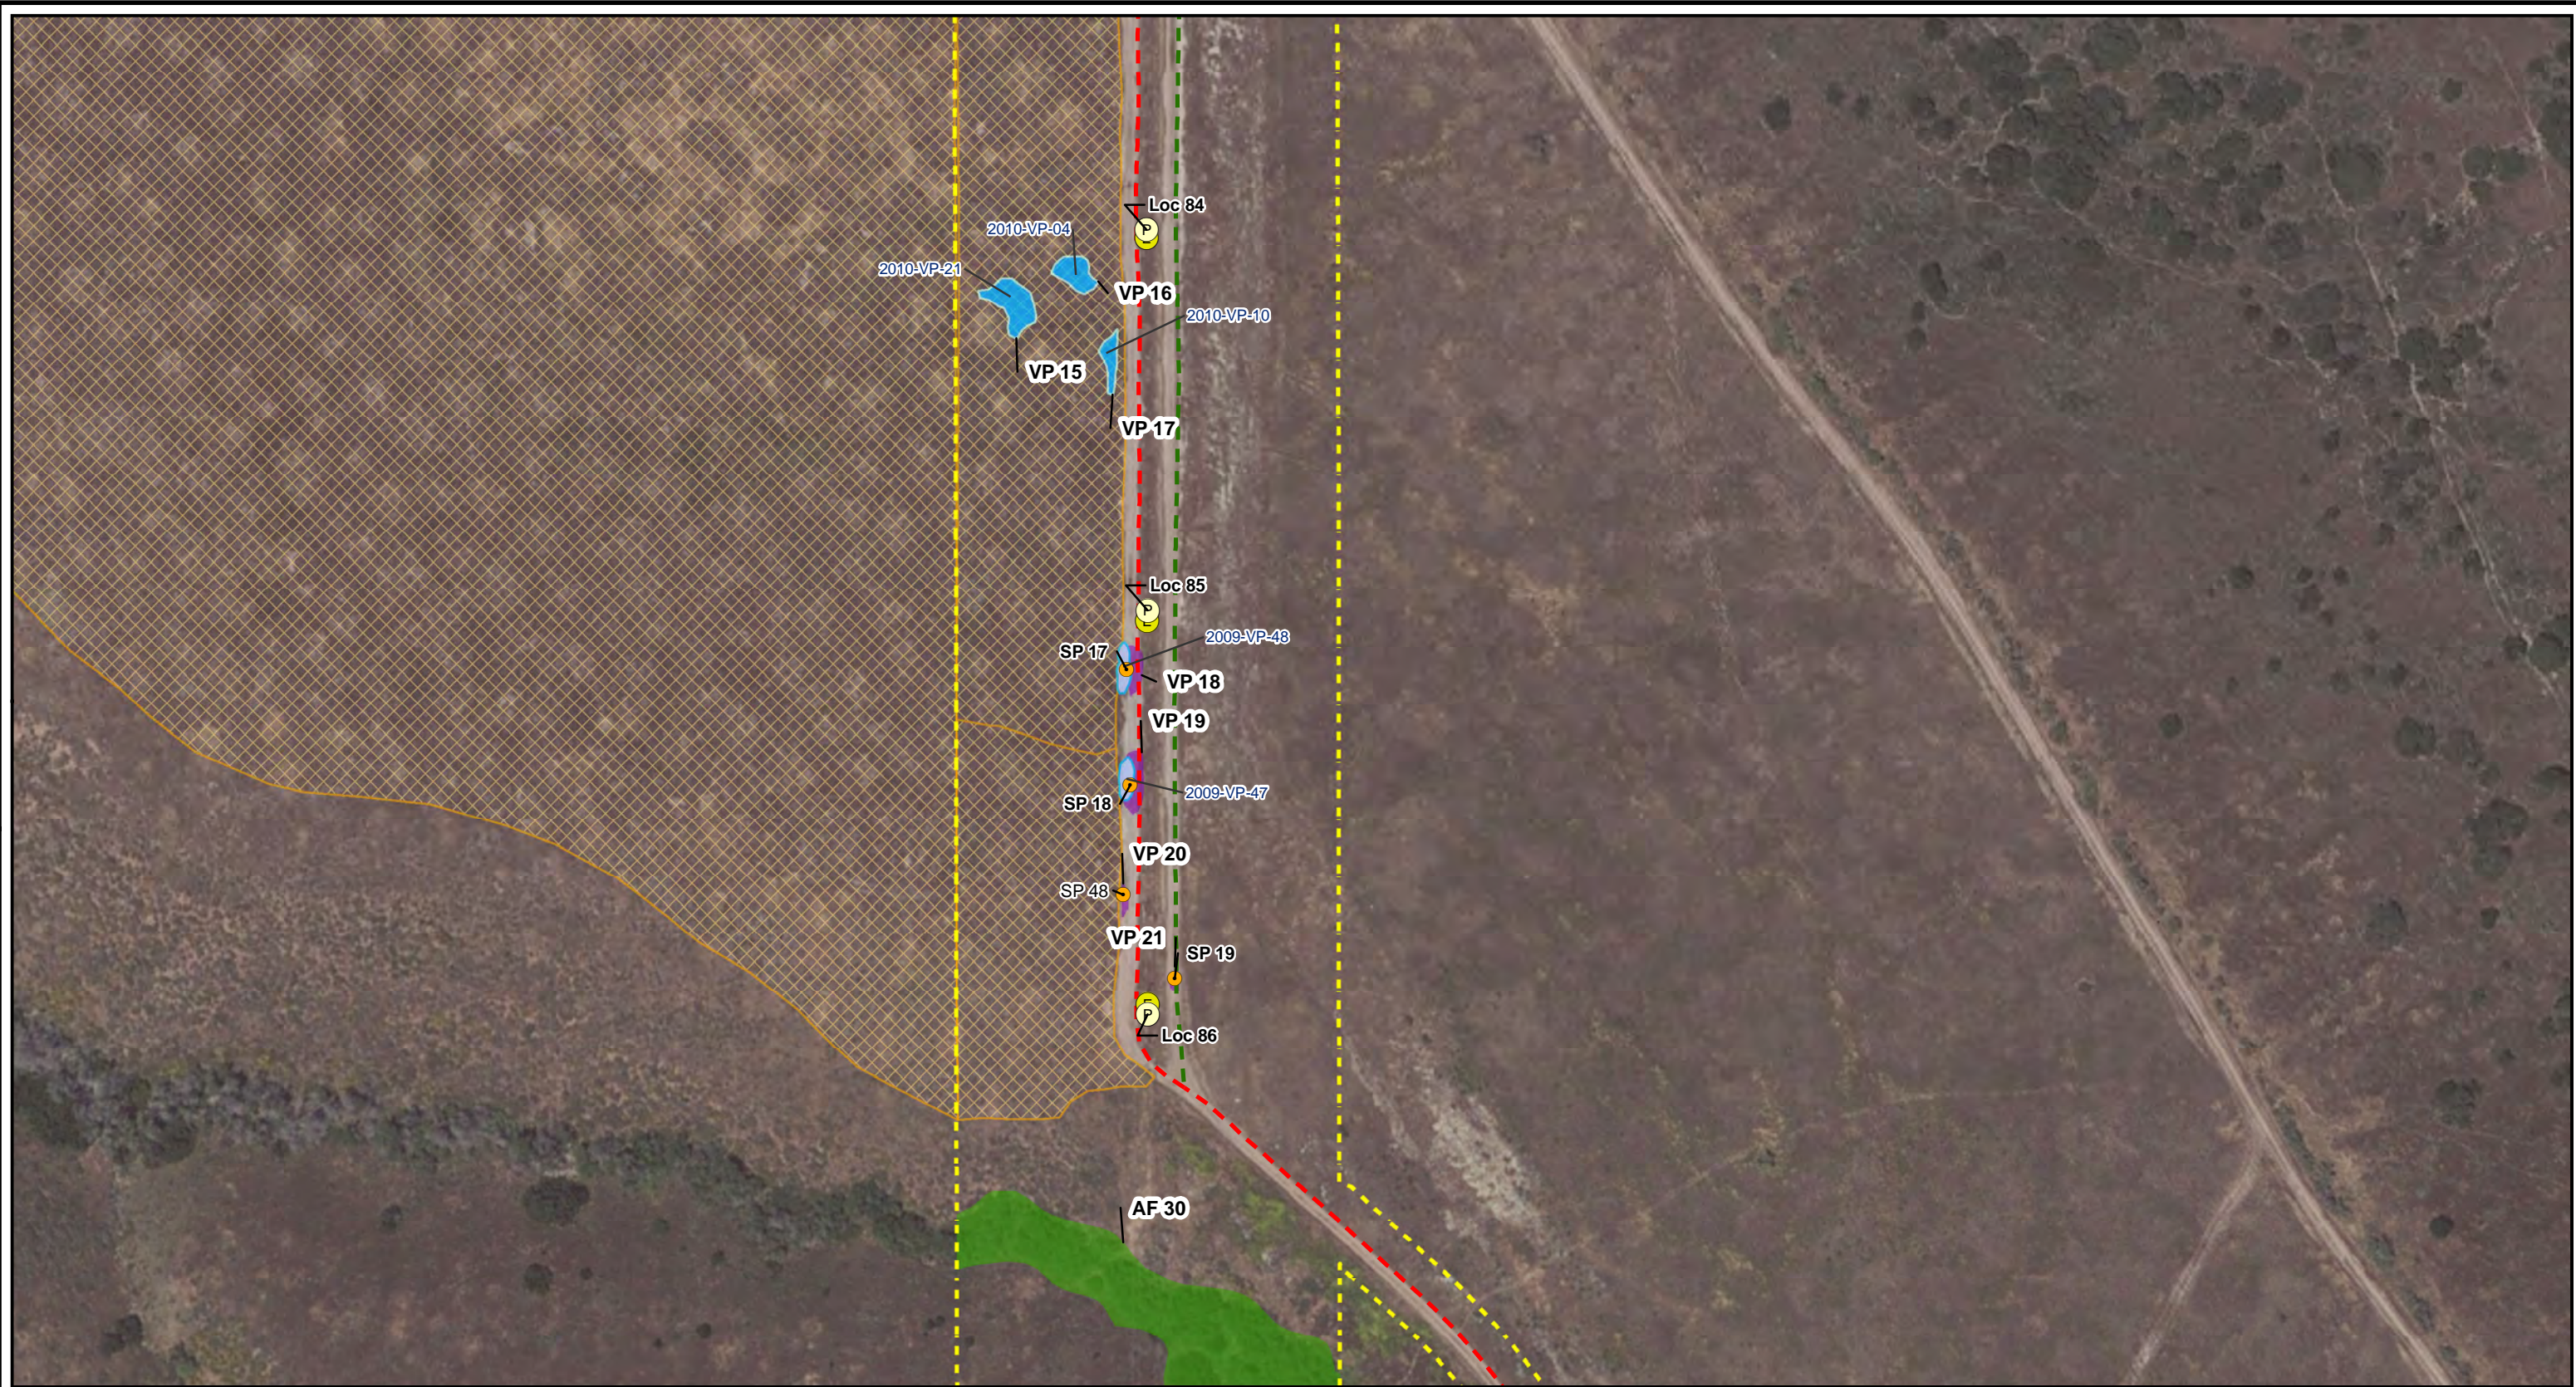
Figure 5
Jurisdictional Resources
TL-649 Wood-to-Steel Project

- Legend**
- Project Pole
 - Existing Pole
 - Existing Non-TCM Access Road
 - - - Access Road
 - - - Survey Corridor
 - Soil Pit
 - Vernal Pool-2009, ACOE Wetland Waters, RWQCB Waters of the State
 - Vernal Pool-2010, ACOE Wetland Waters, RWQCB Waters of the State
 - San Diego Mesa Claypan Vernal Pool Complex - ACOE Wetland Waters, RWQCB Waters of the State
 - ACOE Wetland Waters, CDFW
 - Riparian, RWQCB Waters of the State [Southern Willow Scrub]
 - ACOE Wetland Waters, RWQCB Waters of the State [Vernal Pool]
