Jurisdictional Delineation Report for Tie-Line 649 Wood-to-Steel Pole Replacement Project

Prepared by:
San Diego Gas & Electric (SDG&E)
8315 Century Park Court, CP21E
San Diego, CA 92123
Contact: Ms. Tamara Spear

April 28, 2015

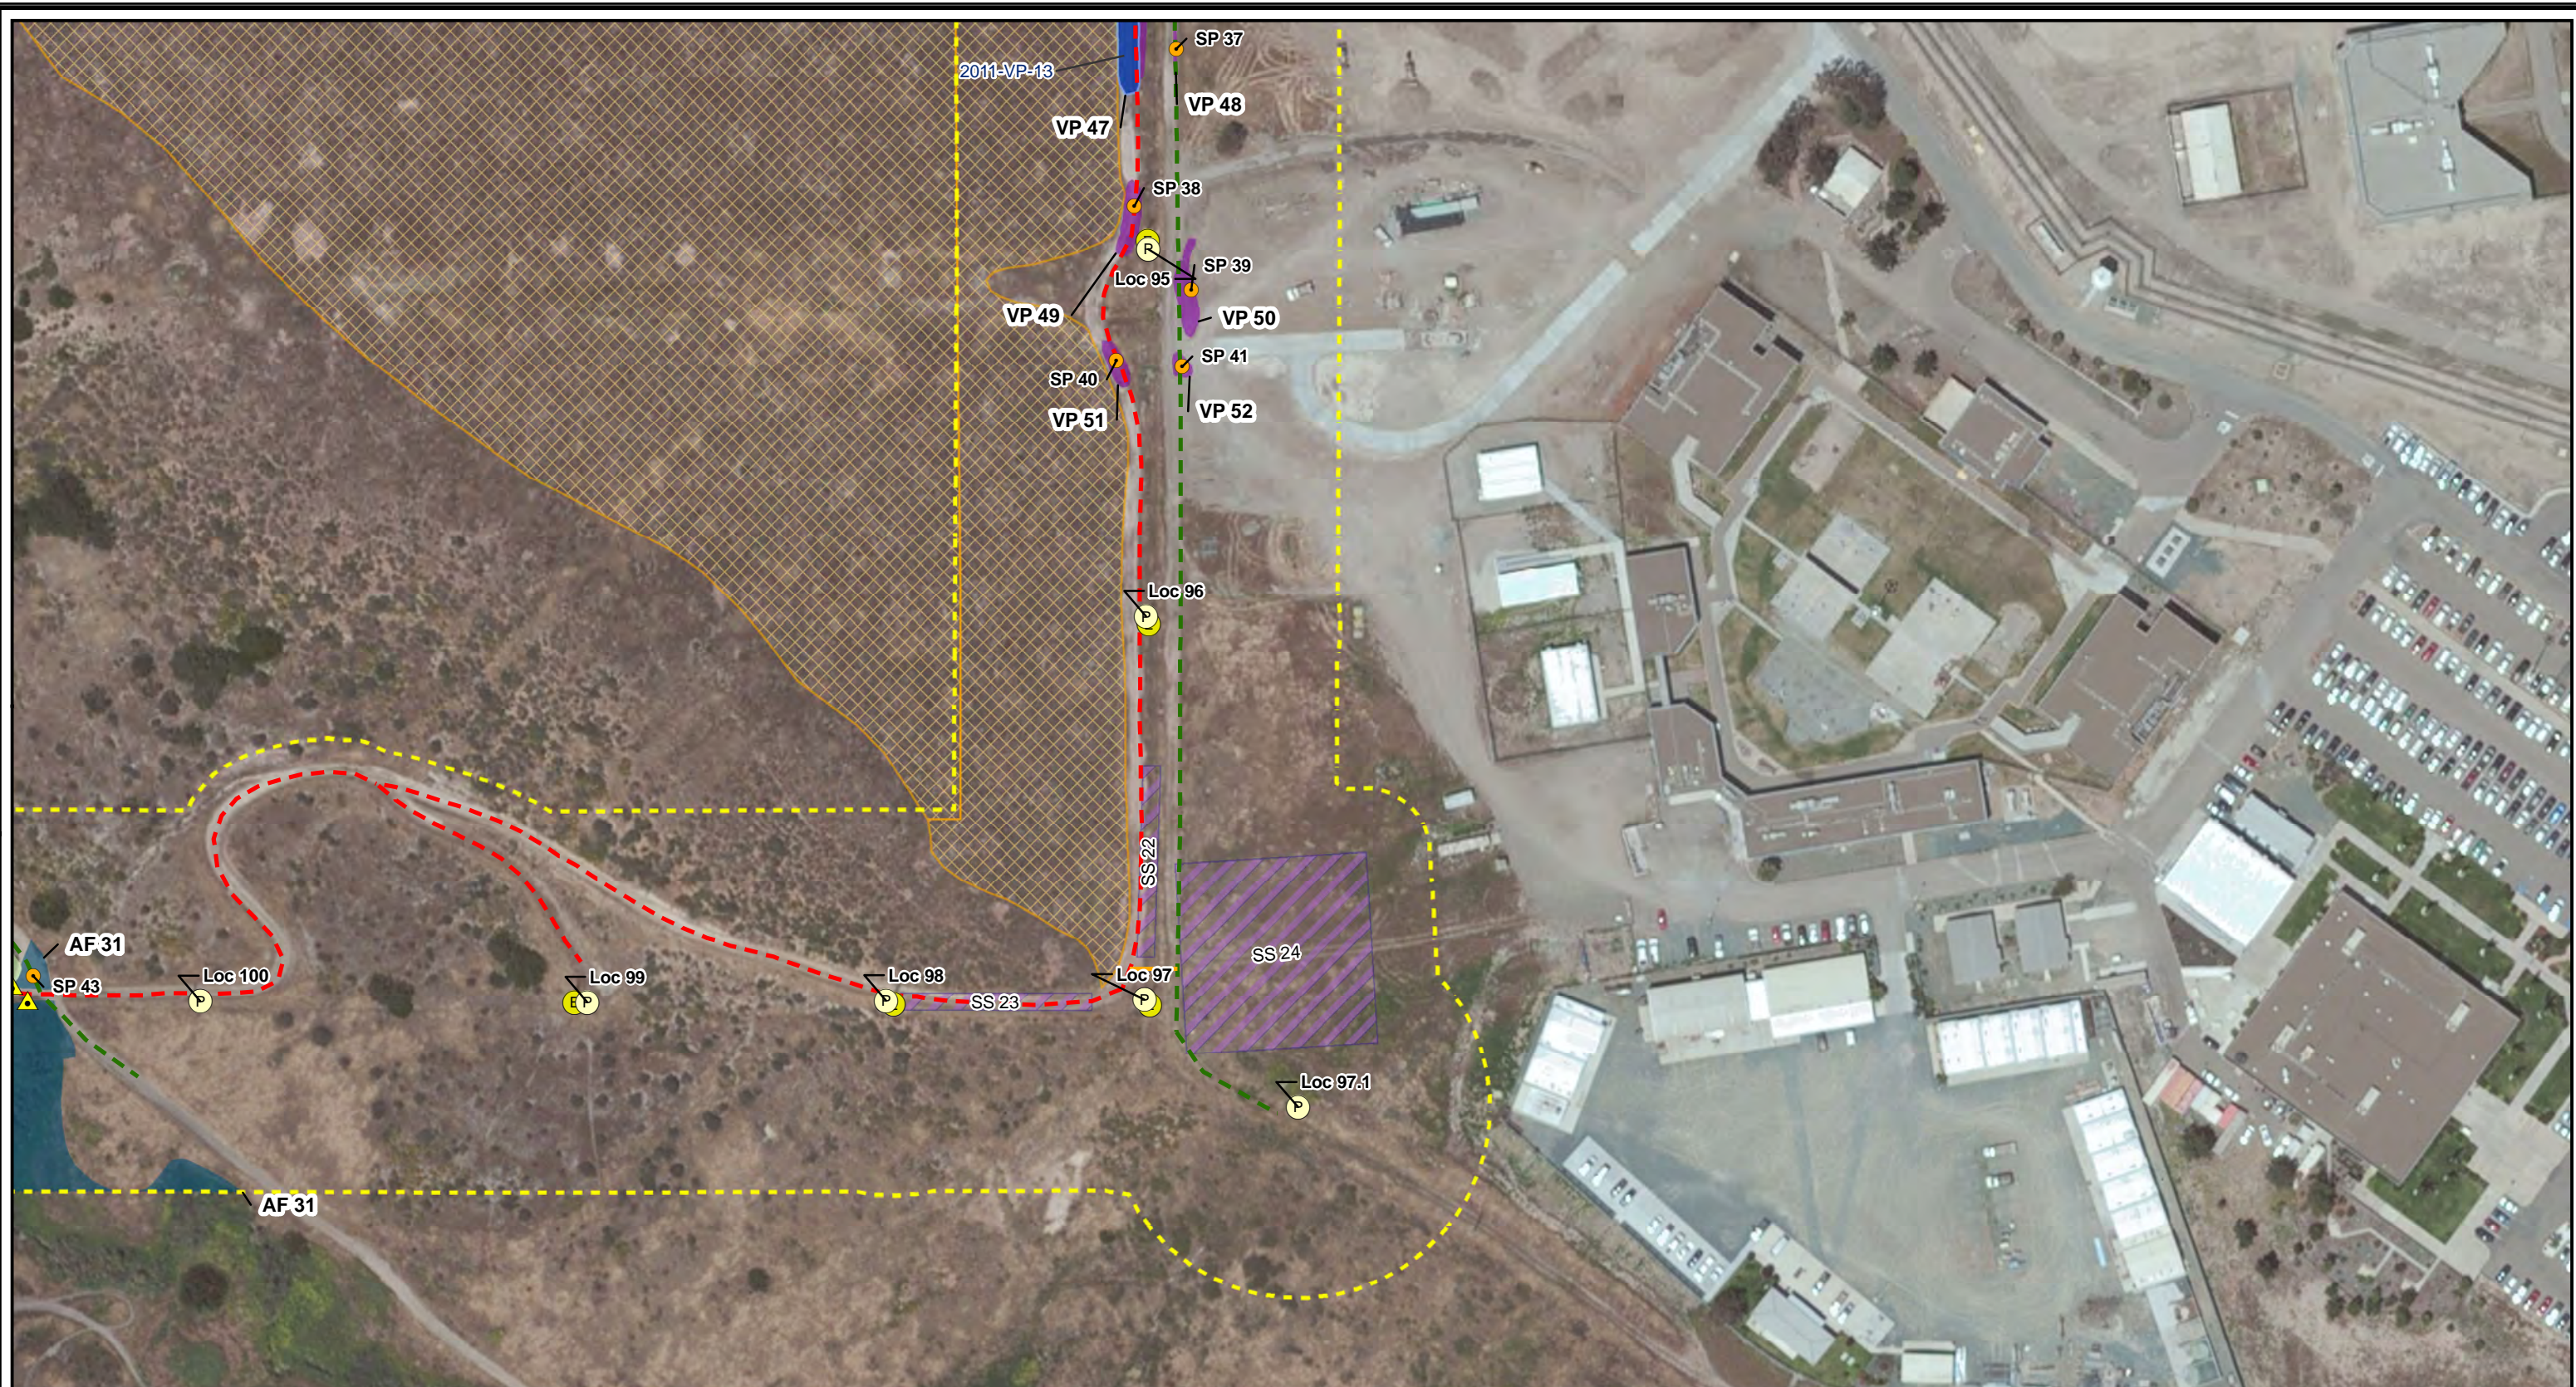
Figure 5
Jurisdictional Resources
TL-649 Wood-to-Steel Project

- Legend**
- Project Pole
 - Existing Pole
 - Existing Non-TCM Access Road
 - - - Access Road
 - Overland Travel
 - ▨ String Site
 - - - Survey Corridor
 - ▲ Culvert
 - Soil Pit
 - Vernal Pool-2011, ACOE Wetland Waters, RWQCB Waters of the State
 - ▨ San Diego Mesa Claypan Vernal Pool Complex - ACOE Wetland Waters, RWQCB Waters of the State
 - ACOE Wetland Waters, CDFW Riparian, RWQCB Waters of the State [Disturbed Wetland]
 - ACOE Wetland Waters, CDFW Riparian, RWQCB Waters of the State [Riparian Scrub]
 - ACOE Wetland Waters, RWQCB Waters of the State [Vernal Pool]

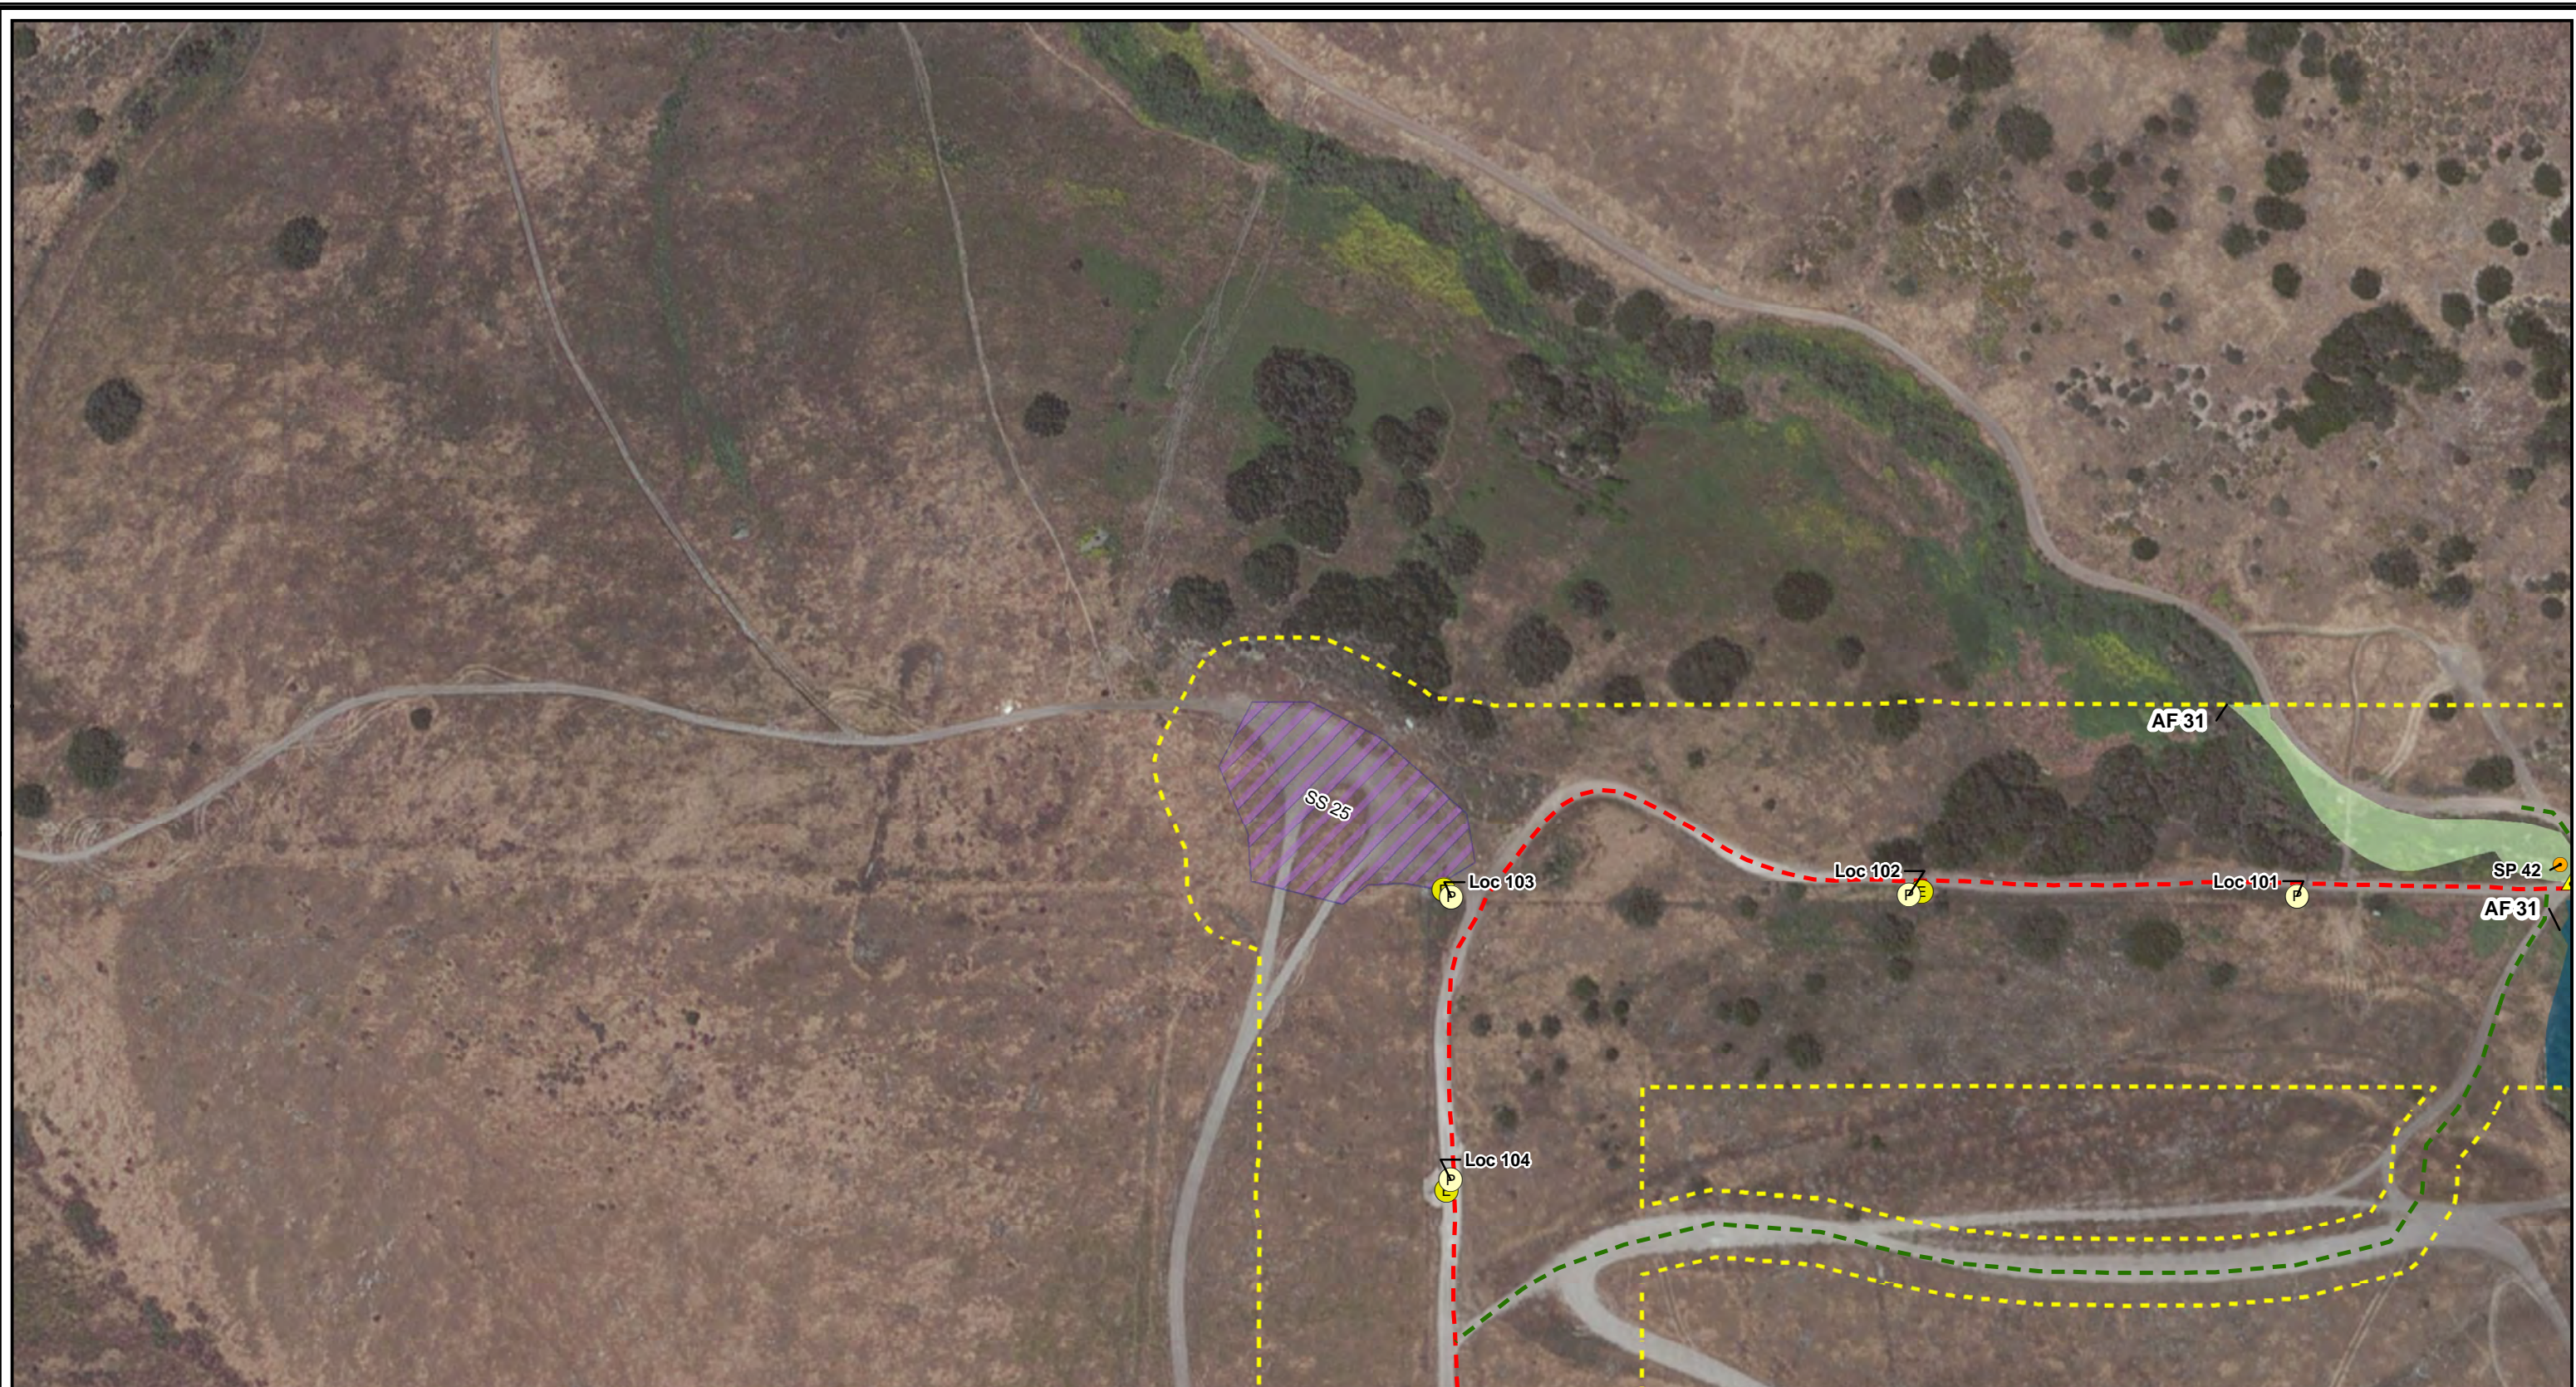
Figure 5
Jurisdictional Resources
TL-649 Wood-to-Steel Project

- Legend**
- (P) Project Pole
 - (E) Existing Pole
 - Existing Non-TCM Access Road
 - Access Road
 - String Site
 - Survey Corridor
 - ▲ Culvert
 - Soil Pit
 - ACOE Wetland Waters, CDFW
Riparian, RWQCB Waters of the State
[Disturbed Wetland]
 - ACOE Wetland Waters, CDFW
Riparian, RWQCB Waters of the State
[Riparian Scrub]

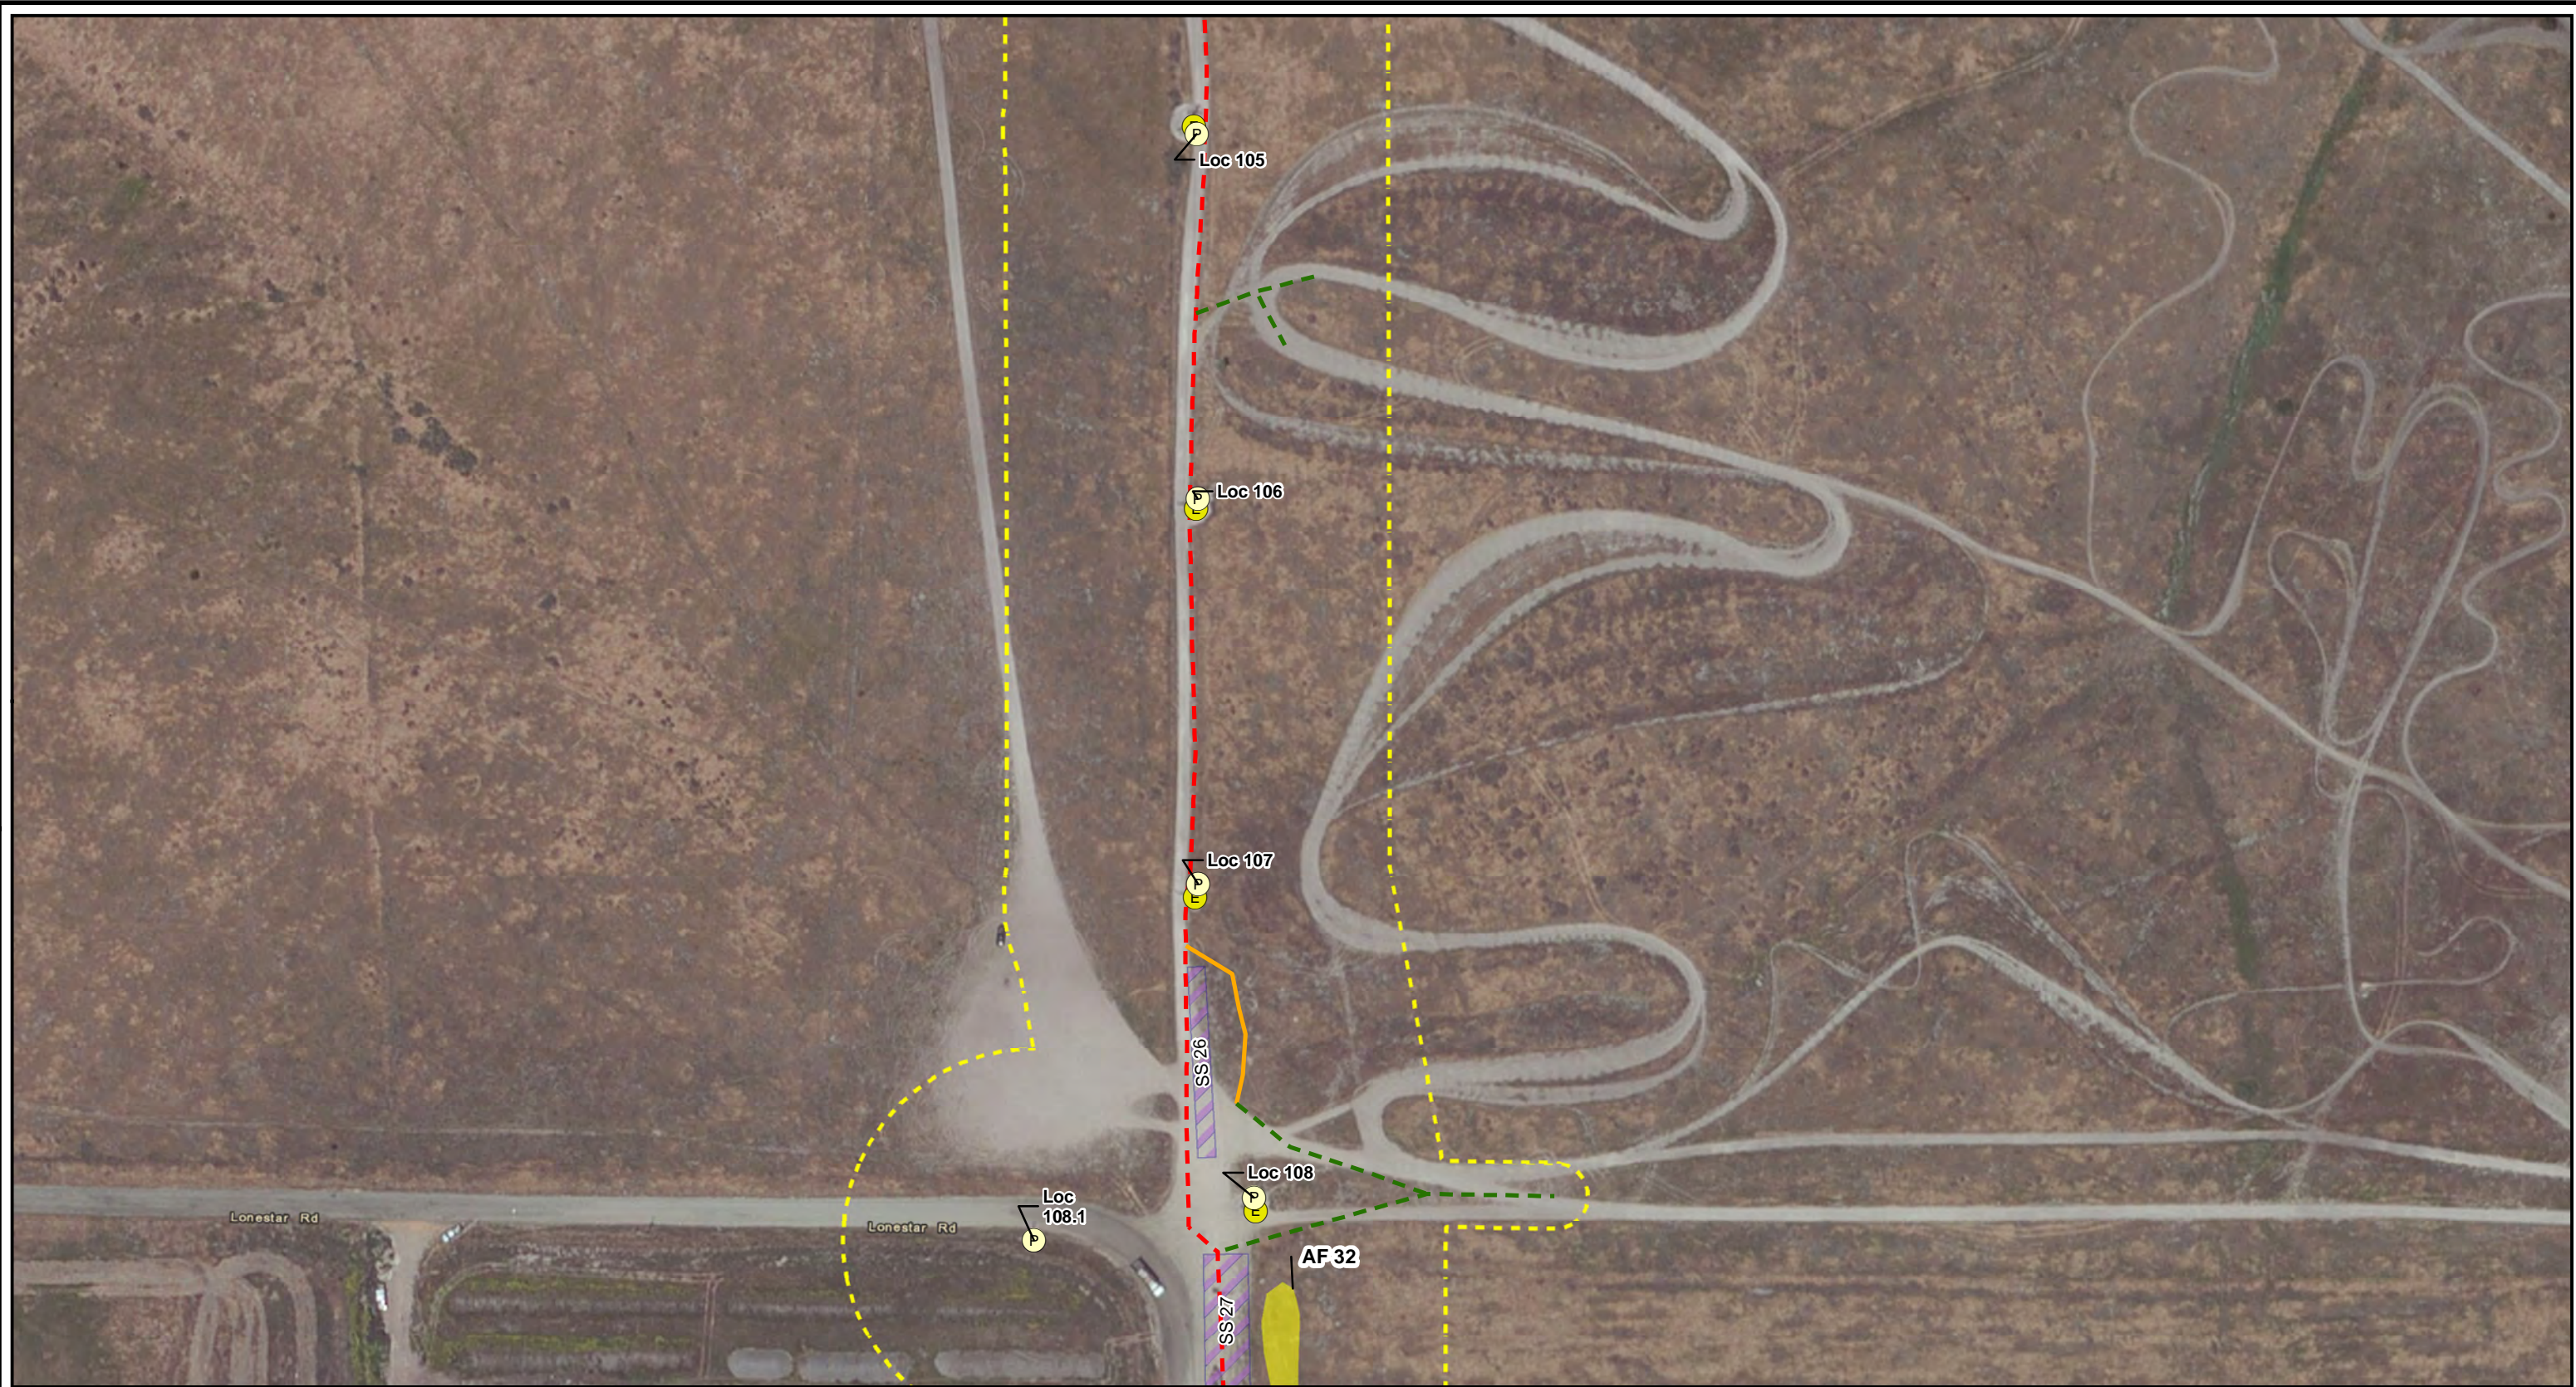
Figure 5
Jurisdictional Resources
TL-649 Wood-to-Steel Project

- Legend**
- Project Pole
 - Existing Pole
 - Existing Non-TCM Access Road
 - Access Road
 - Overland Travel
 - String Site
 - Survey Corridor
 - Non-jurisdictional Swale

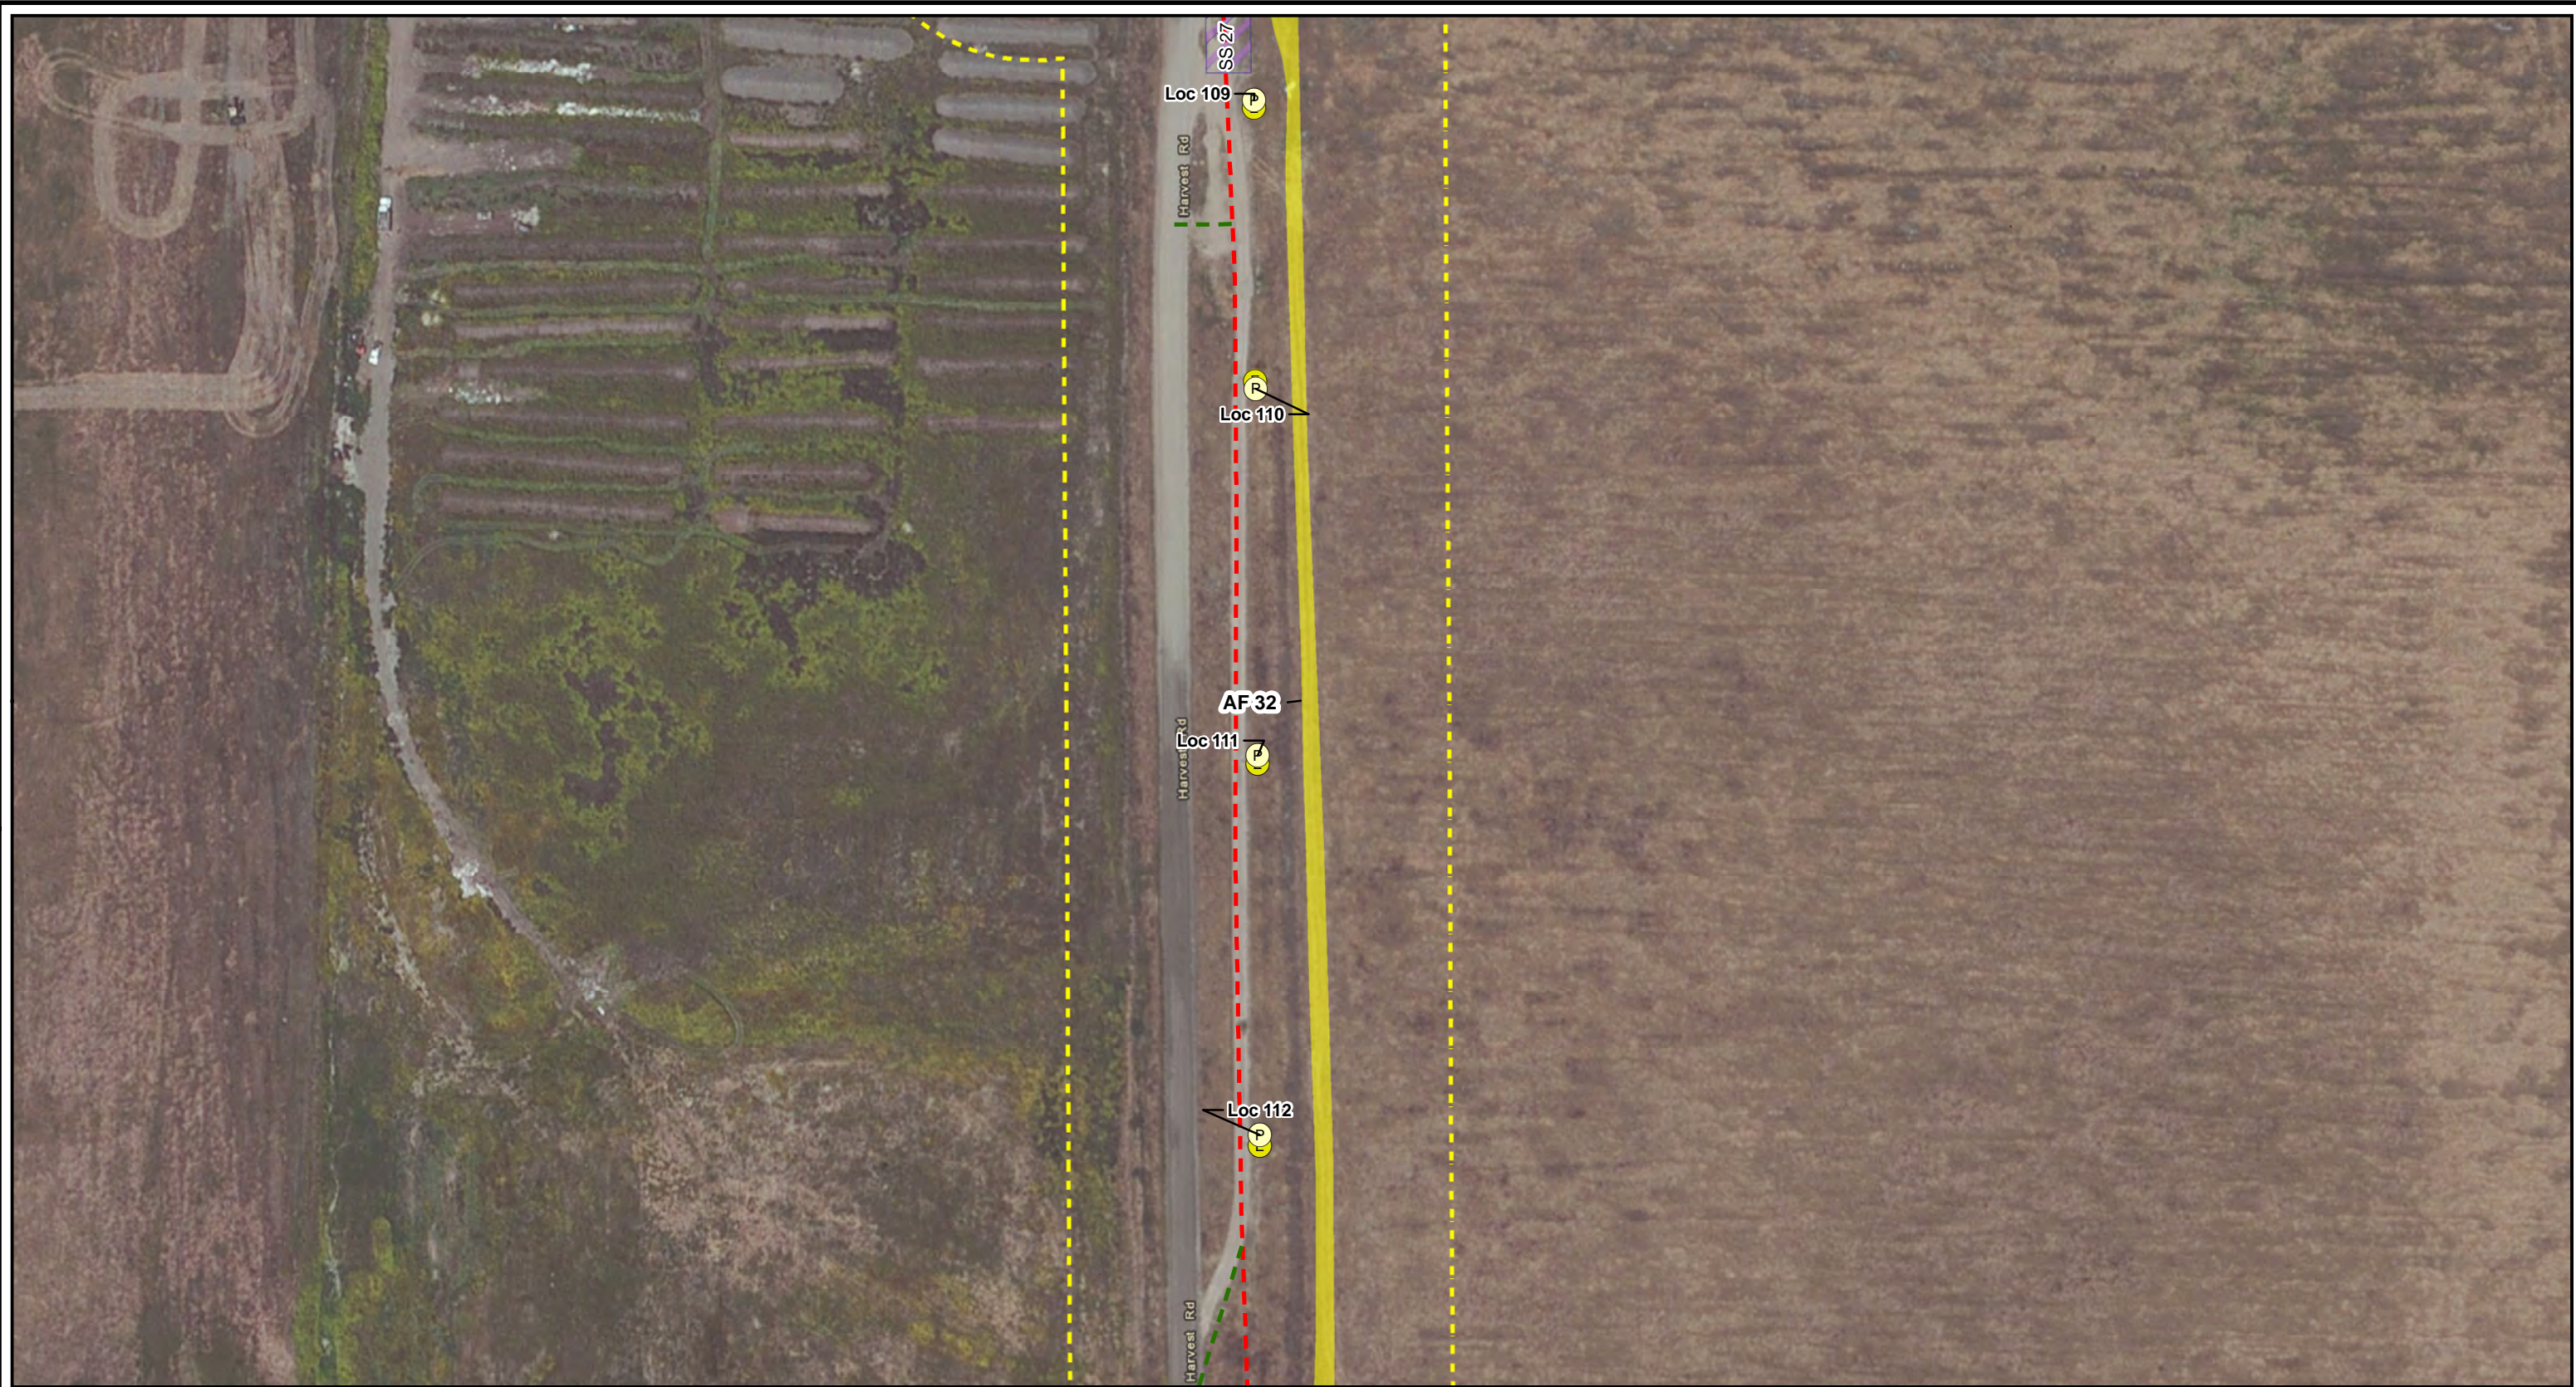
Figure 5
Jurisdictional Resources
TL-649 Wood-to-Steel Project

- Legend**
- Project Pole
 - Existing Pole
 - Existing Non-TCM Access Road
 - - - Access Road
 - String Site
 - - - Survey Corridor
 - Non-jurisdictional Swale
