## Re: SDG&E Response to SDCAN Data Request 02 – Wildfire Expense Memorandum Account

See Attachment Bureau Veritas 8/15/08 Report on Guy Guard Testing hereto.

Submitted herewith are the metallurgical test results and conclusions performed by Mr. Ken Holko of Holko Consulting for the East and West Guy Wire Guards for the above referenced SDG&E Pole. In summary, evidence of electric arcing was not found on either guy wire guard examined. After review of the enclosed report please feel free to contact the undersigned with respect to comments, questions, and/or scheduling of a meeting to discuss the findings.

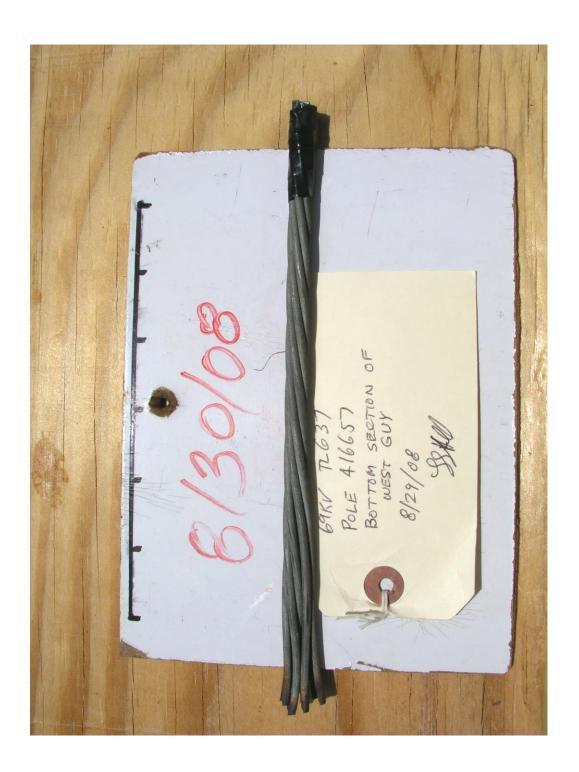
Figure 1. Guy wire sample removed from West guy

The guy wire was sectioned, mounted and metallurgically examined. Metallurgical polishing and etching were done to reveal wire microstructure and coating structure. The sections and the wire surface were also examined by scanning electron microscopy (SEM) and energy dispersive spectroscopy (EDS) for composition. Microhardness testing was done to extrapolate wire strength and determine coating hardness.

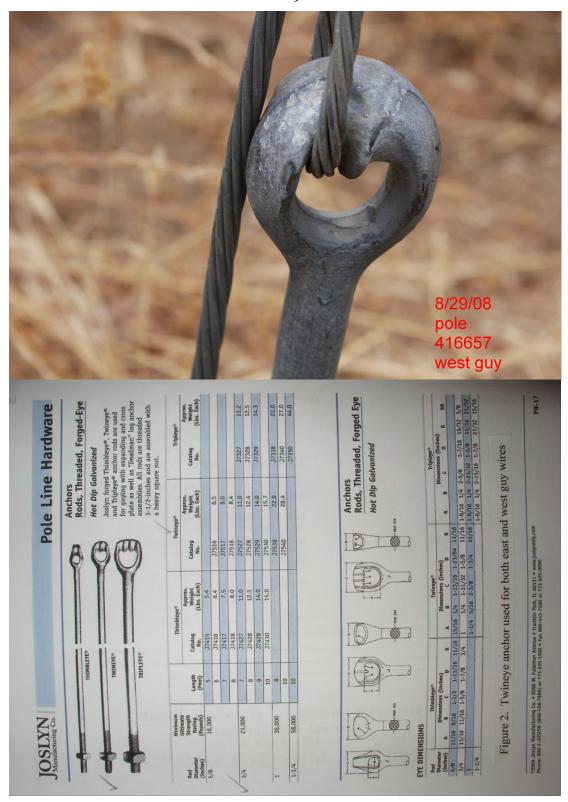
Figure 2. Photograph and drawing of West guy wire anchor and guy wire

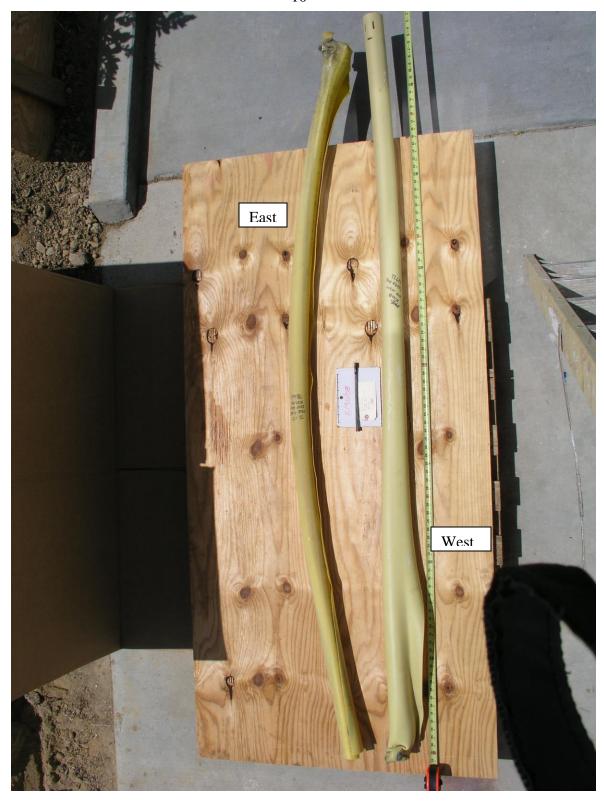
Figure 3. Overall photo of both guy guards – end with bolt was down in the field

The guard exteriors were visually examined and photographed. Any suspicious features were identified with a letter (W for west and E for east) and number. Location was noted relative to the guard ends with the bolts and a tape measure as seen in Figure 3. The interiors of the guards at the ends were visually examined. Suspicious features were noted so they could be avoided when the guards were sectioned.

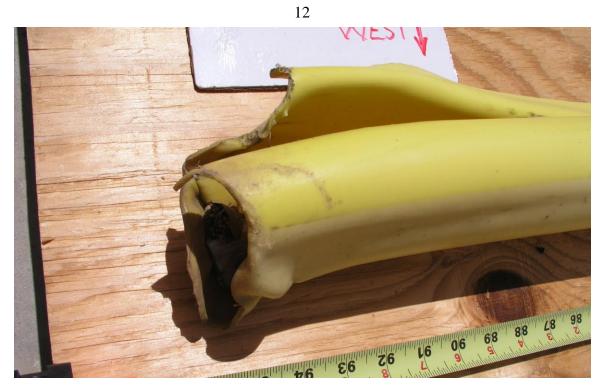
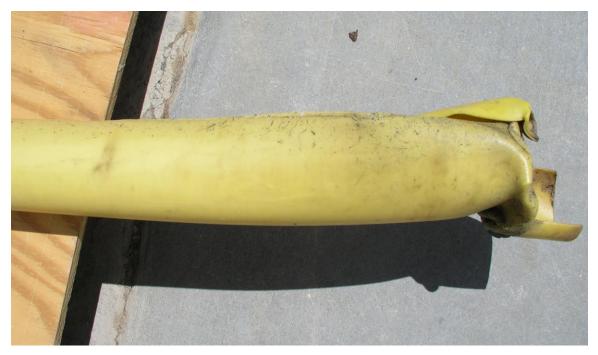
Figure 5. Close-ups of distortion and melting from fire in west guard (top) and east guard (bottom)

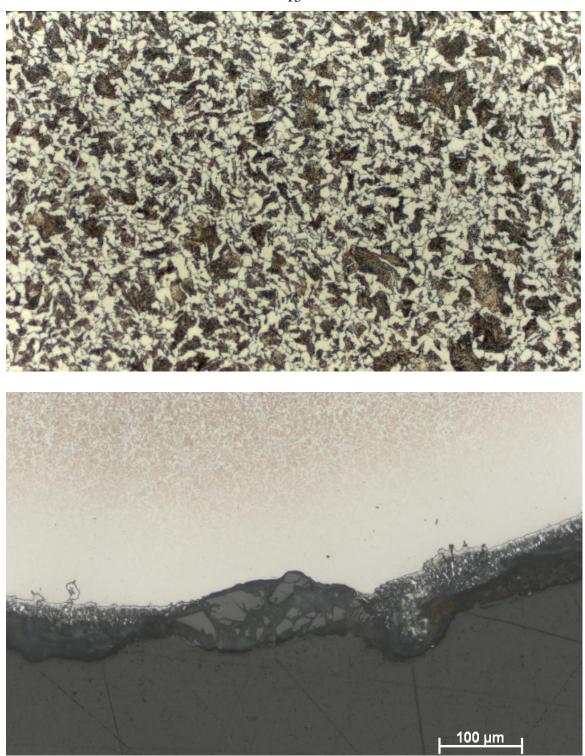
Figure 6a. Metallurgical sections through guy wire in core (top) at 500X and at surface (bottom) at 200X. Etchant: Nital

Guy wire sections are shown in Figure 6. As seen the surface is rough and irregular with contaminant particles present. The wire had a medium to high carbon steel microstructure consisting of ferrite and pearlite. The relatively low hardness (Table 1) indicates it is probably a drawn and heat treated steel product with an approximate tensile strength of 110 ksi. The coating SEM/EDS analyses of the surface and cross section are also shown in Figure 6. This shows the wire has been hot dip galvanized with resultant iron (Fe) - zinc (Zn) alloy formation. Microhardness for the coating is shown in Table 1. The low outer surface hardness and surface EDS indicates at least some free Zn is present. The contaminant shown in Figure 6 was analyzed (not shown) and is probably aluminum oxide. The combination of a rough, irregular surface, low hardness, and contaminants result in a friable surface condition. As the coated guy wire surface impacted and rubbed against the guard interior, particle fracture and release are probable events.

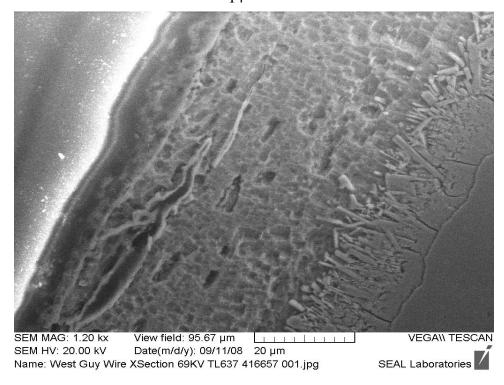
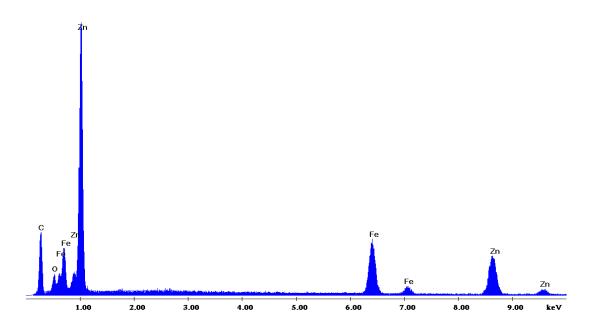
Label A: W-1 West Guy Wire 69KV TL637 - 416657 XSection Coating (20kV)

Elem Wt % At % FeK 34.03 37.64 ZnK 65.97 62.36

Figure 6b. SEM image of guy wire coating section and EDS analysis

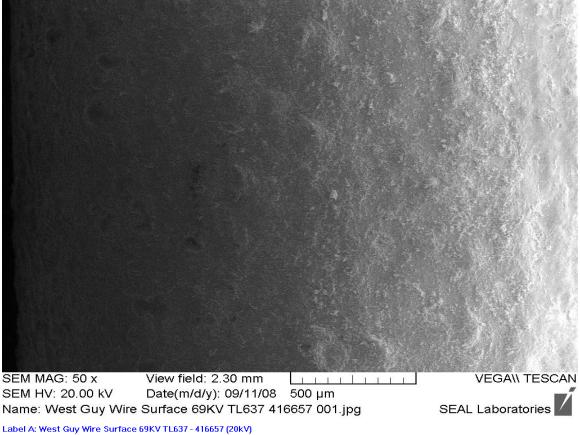
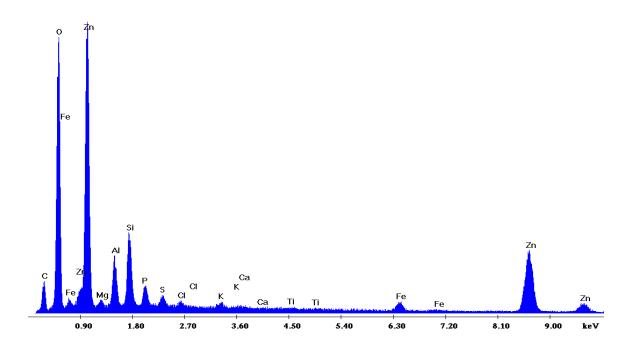
Figure 6c. SEM (top) and EDS analysis (bottom) of guy wire surface

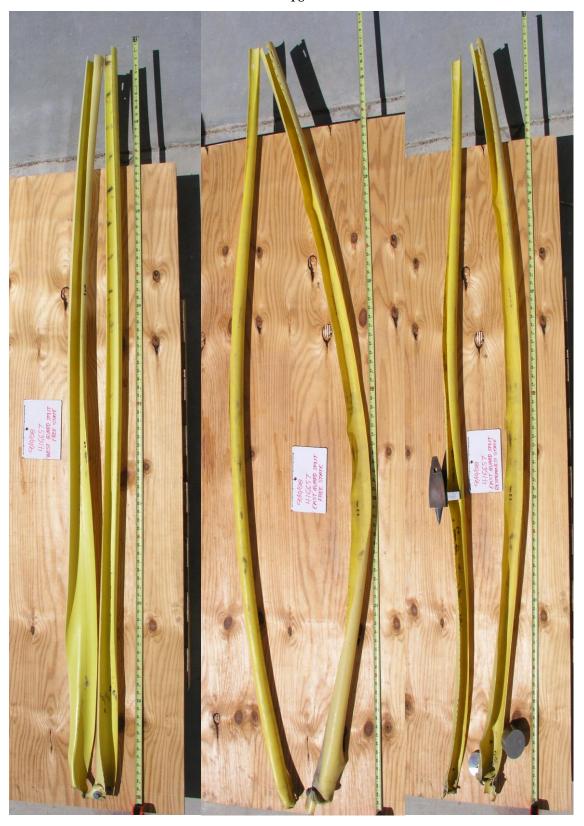
West – free state

East – free state

East - restrained

Figure 7. Overall sections of guy guards

The guards were then sectioned longitudinally with a high speed steel cutter without lubricant to avoid contamination. Care was taken to avoid cutting through areas of interest. Stereomicroscopic examination to 63X magnification was done on the interior surfaces. Location of suspicious defects was indicated with a letter and number (W for West guard and E for East guard) and reference to the tape measure shown. Samples were removed at suspicious locations with a high speed steel cutter.

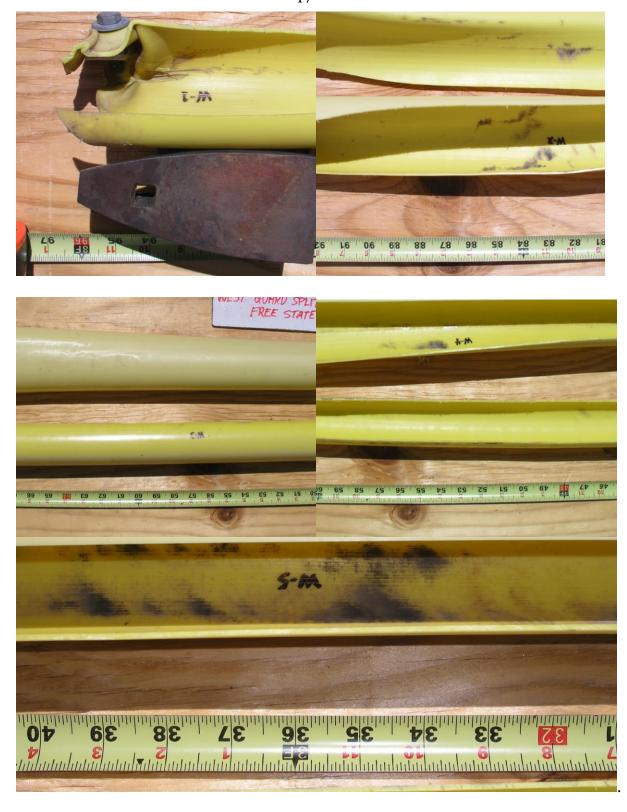
Figure 8a. Sample locations from West guard

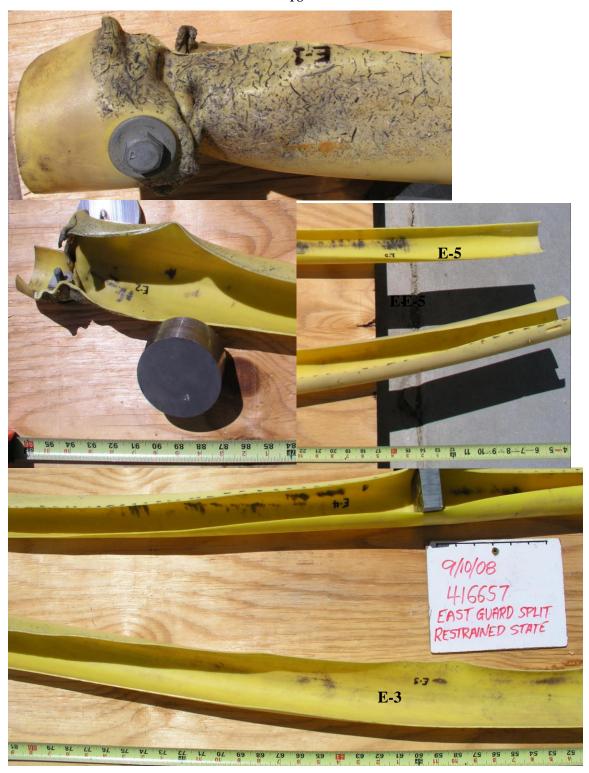
Figure 8b. Sample locations from East guard

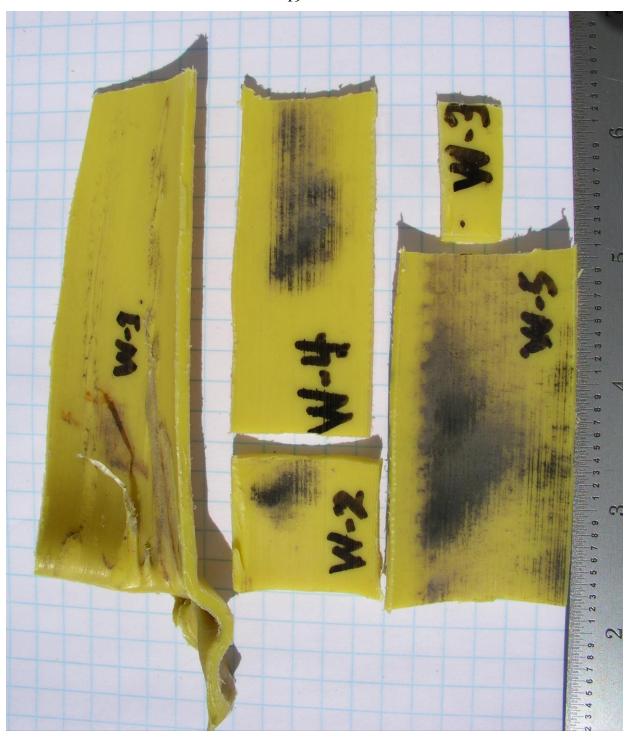
Figure 9a. Close-up of samples removed from West guard

The other locations shown in Figure 9 were examined and analyzed in a similar manner. No evidence of arcing such as carbonization or "treeing" type attack<sup>a</sup> sometimes found in PE insulators was found in the areas selected.

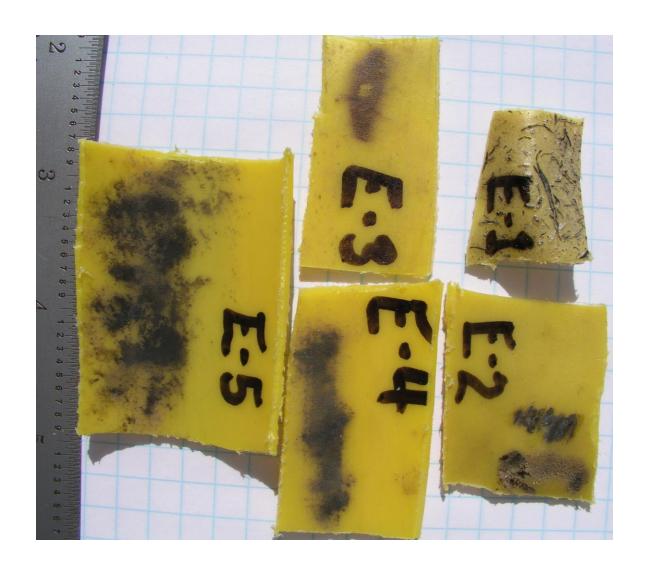
Figure 9b. Close-up of samples removed from East guard

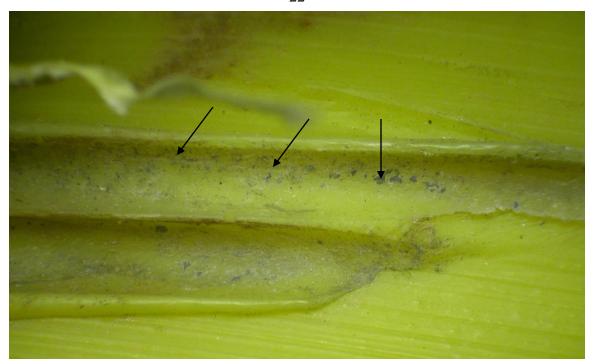
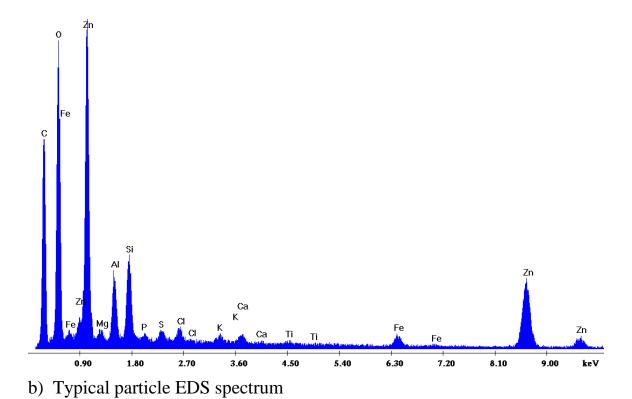
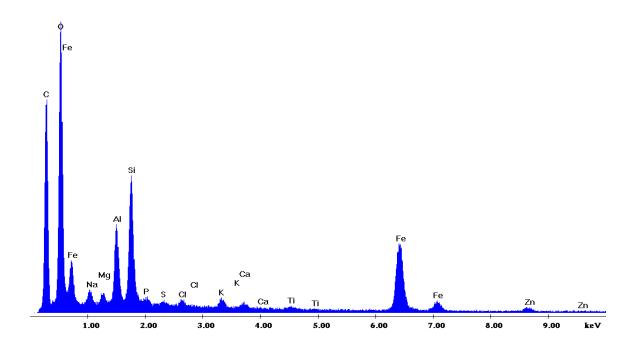
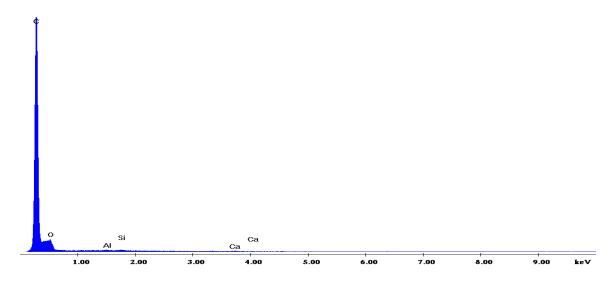
a) Close-up of W-1 showing particles analyzed by EDS, 5X original mag. Label A: W-1 West Guy Guard 69KV TL637 - 416657 Loc1 (20kV)

Figure 11. Sample W-1 examination results (cont.)

# c) Another typical particle EDS spectrum

# d) Clean cut surface EDS for PE without contaminants or particles

Figure 11. Sample W-1 examination results (concluded)

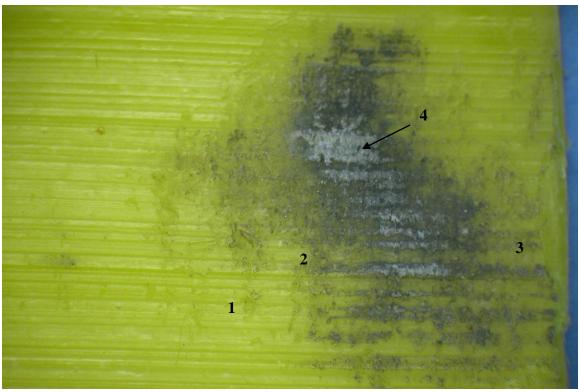
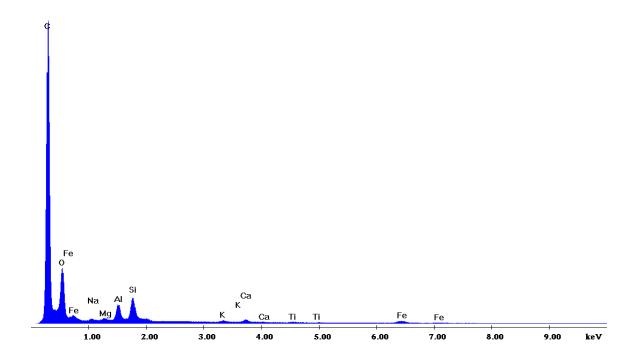
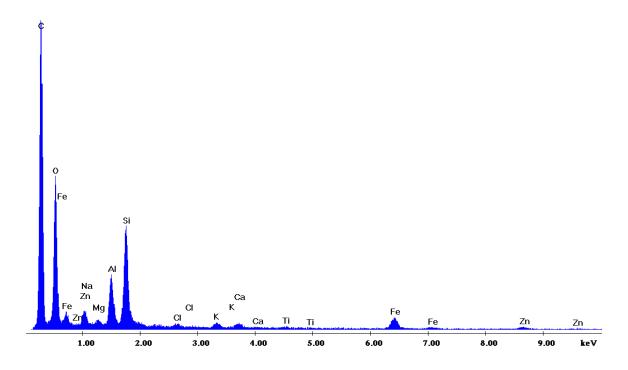
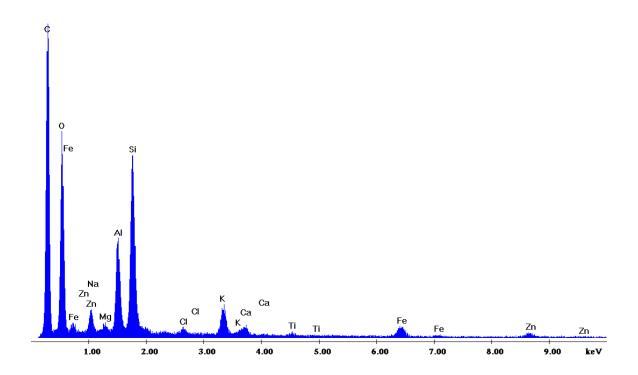
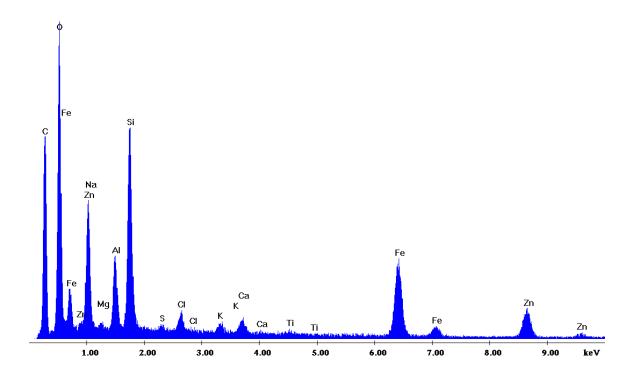
a) Stereomacroscopic view of W-2 showing EDS locations, 5X original

b) SEM view at location 4 in (a) above Figure 12. Sample W-2 examination results (cont.)

c) EDS spectra from locations 1 and 2, sample W-2

d) EDS spectra from locations 3 and 4, sample W-2

Figure 12. Sample W-2 examination results (concluded)

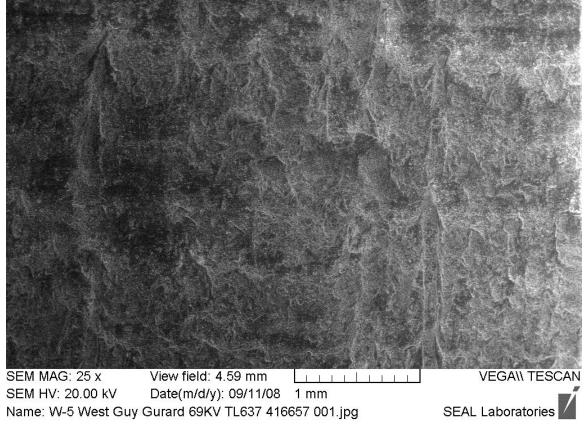
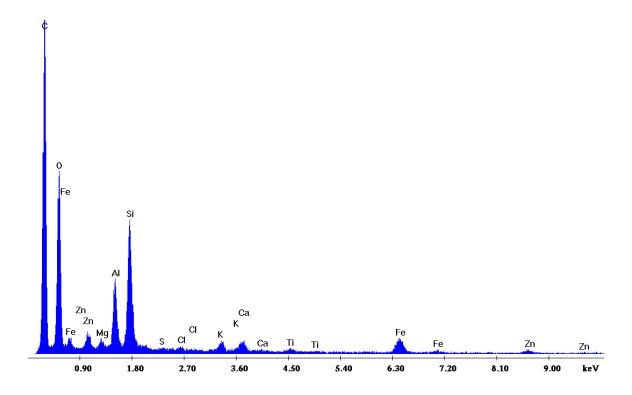
Label A: W-5West Guy Guard 69KV TL637 - 416657 Loc1 (20kV)

Figure 13. Sample W-5 SEM and EDS results in middle of dark area shown in Figure 9(a)

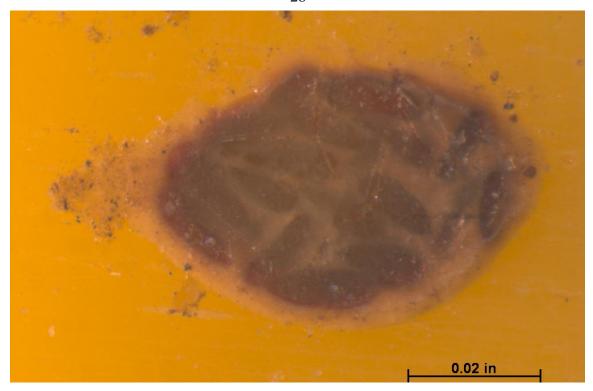
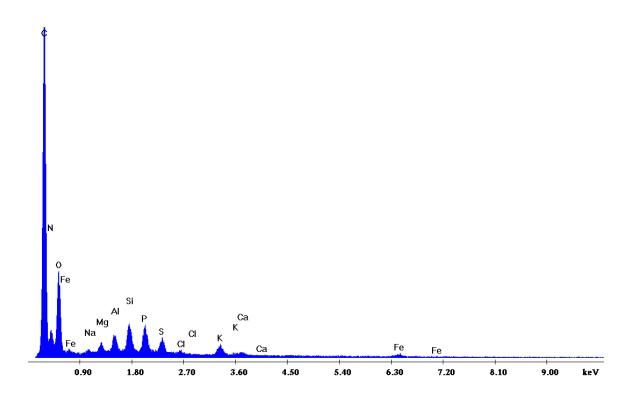
Label A: W-3 West Guy Guard 69KV TL637 - 416657 Loc1 (20kV)

Figure 14. Examination of W-3 "black dot" on outside surface. Stereomicroscopic image (top) and EDS spectrum (bottom).

Evidence of electric arcing was not found here on either guy guard examined. When suspicious, darkened areas were examined by SEM and EDS techniques it was found they were the result of abrasion from contact with the guy wire and pickup of wire coating material along with a sand-like mineral present on the guy guard surface. It was confirmed that both guards were polyethylene by FTIR analysis.

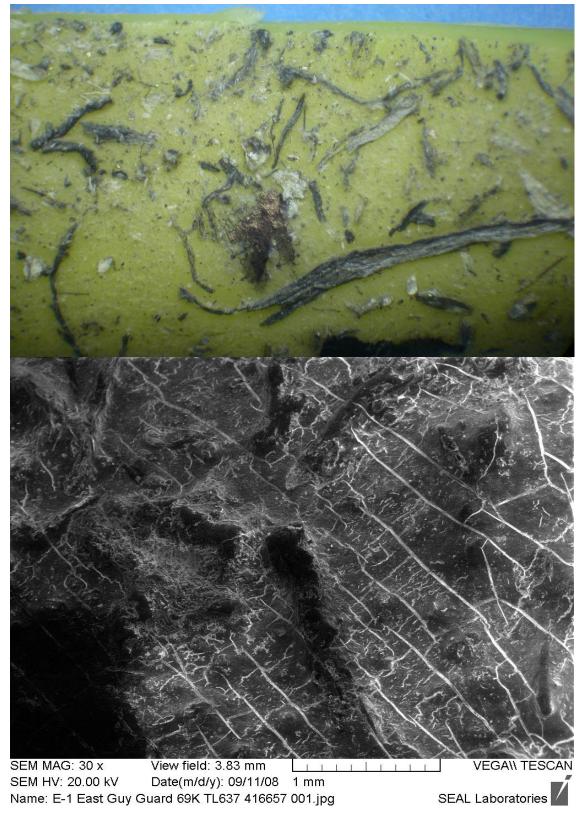
Figure 15. Sample E-1 stereomacroscopic image (5X) and SEM at same location (bottom)

The E-1 location shows burned and carbonized grass / weeds that have mixed with the melted PE at the bottom of the east guard. The stereomicroscopic and SEM photos in Figure 15 illustrate the appearance of melted PE and carbonized material.

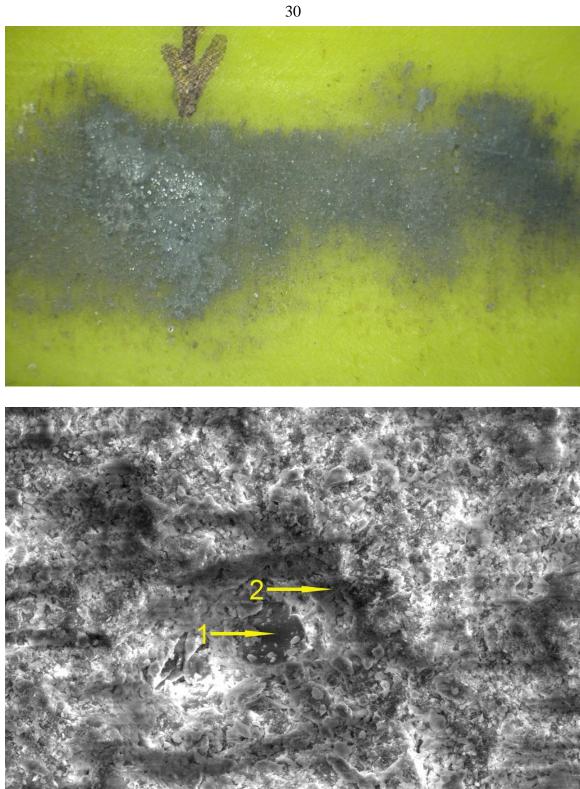
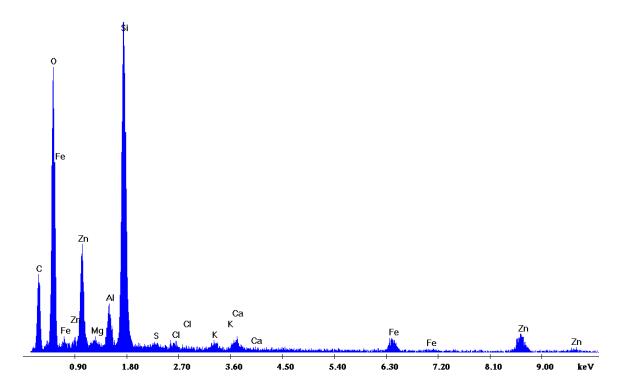
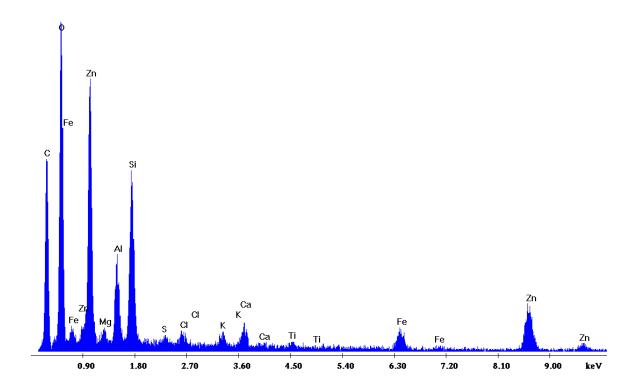
Figure 16. Sample E-4 Stereomacroscopic view (5X original) and SEM indicating EDS locations and results (cont.)

Figure 16. Sample E-4 Stereomacroscopic view (5X original) and SEM indicating EDS locations and results (concluded)

Stereomicroscopic and SEM photos at a suspicious location in E-4 are shown in Figure 15. EDS analyses at the two locations indicated are also shown. Abrasion type distortion and transfer of guy wire coating and sand-like contaminant particles were found. Arcing and carbonization of PE were not found.

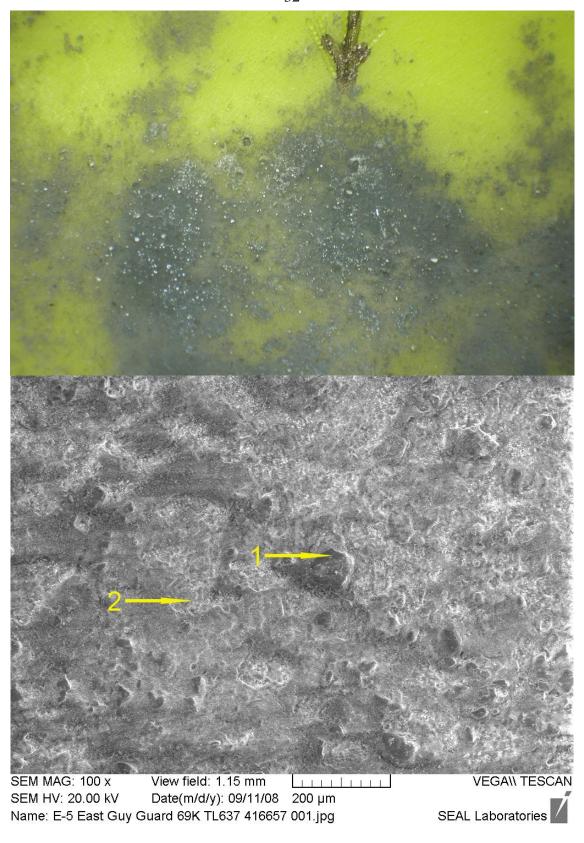
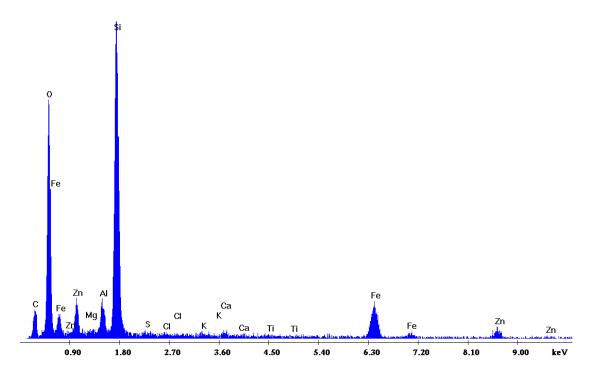
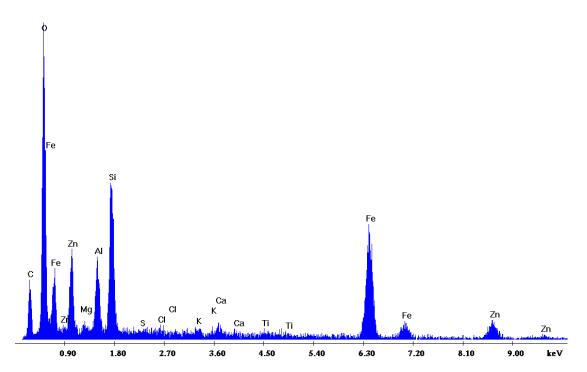
Figure 17. Sample E-5 Stereomacroscopic view (10X original) and SEM indicating EDS locations and results (cont.)

Figure 17. Sample E-5 Stereomacroscopic view (10X original) and SEM indicating EDS locations and results (concluded)

Similar results were found for location E-5 as shown in Figure 17.
