Company: San Diego Gas & Electric Company
Application No.: A.22-10-____
Proceeding: Catastrophic Expense Memorandum Account (CEMA)
Exhibit No.: _____
Witness: Peter M. Pavao

**PREPARED DIRECT TESTIMONY OF
PETER M. PAVAO
ON BEHALF OF
SAN DIEGO GAS & ELECTRIC COMPANY**

**BEFORE THE PUBLIC UTILITIES COMMISSION
OF THE STATE OF CALIFORNIA**

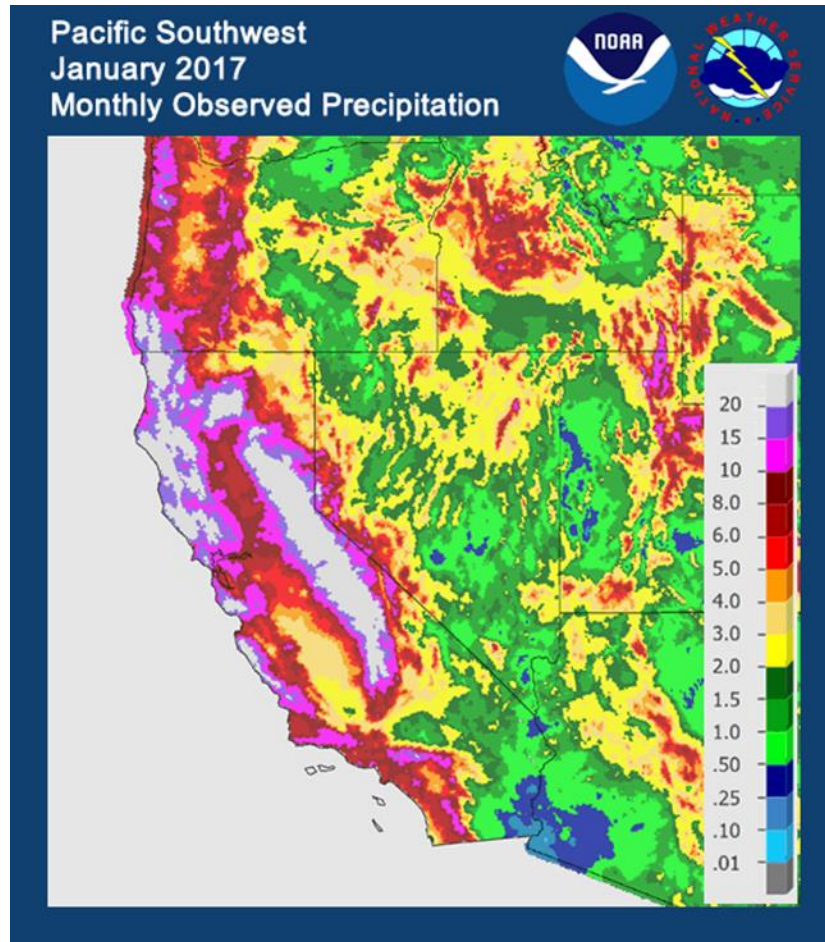
January 2017 Observed Precipitation

Rainfall totals for the month amounted to around 3-4" along the coastline (roughly 1" above average), up to 7-8" across our foothills (roughly 4" above average), and as much as 14-15" across the mountains (roughly 8-9" above average), nearly two-thirds of which fell during the January 19-24, 2017 timeframe.

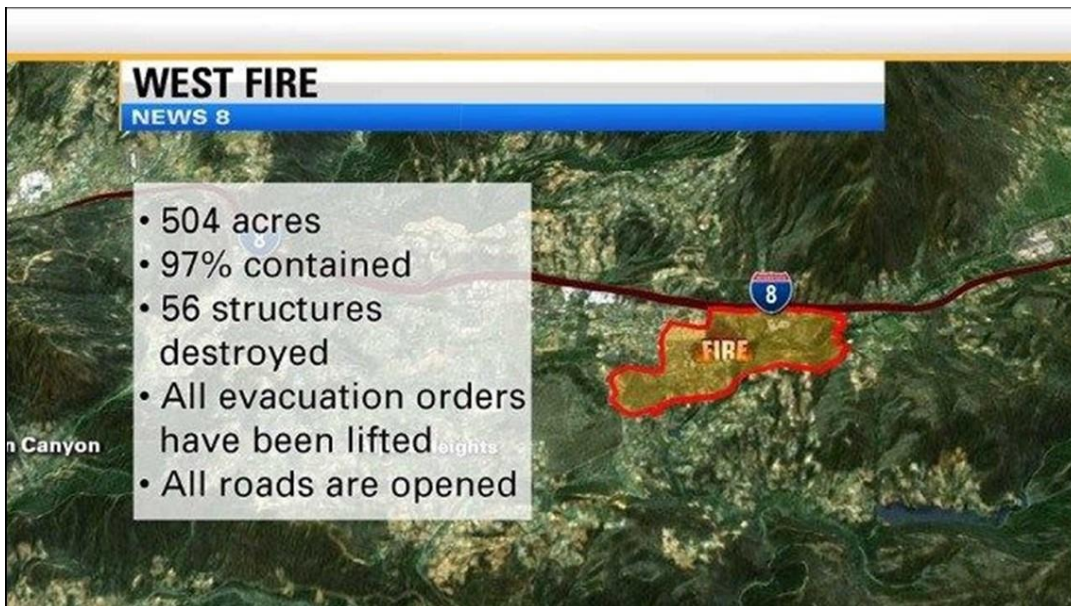
West Fire – Area Burned

22 The 2018 West Fire started on July 6, 2018, near Alpine in San Diego County. In total,
23 the fire consumed 504 acres and destroyed 48 structures before it was contained on July 11,
24 2018. The 2018 West Fire also damaged SDG&E distribution equipment and resulted in outages

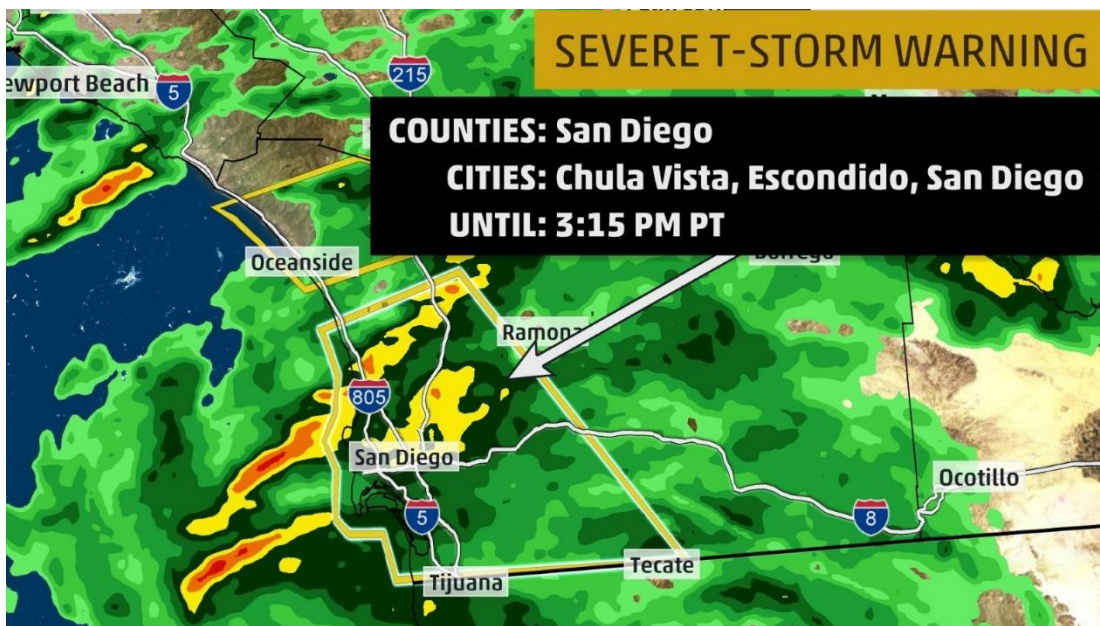
7 **February 2019 Winter Thunderstorm Radar**

14 The most notable storms during this period occurred on February 2, when a strong cold
15 front passed through the region, and February 13-14, when an atmospheric river crossed through
16 the state. The cold front produced widespread rainfall of 1-2" from the coast to the mountains,
17 though the larger impact was winds with gusts of 45-55 mph along the coastline and up to 60+
18 mph in the mountains. The atmospheric river event mid-month produced widespread significant
19 rainfall that resulted in street closures due to flooding of both urban areas and local rivers and
20 streams. Rainfall totals for the two-day event reached up to 2" along the coast, as high as 6.5-7"
21 across the mountains, and over 1.5" in the deserts. This was combined with a brief period of
22 winds when gusts reached 40-50 mph along the coast and as high as 70 mph in the mountains.
23 By the end of February, the percentage of average rainfall for the water year (October 1, 2018-
