BEFORE THE PUBLIC UTILITIES COMMISSION OF THE STATE OF CALIFORNIA

Order Instituting Investigation on the Commission's Own Motion into the Rates, Operations, Practices, Services and Facilities of Southern California Edison Company and San Diego Gas and Electric Company Associated with the San Onofre Nuclear Generating Station Units 2 and 3.	FILED PUBLIC UTILITIES COMMISSION OCTOBER 25, 2012 IRVINE, CA INVESTIGATION 12-10-013

ORDER INSTITUTING INVESTIGATION REGARDING SAN ONOFRE NUCLEAR GENERATING STATION UNITS 2 AND 3

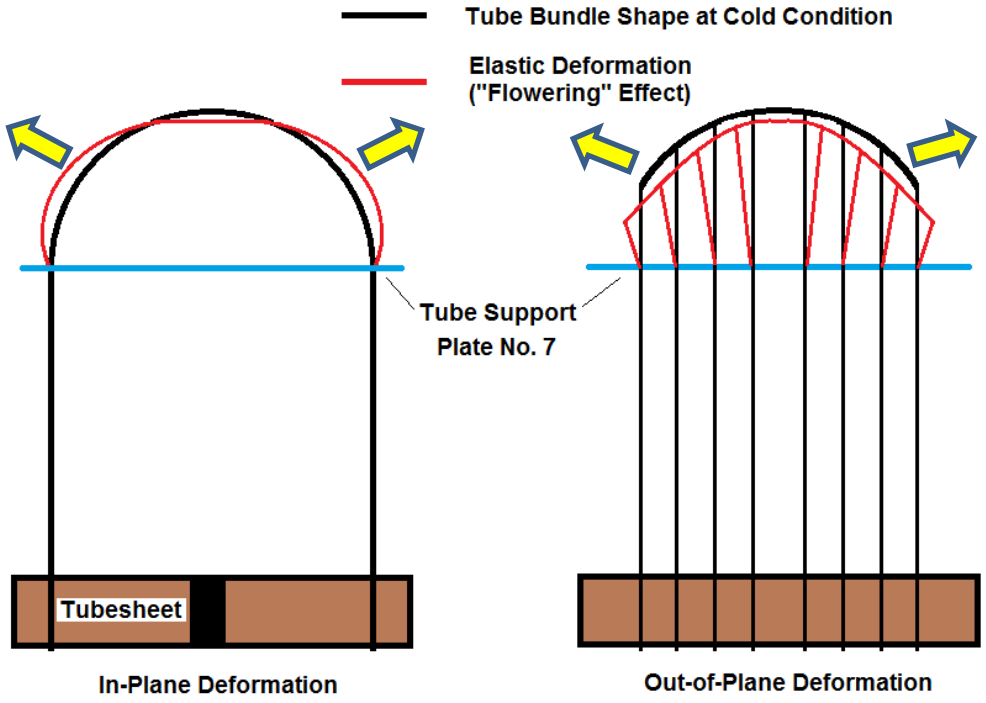
The failure mechanism model also considered a fluid dynamic effect associated with the spreading of the tubes in the U-bend region during normal operating conditions. This effect was informally referred to as "flowering," due to the characteristic shape in which the tube bundle spreads transverse to the plane of the u-bends at normal operating conditions. "Flowering" was described as the elastic deformation of the anti-vibration bar structure and the tube bundle in the U-bend region, as a result of thermal expansion and fluid dynamic pressure acting on the secondary side of the tubes (see figure below). The deformation caused by the "flowering" effect was believed to result in multiple areas of no contact between the anti-vibration bars and the tubes, which minimized resistance to in-plane motion of the u-bend area of the tubes.

Description of "Flowering" Effect (Conceptual Drawing – For Illustration Purposes Only)

Mitsubishi considered that the collective contribution of the factors described above resulted in conditions in the U-bend that were highly susceptible to excessive tube vibration. The in-plane vibration of the tubes in the U-bend region allowed direct contact between free-span sections of the tubes, resulting in the unanticipated tube-to-tube wear.

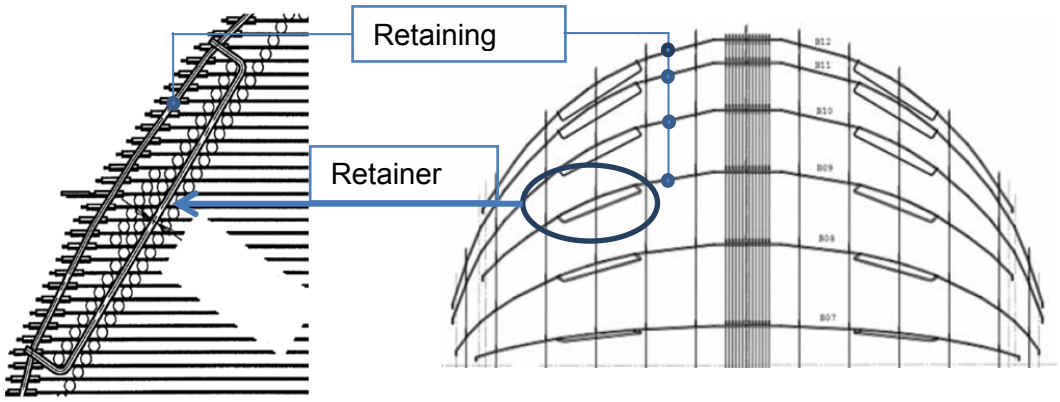
Description: In February 2012, the licensee identified wear indications in Unit 2 replacement steam generators at the tube locations in contact with the retainer bars (see figure below). Some of the indications showed excessive wear with a maximum degradation of 90 percent through wall.

Retainer Bar Design and Location of Affected Tubes (For Illustration Purposes Only)

The team identified that the design of the replacement steam generators did not expect any potential vibration concerns in the area of the tube bundle where the retainer bars were located. The basis for Mitsubishi's design philosophy relied on the following factors:

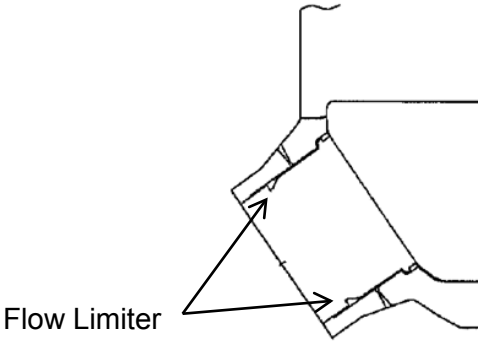
- Flow Limiter for Primary Inlet Nozzles – The replacement steam generators were designed with a flow limiter located in the primary inlet nozzle (see figure below) in order to make the reactor coolant system flow similar to the flow rate of the

Replacement Steam Generator Primary Inlet Nozzle (For Illustration Purposes Only)

The flow limiter was designed to ensure the total "best estimate" reactor coolant flow rate with the replacement steam generators installed would not exceed 106.5 percent of the design volumetric flow rate of 396,000 gallons per minute at a reactor coolant system cold leg temperature of Tcold = 540.9^{o}F. For Unit 2 replacement steam generators, the flow limiter diameter to nozzle inner diameter ratio was 0.94 while the ratio for Unit 3 steam generators was 0.915 due to Unit 3 reactor coolant pump replacement. The flow limiter dimensions resulted from a scaled model test performed by Mitsubishi and it was designed to be machined as part of the nozzle base metal.

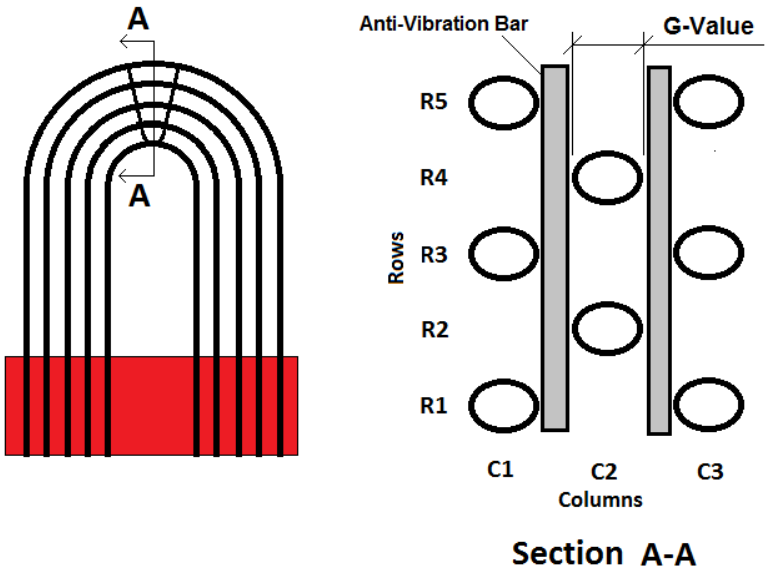
The first dimensional control under consideration was the improvement of tube roundness in the section of the tubes that was bent to form the U-bend shape. During fabrication of Unit 2 steam generator 2E0-89, the supplier of tubular product for Mitsubishi (i.e. Sumitomo), experienced quality issues to meet the G-values established in the design specifications, resulting in a high number of tube rejections. The G-value was a measure of departure from roundness, or "ovality," after the tubes were bent and it was controlled in order to control the gap between tubes and anti-vibration bars (see figure below). The G-values were measured at different locations along the U-bend section of the tubes for a selected number of tubes per row, as established in Mitsubishi's procedure. The acceptance criteria for G-value varied depending on the row where the tubes were installed. The acceptance criteria also remained the same throughout the fabrication of Unit 2 and Unit 3 replacement steam generators.

Description of G-Value Parameter (Conceptual Drawing – For Illustration Purposes Only)

Based on discussions with licensee personnel and documentation reviews, the team noted that Sumitomo implemented measures to improve the quality of the tube bending process which resulted in less deviation of G-values and a reduction in the amount and variability of tubing "ovality." Based on the statistical analysis of G-value data collected during fabrication of the Unit 2 and Unit 3 steam generators, Mitsubishi concluded that the G-values standard deviation gradually decreased since the fabrication of the first steam generator.

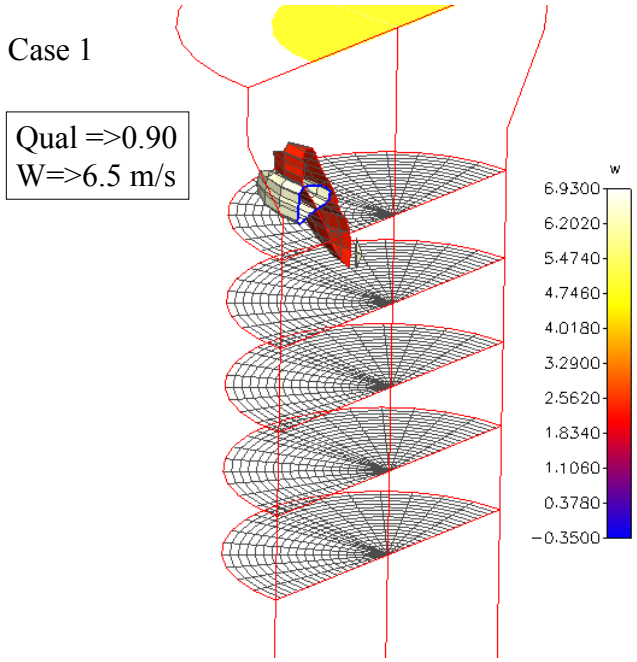
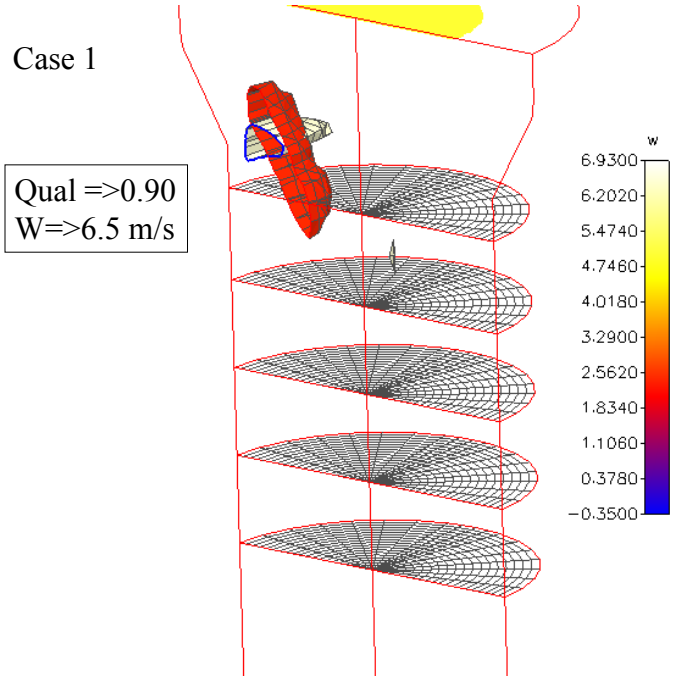
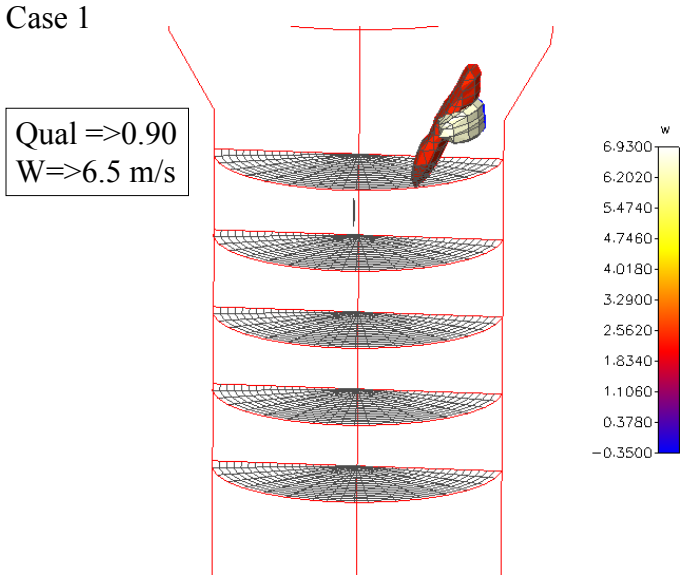
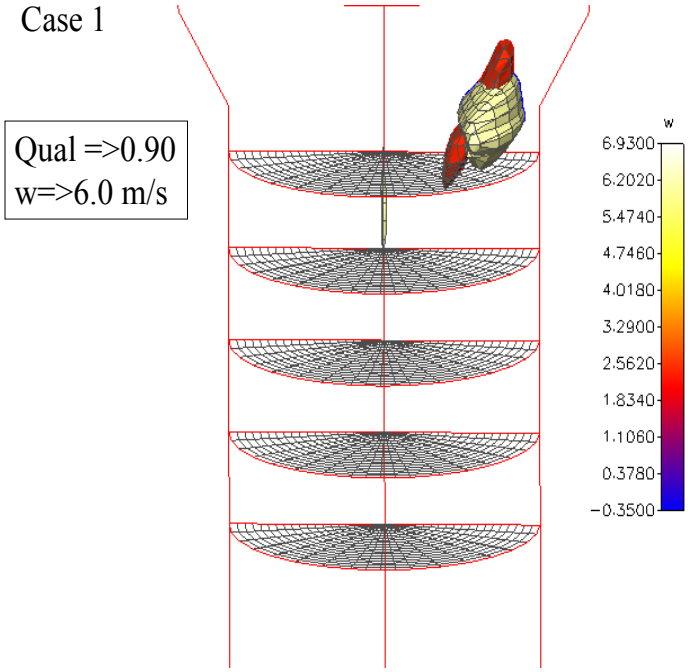
The tube-to-tube wear indications align with anti-vibration bar wear indication trends; however, the anti-vibration bar wear patterns appear to indicate a more square-like, essentially rectangular behavior that suggests that there may also be a mechanical, fabrication, assembly, and/or material contribution to the tube-to-tube wear degradation.

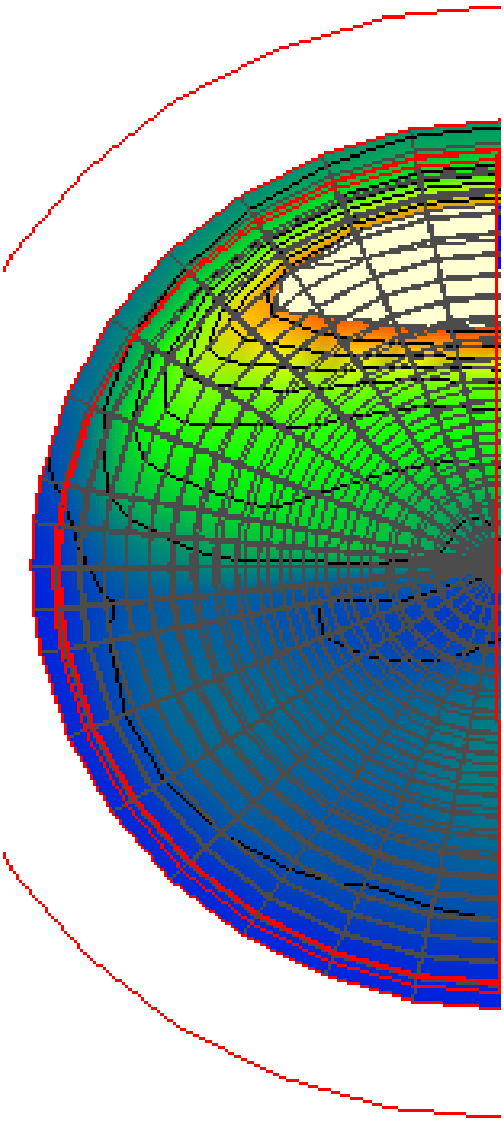
Figure 5 The ATHOS code predicted regions of high void fraction and high steam velocities are superimposed with tube-to-tube wear indications from Unit 3 steam generator 3E0-88

The NRC analysis indicated a correlation with the tube-to-tube wear based on a combination of high void fraction and high steam velocities. It should be noted that the traditional forcing function, fluid velocity squared times density, does not show good agreement with the tube-to-tube wear patterns. This indicated that the high quality steam fluid velocities and high void fraction may be sufficiently high to cause conditions in the generators conducive for onset of fluid-elastic instability.

The above analyses apply equally to Units 2 and 3, so it does not explain why the accelerated fluid-elastic instability wear damage was significantly greater in Unit 3 steam generators. The ATHOS thermal-hydraulic model predicts bulk fluid behavior based on first principals and empirical correlations and as a result it is not able to evaluate mechanical, fabrication, or structural material differences or other phenomena that may be unique to each steam generator. Therefore this analysis cannot account for these mechanical factors and differences which could very likely also be contributing to the tube degradation.

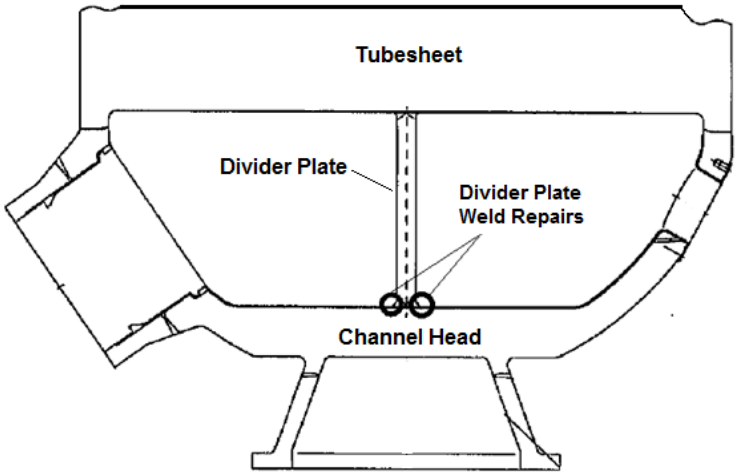
On March 18, 2009, Mitsubishi identified cracking indications in the weld between the divider plate and the channel head of Unit 3 replacement steam generator 3E0-88 (see figure below), after completion of the ASME Section III hydrostatic test on the secondary side. The extent of condition investigation also identified similar cracking indications in Unit 3 replacement steam generator 3E0-89. As discussed in Section 4 of this report, the cause of the cracking was attributed to the air carbon-arc gouging process used to remove the clad weld from the channel head. The team reviewed information associated with the repair of the cracking indications to assess whether the repair activities resulted in relevant differences in design and fabrication that could be considered as contributing factors for the cause of the tube-to-tube wear issue in Unit 3.

Location of Divider Plate Weld Repairs in Unit 3 Steam Generators (For Illustration Purposes Only)
